# CLINTON RESERVOIR DAM

NJ 00314

PHASE 1 INSPECTION REPORT  
NATIONAL DAM SAFETY PROGRAM

APRIL 1980

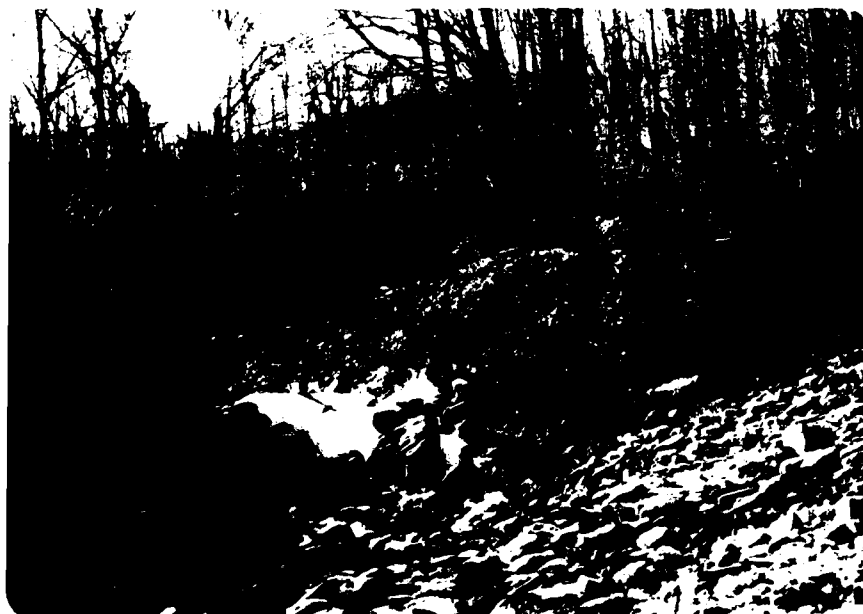
| VISUAL EXAMINATION OF | OBSERVATIONS | REMARKS AND RECOMMENDATIONS |
|---|---|---|
| DISCHARGE CHANNEL | Riprap, in good condition, at bottom of channel. Downstream side of spillway has leakage. Leakage is located about 60 feet downstream from the spillway crest, about 5 feet from the right abutment wall. | Monitor leakage for clearness and quantity. |

Photo 10 - View from the spillway looking toward the downstream channel. Photo taken on December 4, 1979).
