**CRANES LAKE DAM**

**NJ 00444**

**PHASE 1 INSPECTION REPORT  
NATIONAL DAM SAFETY PROGRAM**

**MARCH 1980**

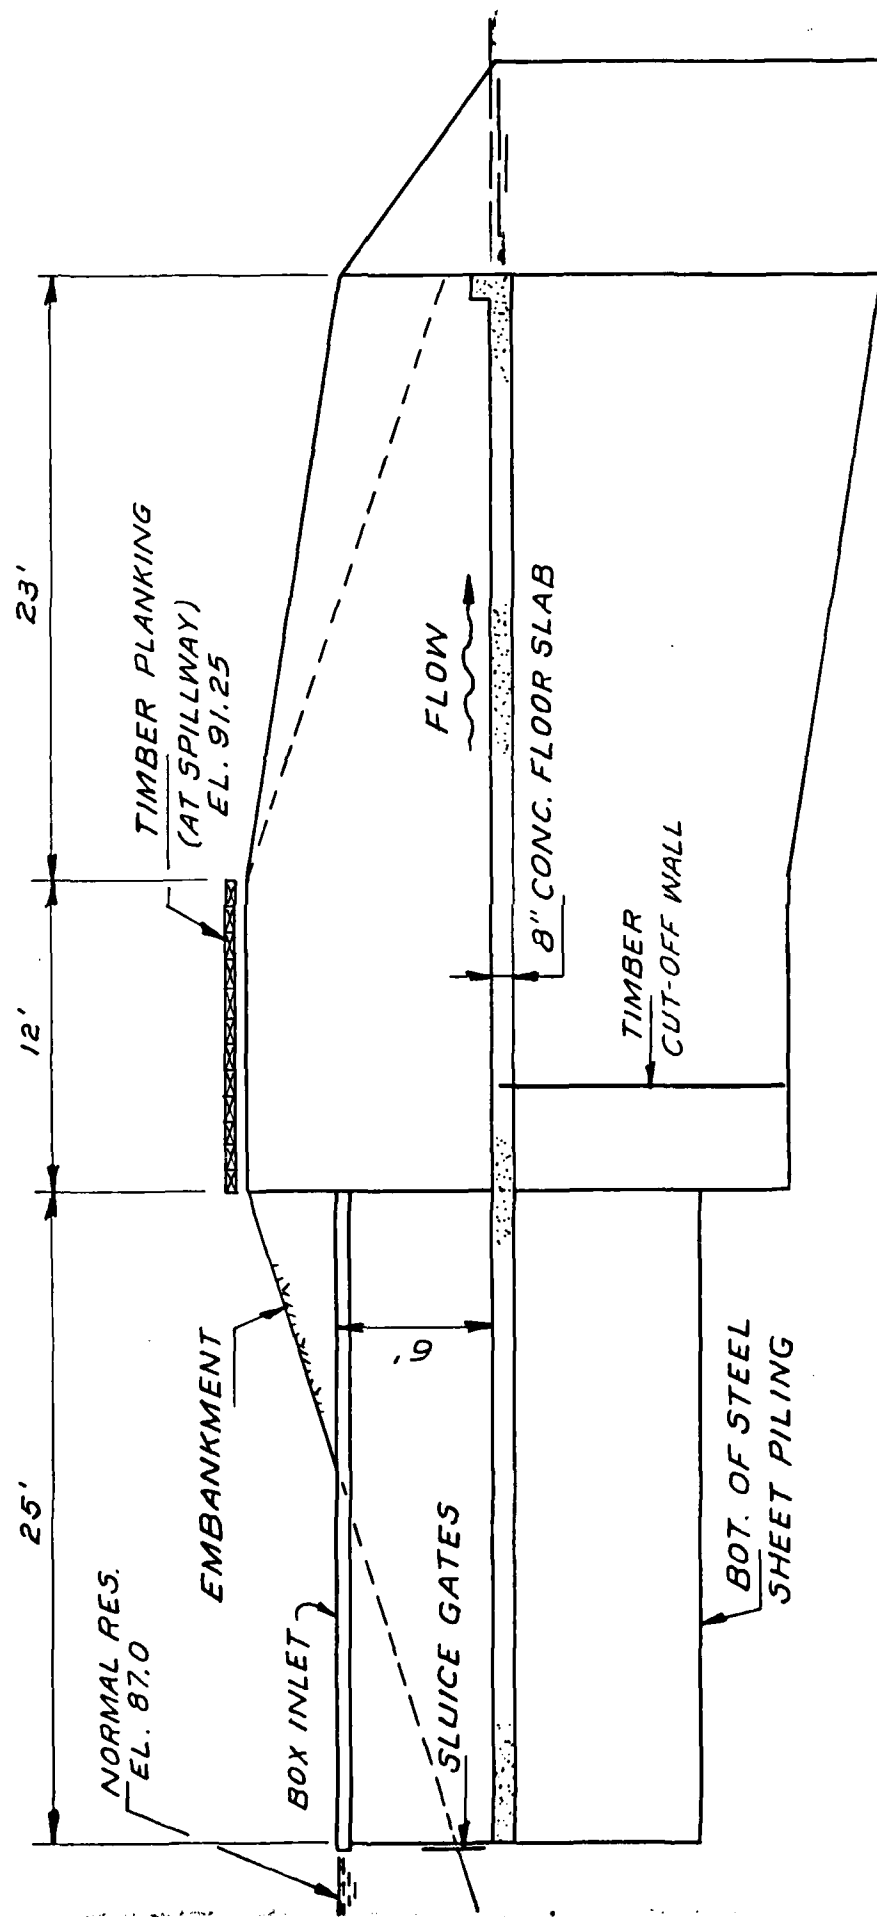
FIGURE 3

The design information available for review were the 1971-2 construction plans for the spillway (see Figures 2 and 3). The design was undertaken by Mr. James W. Stingel, P.E. Ass't State Conservation Engineer of the U.S. Department of Agriculture. It is unknown to what capacity the steel sheeting was driven but the overall design appears to be quite conservative and follows accepted standard practices. The steel section is U.S. Steel MP 115.

SECTION THRU SPILLWAY  
NOT TO SCALE
