NATIONAL DAM SAFETY PROGRAM. UPPER AETNA LAKE DAM (NJ 00420), D--ETC(U)

**UPPER AETNA  
LAKE DAM  
NJ 00420**

**PHASE 1 INSPECTION REPORT  
NATIONAL DAM SAFETY PROGRAM**

**FEBRUARY 1980**

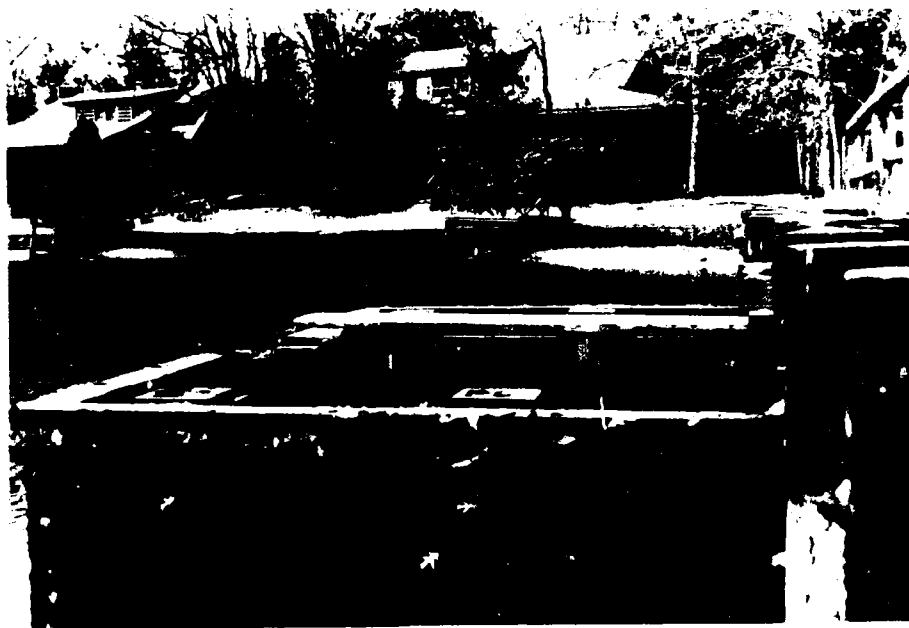
The three-sided timber box spillway which measures approximately 16' x 10' is in reasonably good condition except for some deterioration of

individual posts and planks. The entire structure is solidly constructed of heavy, creosoted wood members and is equally solidly founded on a substantial pattern of timber piles. Horizontal and vertical alignment is true throughout. Bridge deck planking is in satisfactory condition as is the remainder of the spillway outlet. The structure is clean and the flashboards of the intake seem to be kept in good working order. No designed auxiliary spillway exists, except for a relative low point in the paved roadway near the west end of the embankment. Excess flows can be carried across the embankment here in an emergency, and a small paved outlet is provided on the downstream slope. There is evidence of asphalt patching on the crest roadway surface and minor ravelling at the edges but the overall condition is satisfactory.

| VISUAL EXAMINATION OF | OBSERVATIONS | REMARKS OR RECOMMENDATIONS |
|---|---|---|
| CONCRETE WEIR | Overflow timber box spillway, several piles and boards need replacement, horizontally and vertically true, one set of removable flashboards. Lake level down. | |

View of Timber Spillway

(2) Conduct an examination of the overall spillway structure with a view to planning the repair or replacement of selected timbers before their condition becomes critical.

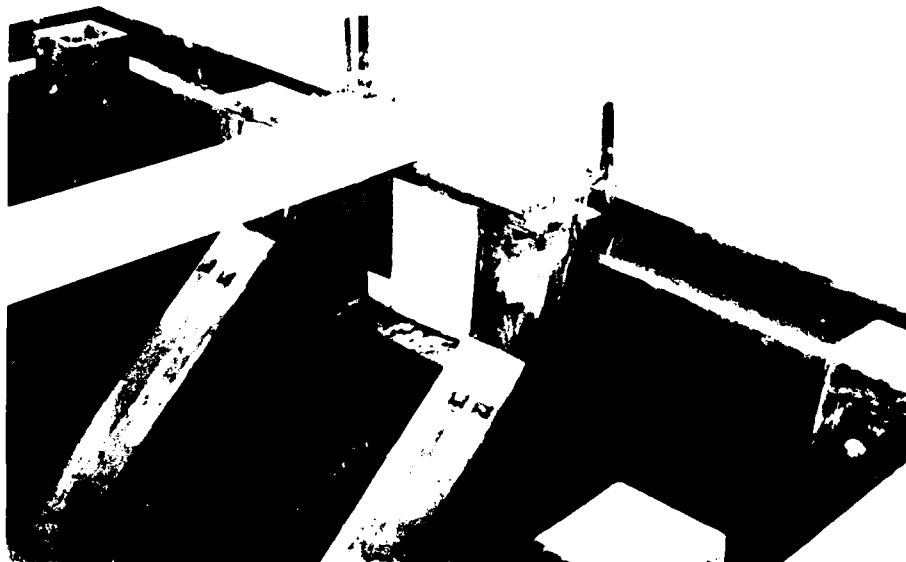
View of 3'-4" Gate
