PEDDIE LAKE DAM

NJ 00149

PHASE 1 INSPECTION REPORT
NATIONAL DAM SAFETY PROGRAM

MARCH 1980

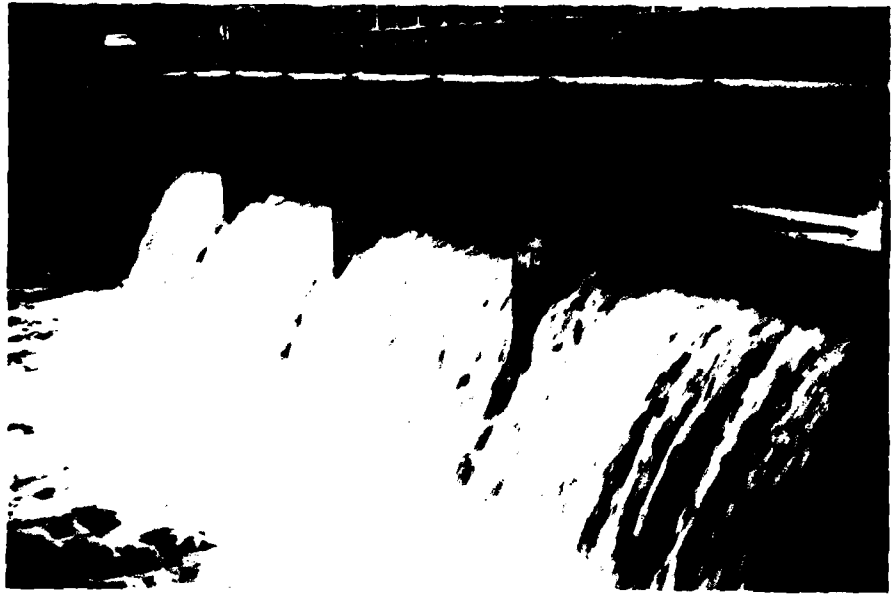
PHOTO 1
SPILLWAY

VISUAL EXAMINATION OF	OBSERVATIONS	REMARKS OR RECOMMENDATIONS
WEIR	Weir was obscured by overflow but appeared to be in generally satisfactory condition.	
DISCHARGE CHANNEL	Spillway discharges into stilling basin formed by stone masonry training walls on the sides and a stone masonry road bridge at the downstream end.	
PIERS	Stone masonry piers appeared to be generally sound with some deterioration noted. Some of the grout appeared to be deteriorated causing displacement of some stones.	
BRIDGE	Concrete slab pedestrian bridge spans the spillway supported by piers and abutments. Concrete surfaces appeared to be in satisfactory condition. Steel pipe railing was in sound condition.

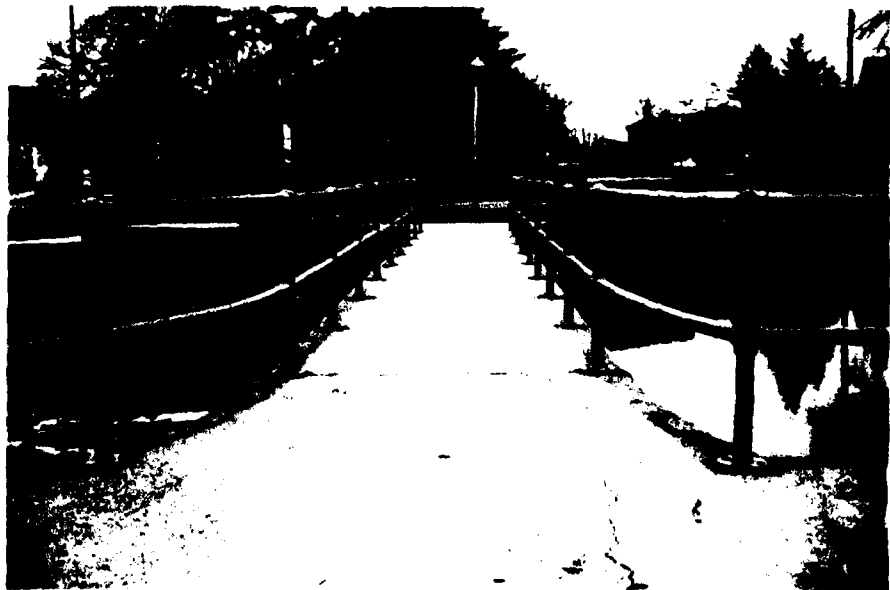
PHOTO 2
WALKWAY OVER SPILLWAY

The concrete on the upstream side of the dam was submerged and could not be observed. Piers supporting the walkway appeared structurally stable although some surface deterioration was observed resulting in loosened stones. The downstream face of the dam is composed of a stepped stone masonry wall. Condition of the wall is generally satisfactory although there is some deterioration with loose stones and missing mortar. Evidence of subsidence of soil was noted at each end of the dam. According to the Public Works Department of Hightstown, this is due to overtopping in major storms. Concrete steps at each end were cracked and settled. Also, asphalt pavement adjacent to the right end of the dam was settled.

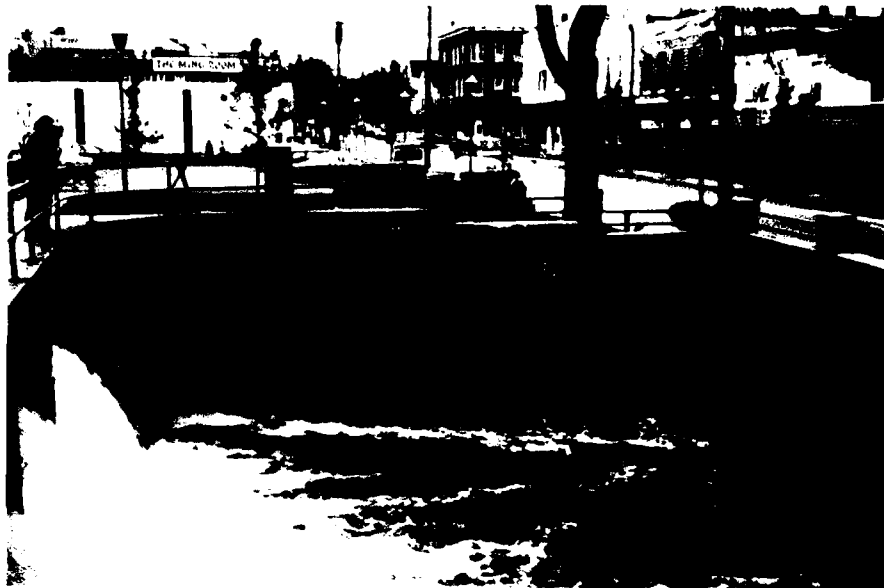
PHOTO 3

SOUTH DOWNSTREAM TRAINING WALL

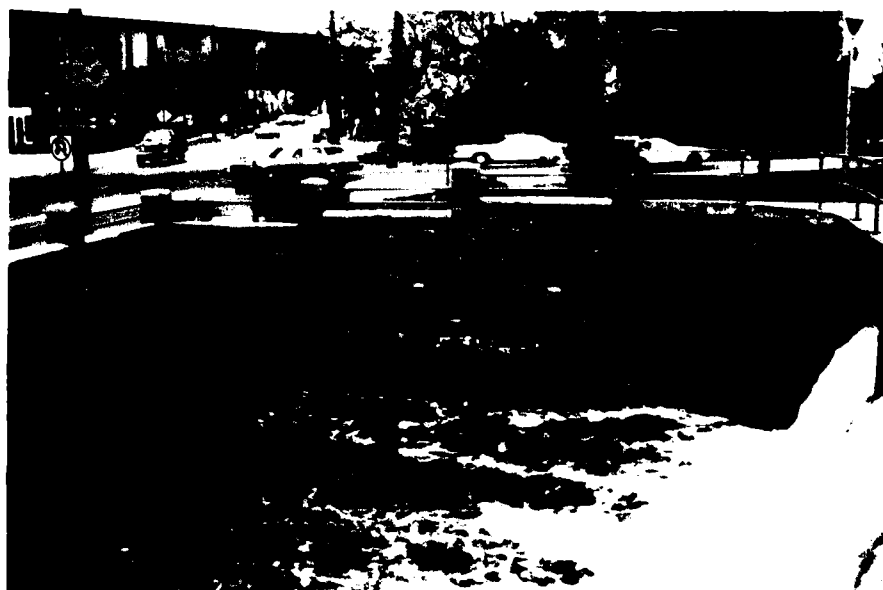
PHOTO 4

NORTH DOWNSTREAM TRAINING WALL

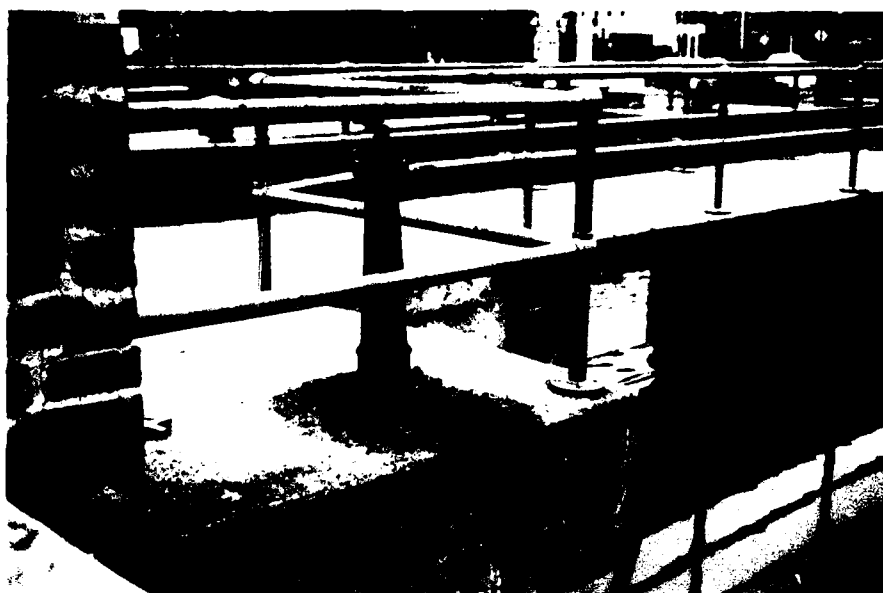
PHOTO 5

The outlet works operating mechanism at the south end of the dam is mounted on a concrete slab which is an extension of the walkway. Beneath the slab, the concrete wall on which the gate is mounted was spalled above the water line. The gate lift stem was rusted but appeared to be sound.

OUTLET WORKS OPERATING MECHANISM

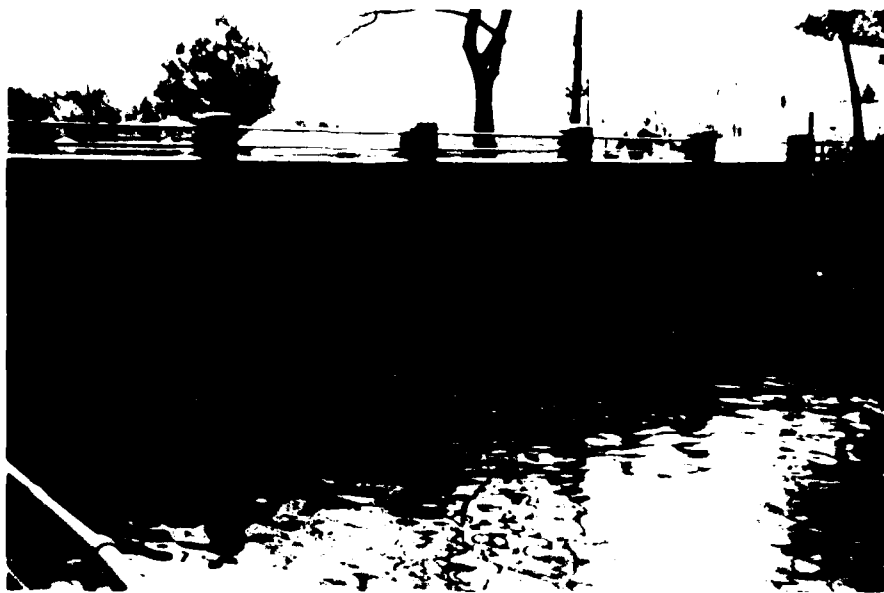
PHOTO 9

MASONRY BRIDGE DOWNSTREAM FROM DAM - DOWNSTREAM VIEW

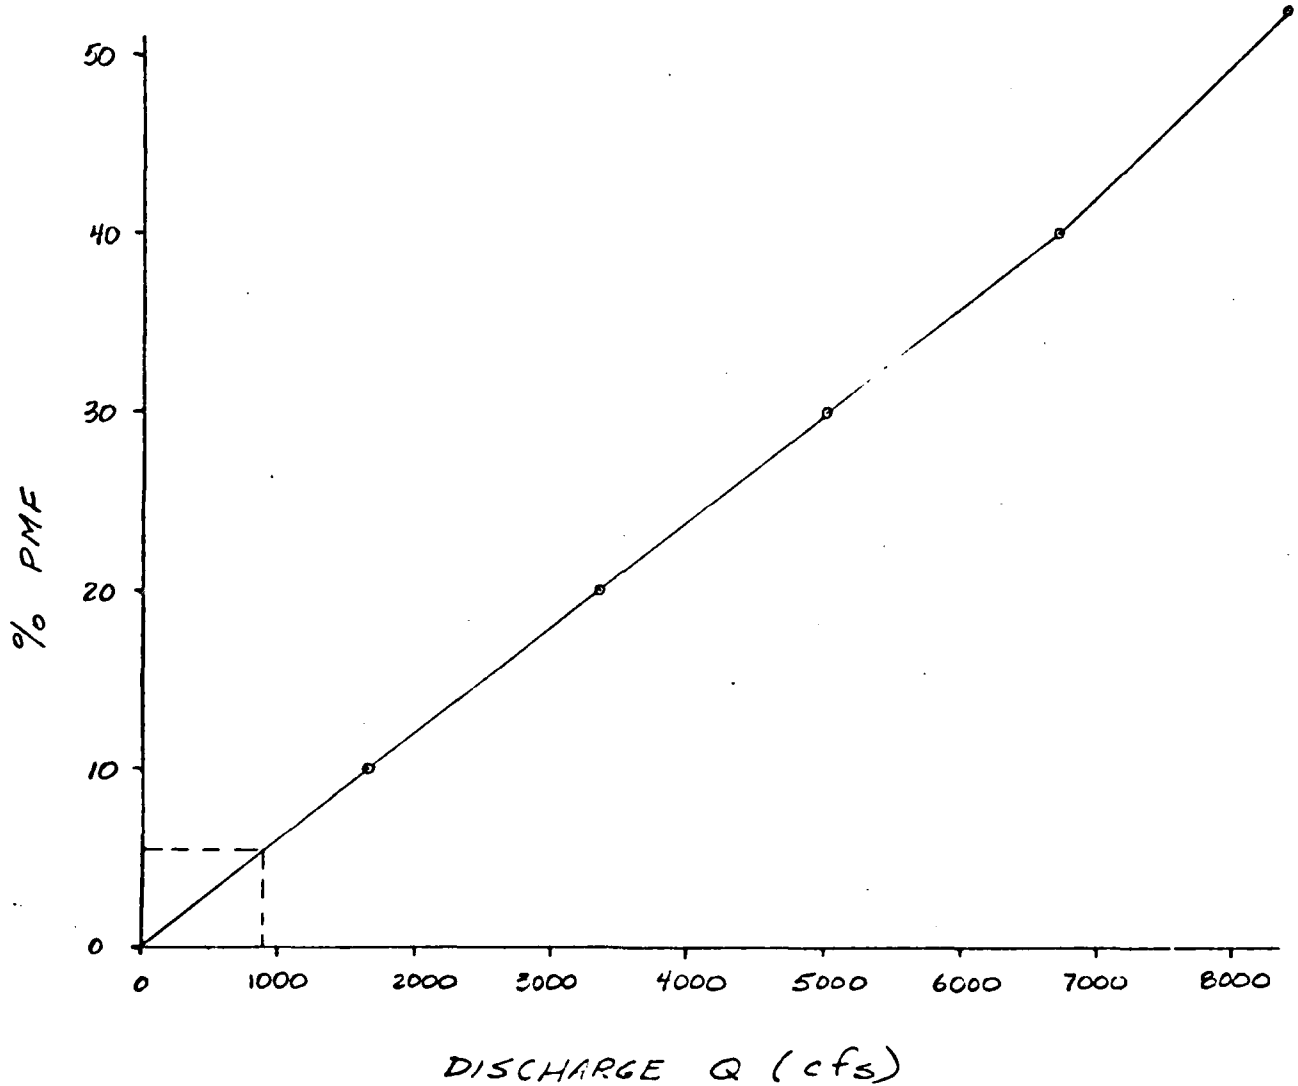
OVERTOPPING POTENTIAL

DAM CAN PASS 6% of PMF
OR 12% of SDF

Based on hydraulic and hydrologic analyses outlined in paragraph 5.1.a, the spillways are considered to be inadequate. It is therefore recommended that a professional engineer experienced in the design and construction of dams be engaged in the near future to perform more accurate hydraulic and hydrologic analyses. Based on the findings of the analysis, the need for and type of remedial measures should be determined and then implemented.
