LINDYS LAKE DAM

NJ 00201

**PHASE 1 INSPECTION REPORT
NATIONAL DAM SAFETY PROGRAM**

FEBRUARY 1980

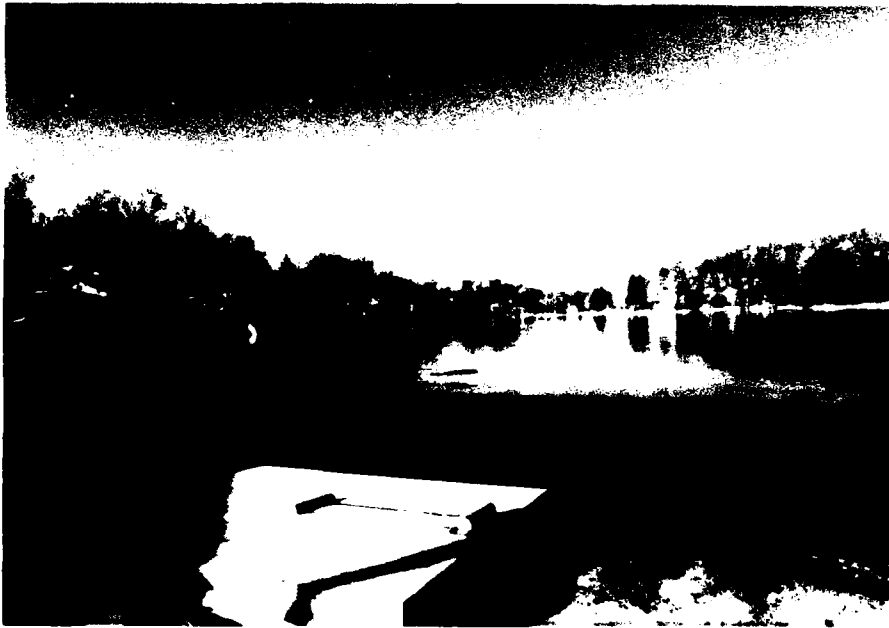
Photo 11 - View of Lindys Lake taken from spillway.
(Photo taken on January 20, 1980).
