PASSAIC RIVER BASIN
TROY BROOK, MORRIS COUNTY
NEW JERSEY

**DE COZEN'S DAM
NJ 00353**

**PHASE 1 INSPECTION REPORT
NATIONAL DAM SAFETY PROGRAM**

APRIL 1980

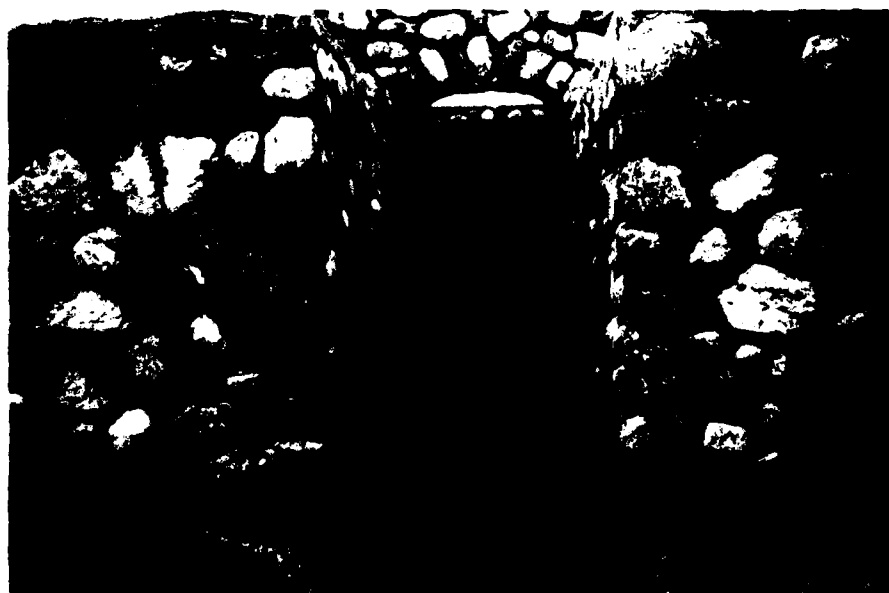
PHOTO 2

The downstream surface of the set of timber stoplogs appeared to be in satisfactory condition. The timber walkways spanning the spillway and outlet works were in satisfactory condition.

DOWNSTREAM SIDE OF OUTLET WORKS SHOWING STOPLOGS

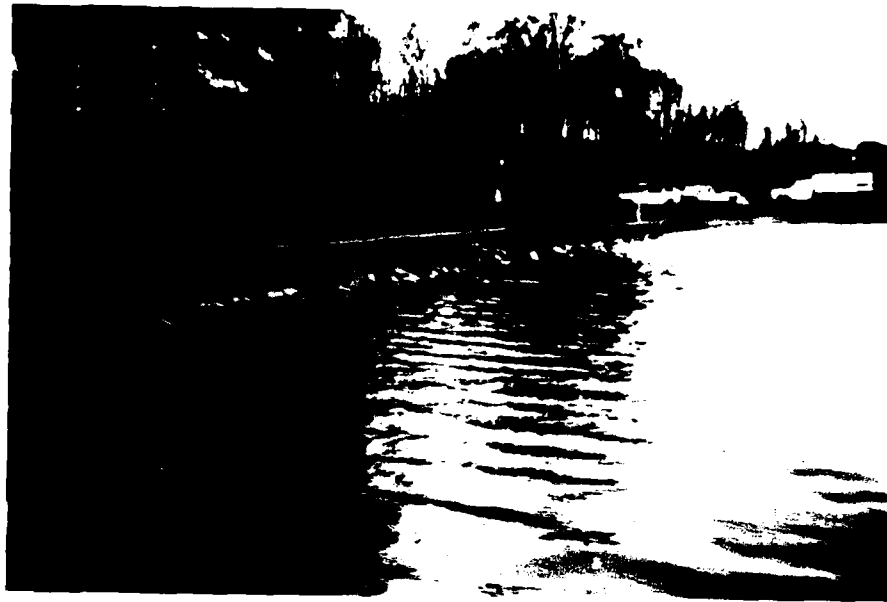
PHOTO 7
UPSTREAM FACE OF DAM

Riprap was observed along the sloped upstream face, adjacent to the stone masonry wall. The stones appeared to be of adequate size.

UPSTREAM FACE	<p>The stone masonry wall is in generally satisfactory condition although in two places its concrete cap was broken off. The concrete wall was in generally good condition.</p>	<p>A concrete capped stone masonry wall comprises the upper portion of the upstream face of dam for most of its length. A concrete wall forms the south portion of the upstream face.</p>
DRAINS	<p>None observed</p>

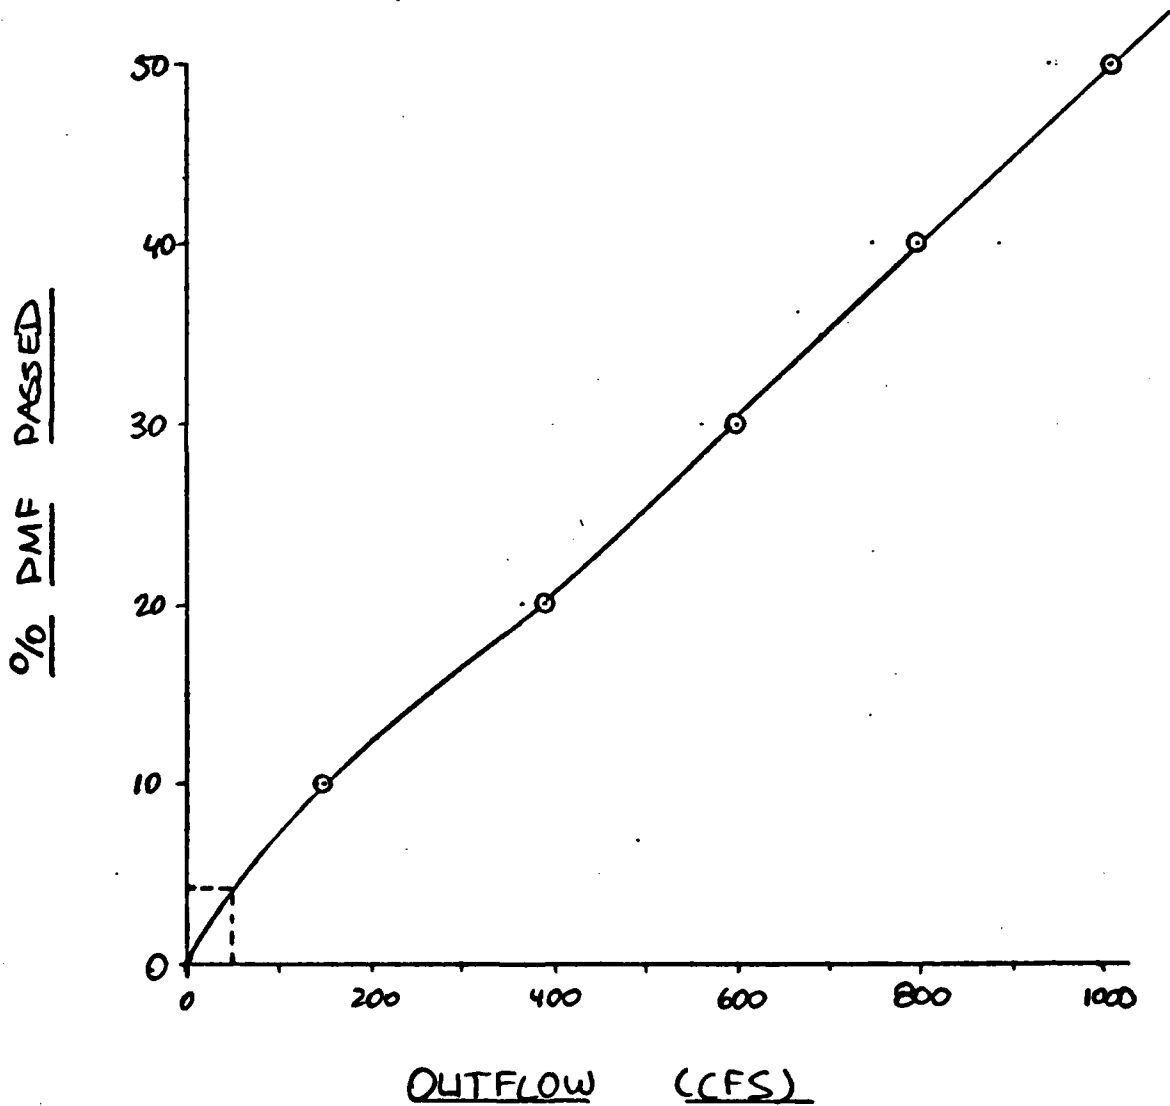
OVERTOPPING POTENTIAL

As indicated in paragraph 5.1.a, a storm of magnitude equivalent to the SDF would cause overtopping of the dam by a depth of 1.3 feet above the top of dam. The spillway is capable of passing approximately 4 percent of the PMF or 8 percent of the SDF with lake level equal to the top of dam (elev. 227.4).

OVERTOPPING OF THE DAM OCCURS AT ELEVATION 327.4, WITH $Q = 50$ CFS \therefore DAM CAN PASS APPROXIMATELY 4.2 % PMF OR 8.4 % SDF

Based on hydraulic and hydrologic analyses outlined in paragraph 5.1.a., the spillway is assessed as being inadequate. It is therefore recommended that a professional engineer experienced in the design and construction of dams be engaged in the future to perform more accurate hydraulic and hydrologic analyses. Based on the findings of the analyses, the need for and type of remedial measures should be determined and then implemented.
