INDIAN LAKE DAM

NJ 00188

PHASE 1 INSPECTION REPORT NATIONAL DAM SAFETY PROGRAM

MARCH 1980

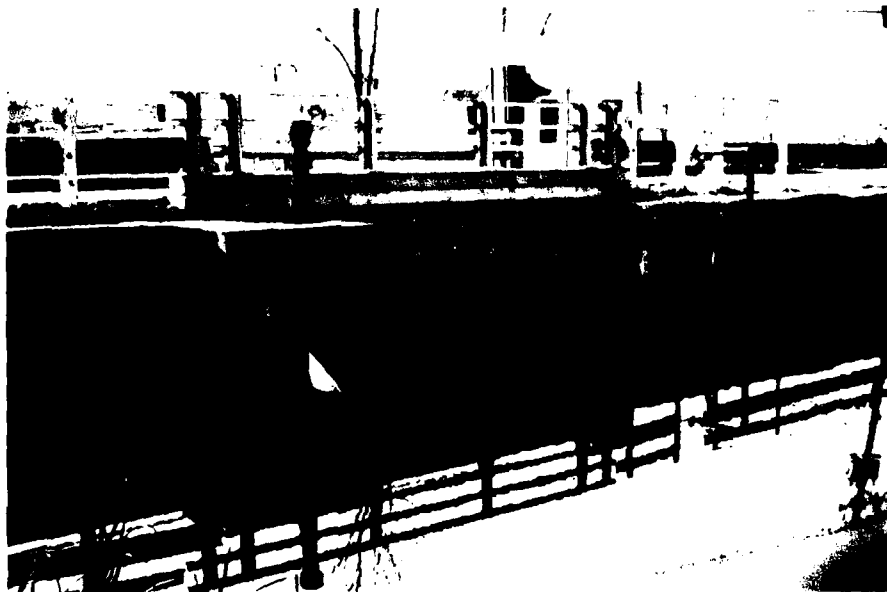
The spillway structure appeared to be structurally sound. Concrete surfaces were eroded with some spalling and exposed aggregate observed. The spalling was most pronounced near the crest.

PHOTO 1
SPILLWAY

- 1) The gaps adjacent to the bridge wingwalls should be suitably repaired and the embankment filled and stabilized.
- 2) The spillway structure and outlet works should be thoroughly inspected with the lake drawn down and then renovated as required.

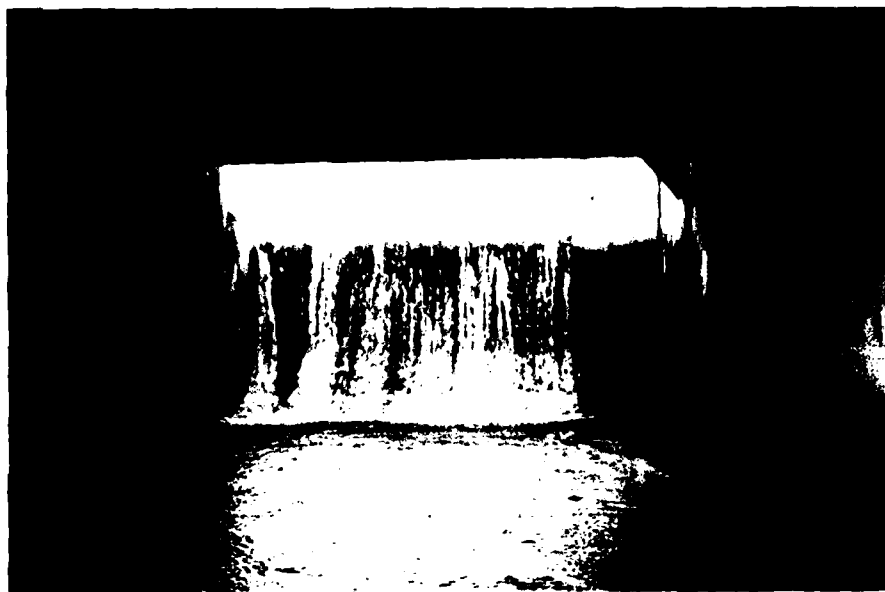
PHOTO 2
DOWNSTREAM FACE OF SPILLWAY AND DISCHARGE CHANNEL

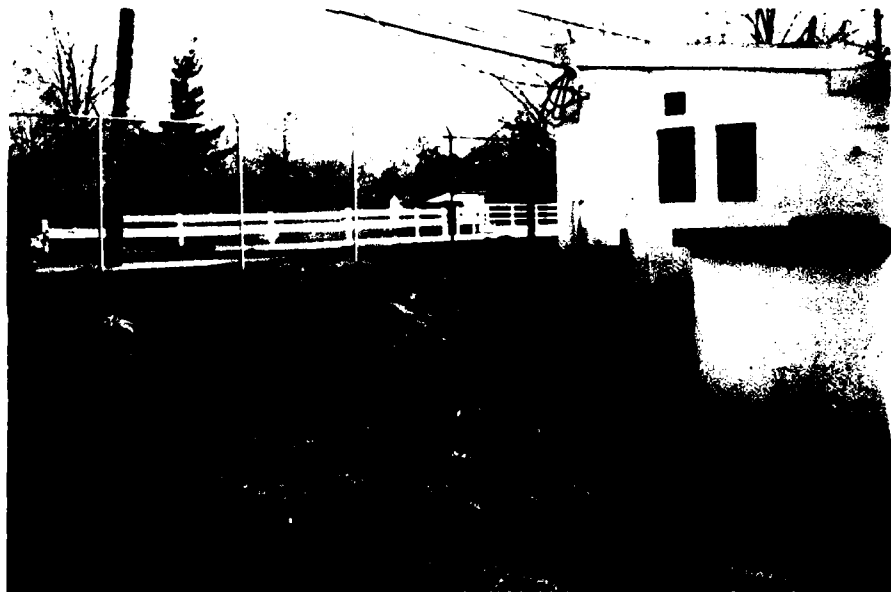
The crest of dam appeared to be level and uniform in width and the paved road was in good condition. The downstream face, north of the waterworks, was uniformly graded and covered with a uniform stand of grass. The downstream face, south of the waterworks, was covered with ground cover, weeds and small trees.

PHOTO 4
DOWNSTREAM FACE OF DAM

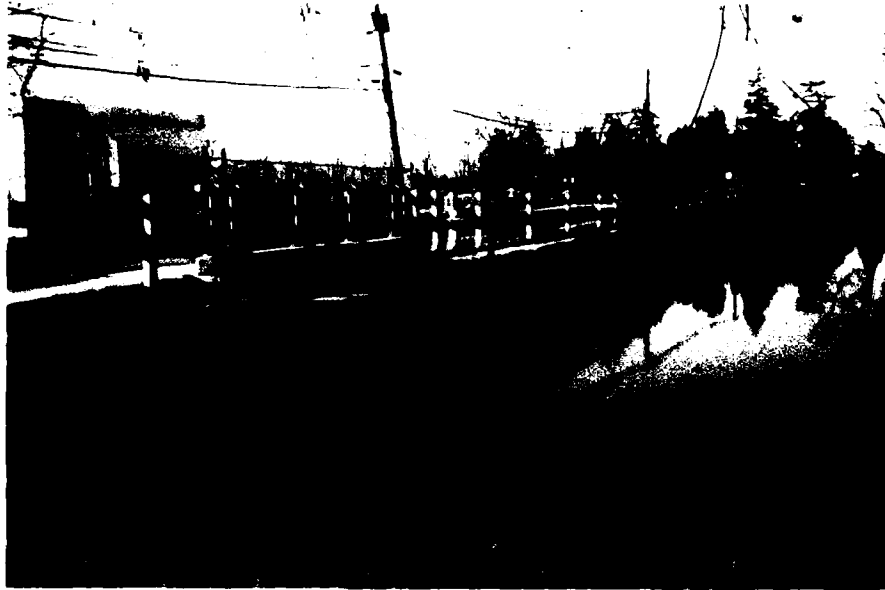
PHOTO 5

UPSTREAM FACE OF DAM - LOOKING EAST

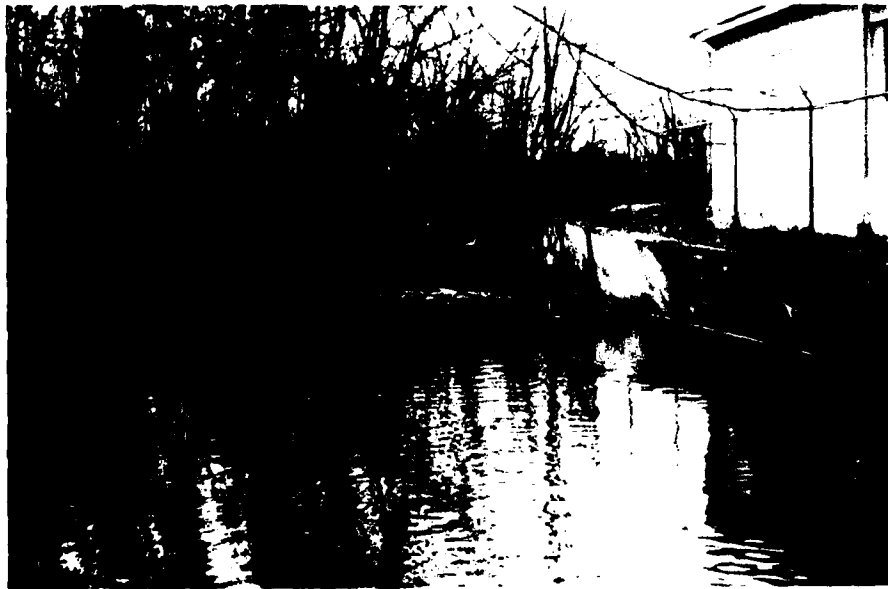
PHOTO 10

DOWNSTREAM CHANNEL
