| REPORT DOCUMENTATION PAGE | | READ INSTRUCTIONS<br>BEFORE COMPLETING FORM |
|---|---|---|
| 4. TITLE (and Subtitle)<br><del>Phase I Inspection Report</del><br>National Dam Safety Program-<br>Stony Brook Watershed Dam Site 7 (NJ00344),<br>Mercer County, New Jersey, Raritan River<br>Basin, Stony Brook, Mercer<br>County, New Jersey-<br>Phase I Inspection Report. | | 5. TYPE OF REPORT & PERIOD COVERED<br>(9) FINAL rept. 7 |

OVERVIEW - STONY BROOK WATERSHED SITE NO. 7 DAM

| <b>STORCH ENGINEERS</b><br>FLORHAM PARK, NEW JERSEY | <b>INSPECTION AND EVALUATION OF DAMS</b><br><b>KEY MAP</b><br><b>STONY BROOK WATERSHED SITE No. 7 DAM</b> | |

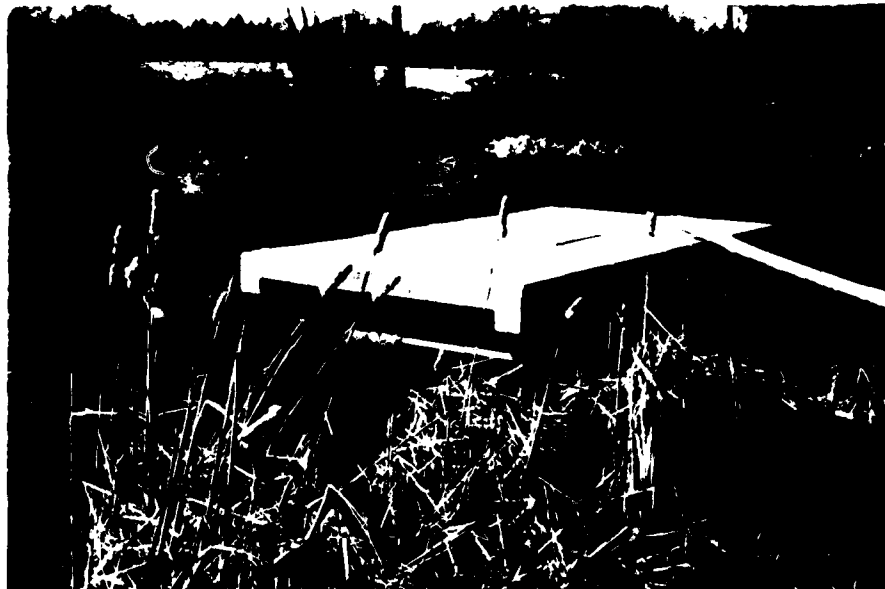
PHOTO 1

Most of the principal spillway (riser) was submerged or below grade, and therefore could not be inspected. The exposed portion of the spillway was in good condition with no cracks or spalls. The trash racks were sound and clear of debris. The access opening cover plate was sound and firmly fastened in place.

SPILLWAY STRUCTURE

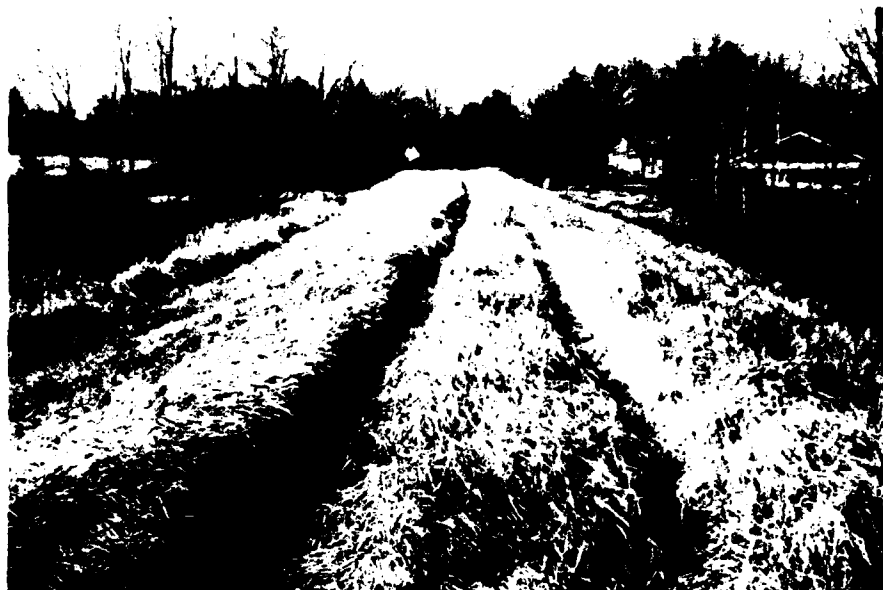
The earthfill embankment crest is straight and approximately level. There were two well defined vehicle tire paths extending along the entire embankment crest. The tire path areas exhibited a good stand of grass indicating infrequent traffic. There were no signs of subsidence or distress and the overall embankment was covered with moderate height, dense, hardy grass. No woody growth was observed on the embankment.

PHOTO 5  
CREST OF DAM

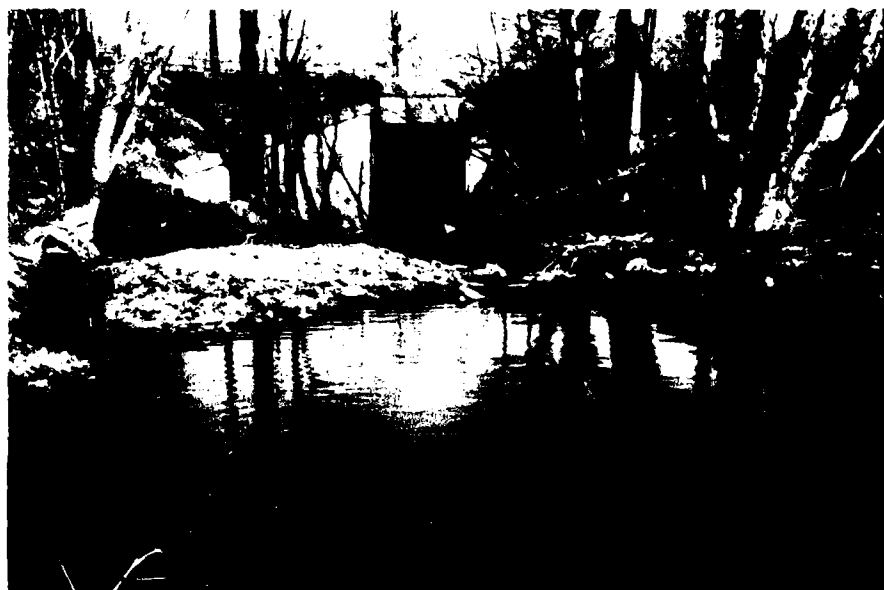
PHOTO 10

CULVERT UNDER ROAD DOWNSTREAM FROM DAM
