PASSAIC RIVER BASIN  
LONGHOUSE CREEK, PASSAIC COUNTY  
NEW JERSEY

**WEST MILFORD  
LAKE DAM  
NJ 00189 S**

**PHASE 1 INSPECTION REPORT  
NATIONAL DAM SAFETY PROGRAM**

**FEBRUARY 1980**

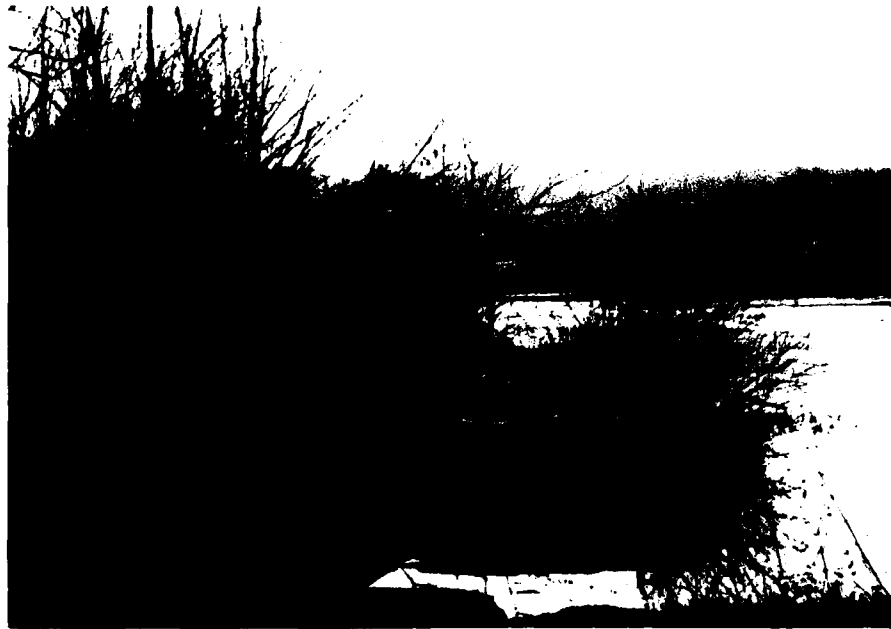
Photo 7 - Showing spalling of right abutment and portion of embankment beyond abutment.
