# KITCHELL LAKE DAM

NJ 00026

## PHASE 1 INSPECTION REPORT NATIONAL DAM SAFETY PROGRAM

FEBRUARY 1980

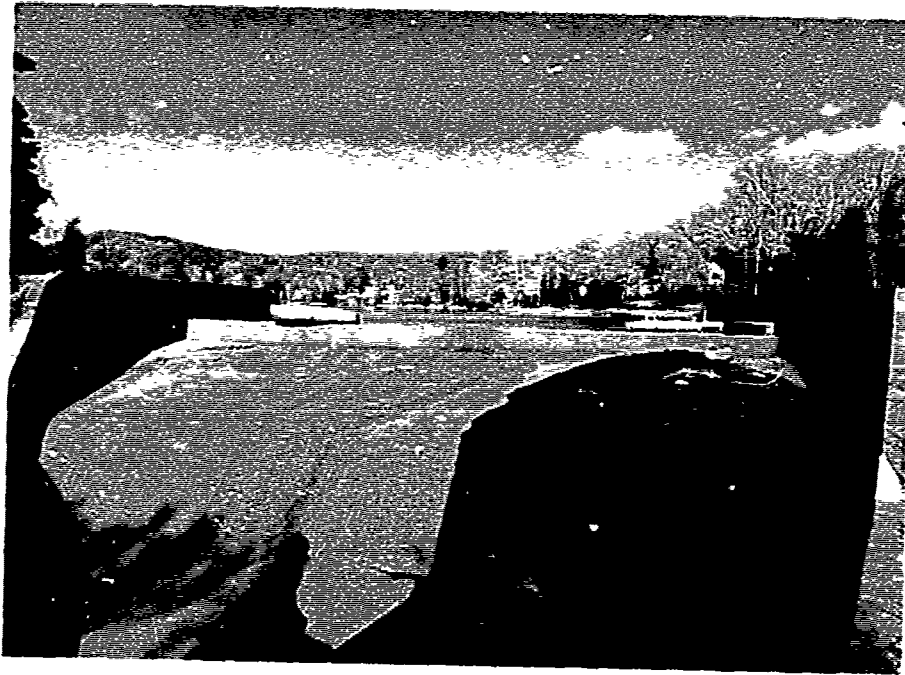
Photo 11 - View of spillway looking upstream. Note low level outlet drains in apron at bottom left and at right center. Also note completed repairs to right abutment mentioned in Photo 2. (Photo taken on January 21, 1980)
