**DSCS II**

**BATTERY ANOMALY INVESTIGATION  
SATELLITES 9437 AND 9438**

TRW DEFENSE AND SPACE SYSTEMS GROUP  
ONE SPACE PARK  
REDONDO BEACH, CALIFORNIA 90278  
REPORT NO. 32824-AR-019-01

**FINAL REPORT**

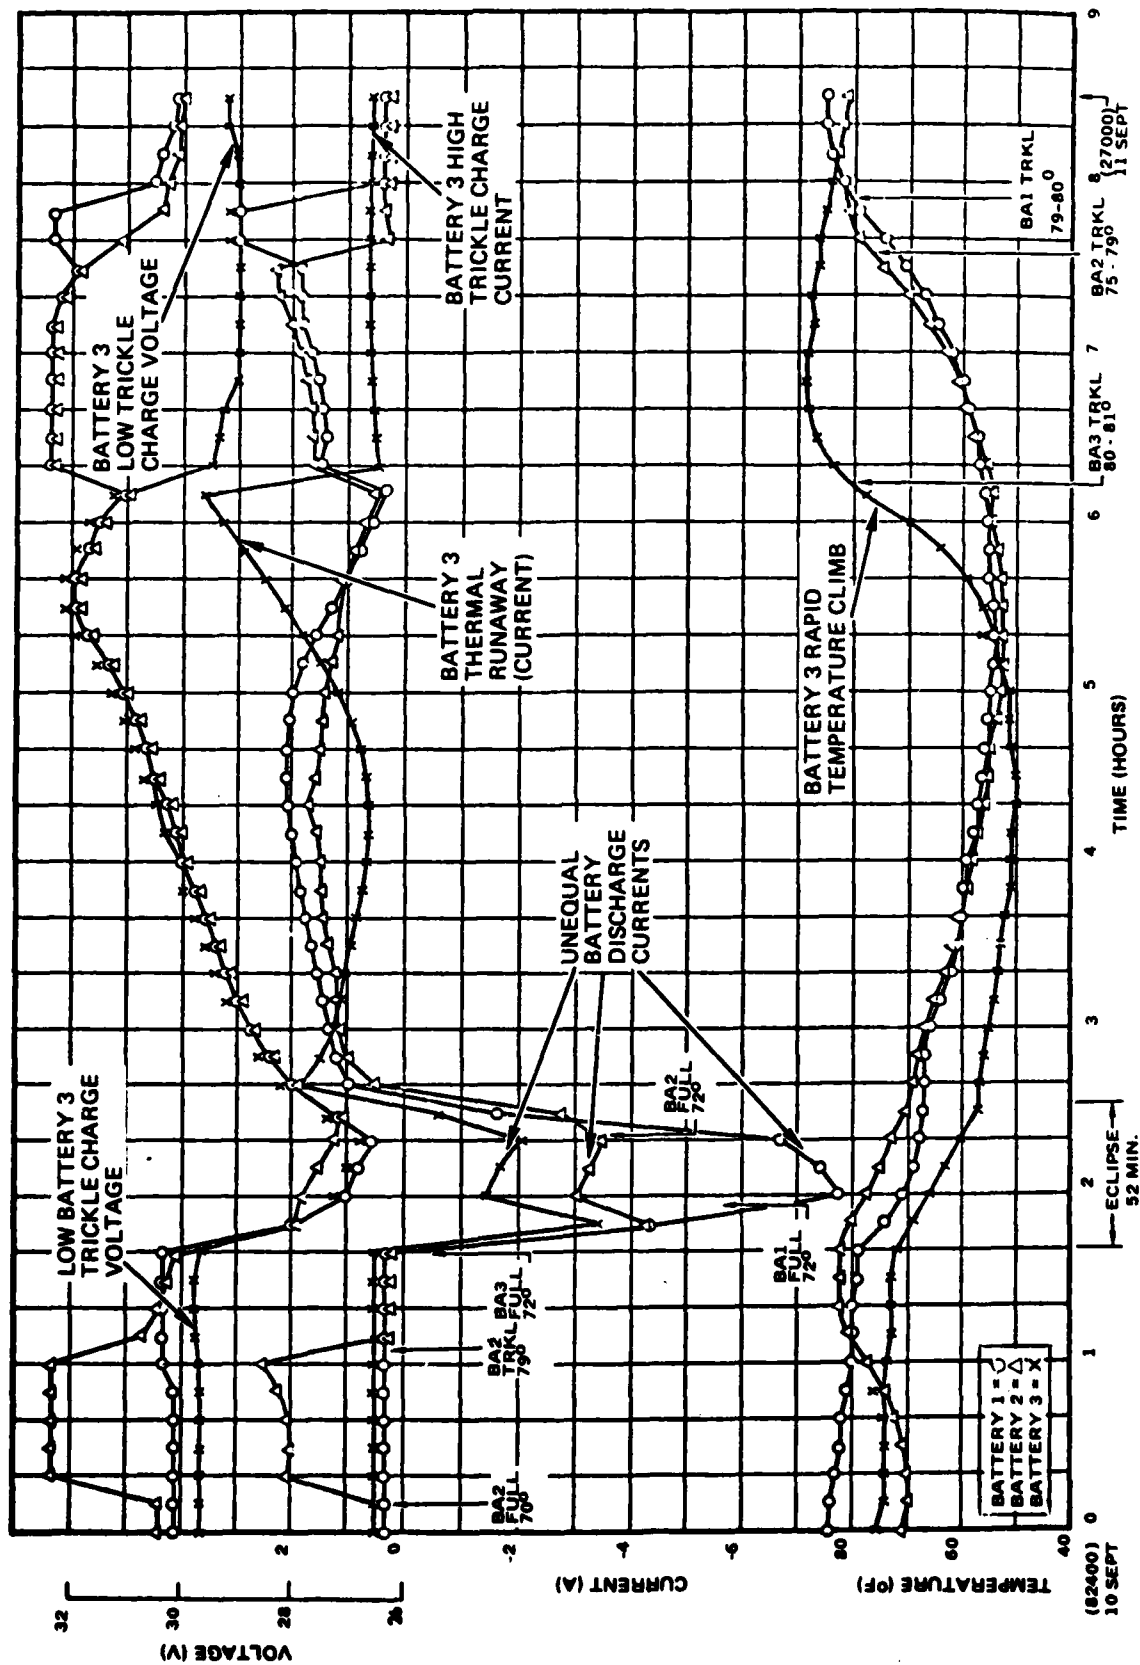
Figure 3-1. Satellite 9437, 10 to 11 September 1978, 27-Hour Automonitor Showing Battery 3 Anomalous Behavior

- a) Although the three batteries were under automatic control, (auto mode) a severe current imbalance occurred during discharge. Battery 3 failed to carry its share of the discharge load current, and accepted more than its share of charging current.

- d) The solid state temperature switch (SSTS), which is designed to operate at 77°F, appeared to be operating at an indicated temperature of 80 to 81° on Battery 3, and 79 to 80°F on Battery 1. This was found to be due to temperature gradients in the battery rather than a SSTS malfunction.

From the above observations it was concluded that Battery 3 was exhibiting symptoms which could lead to rapid deterioration due to over-temperature operation, and on 12 September 78 it was switched to manual trickle charge at 0610 Z.

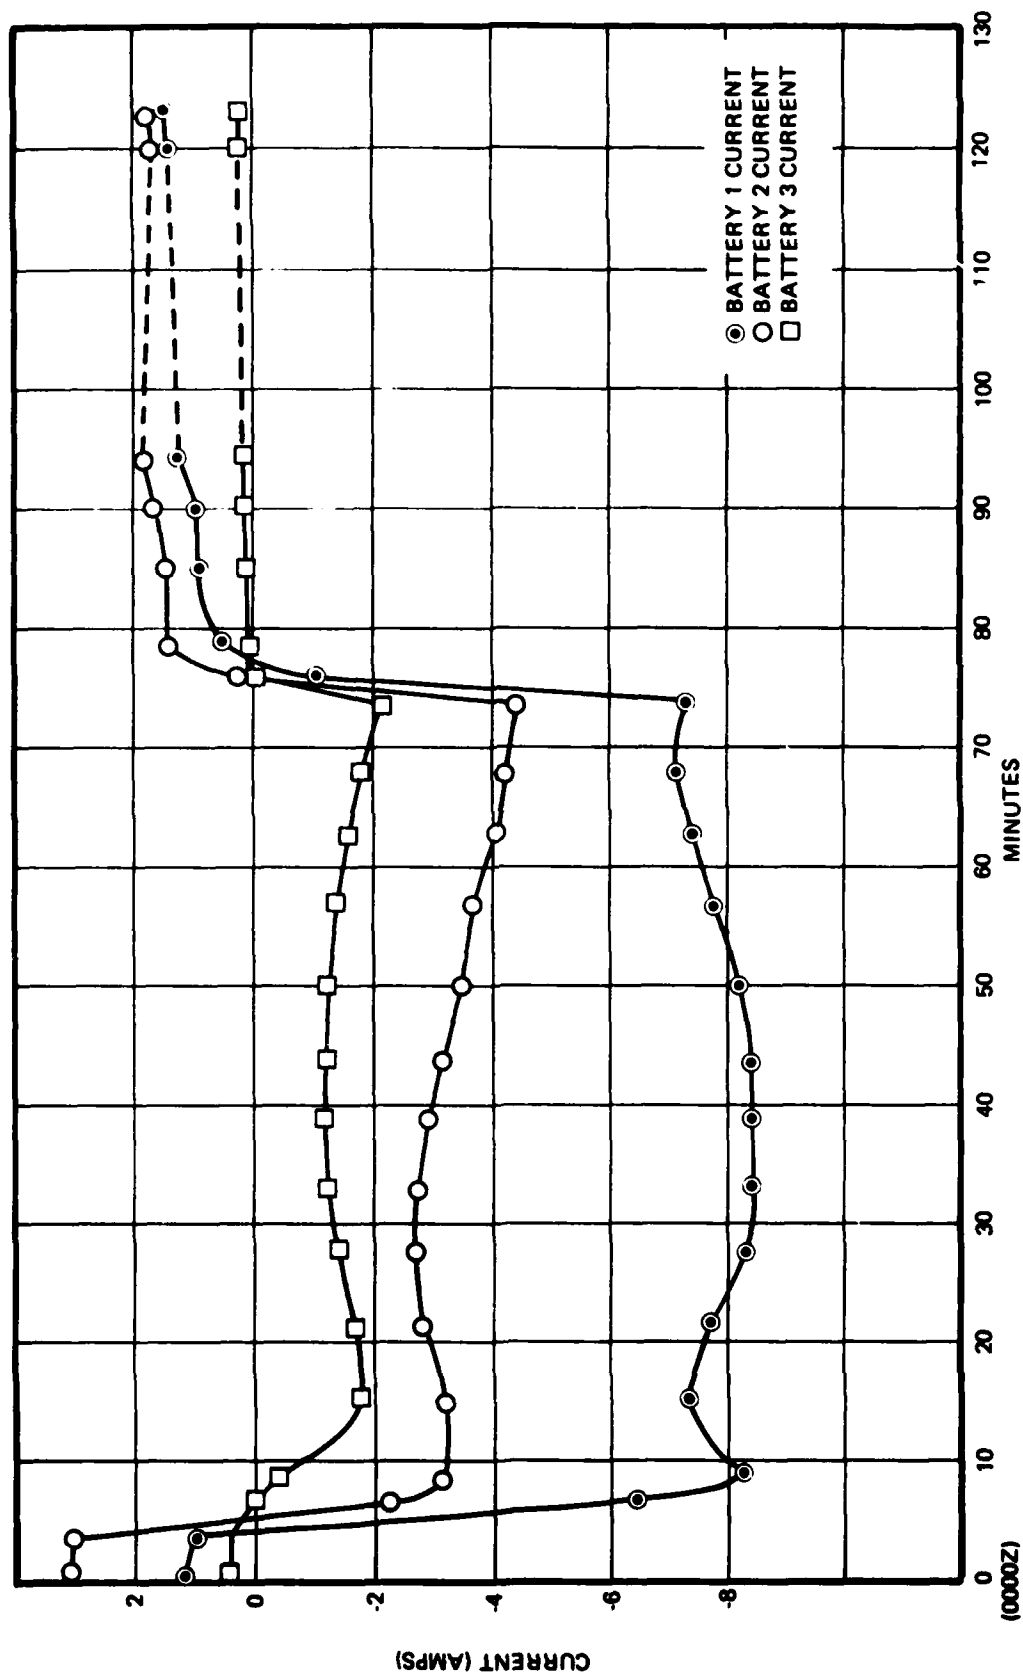
Figure 3-2. Satellite 9437 - 26 September 1978 - Eclipse 24 - Battery Load Sharing

Severe imbalances in battery discharge currents continued, as shown in Figure 3-2. (Telemetry data falling outside the current sensor design range has been corrected.)

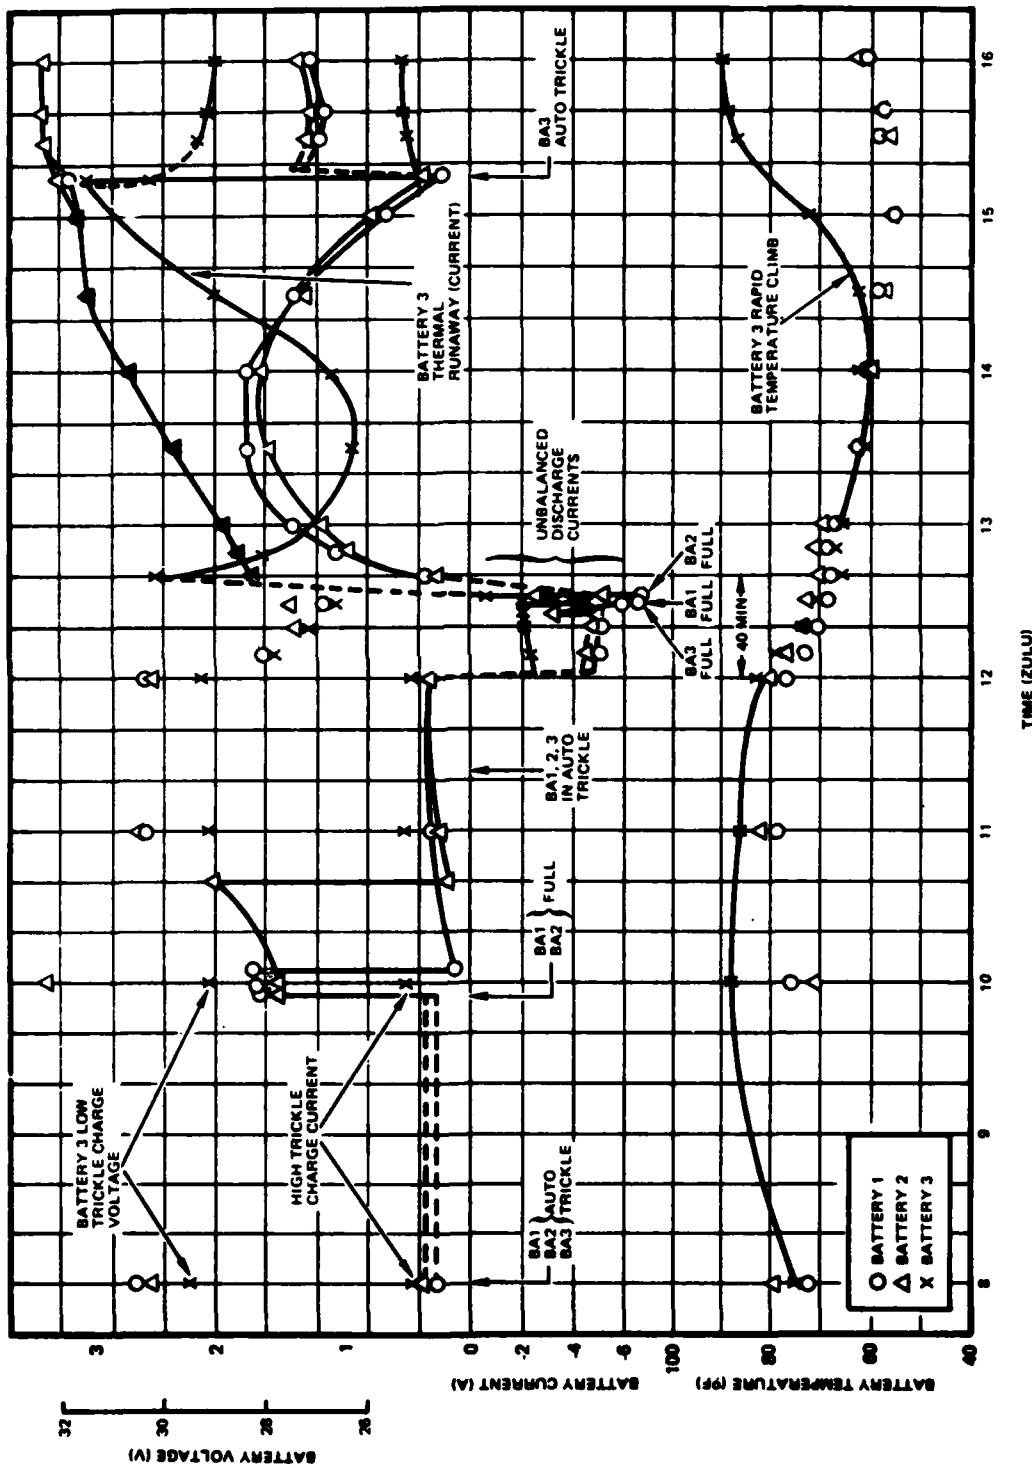
Figure 3-3. Satellite 9438 - 7 September 1978 - Excerpt from 50-Hour Monitor Showing Battery 3 Anomalous Behavior

For diagnostic purposes Satellite 9438 was continuously observed for a period of 50 hours, beginning at 1000 Z on 7 September 1978. Figure 3-3 is an excerpt of this test period, showing current and temperature imbalances similar to those observed in Satellite 9437.

The above indicates that Batteries 1 and 2 are almost equivalent, and that Battery 3 is degraded or has a shorted cell.

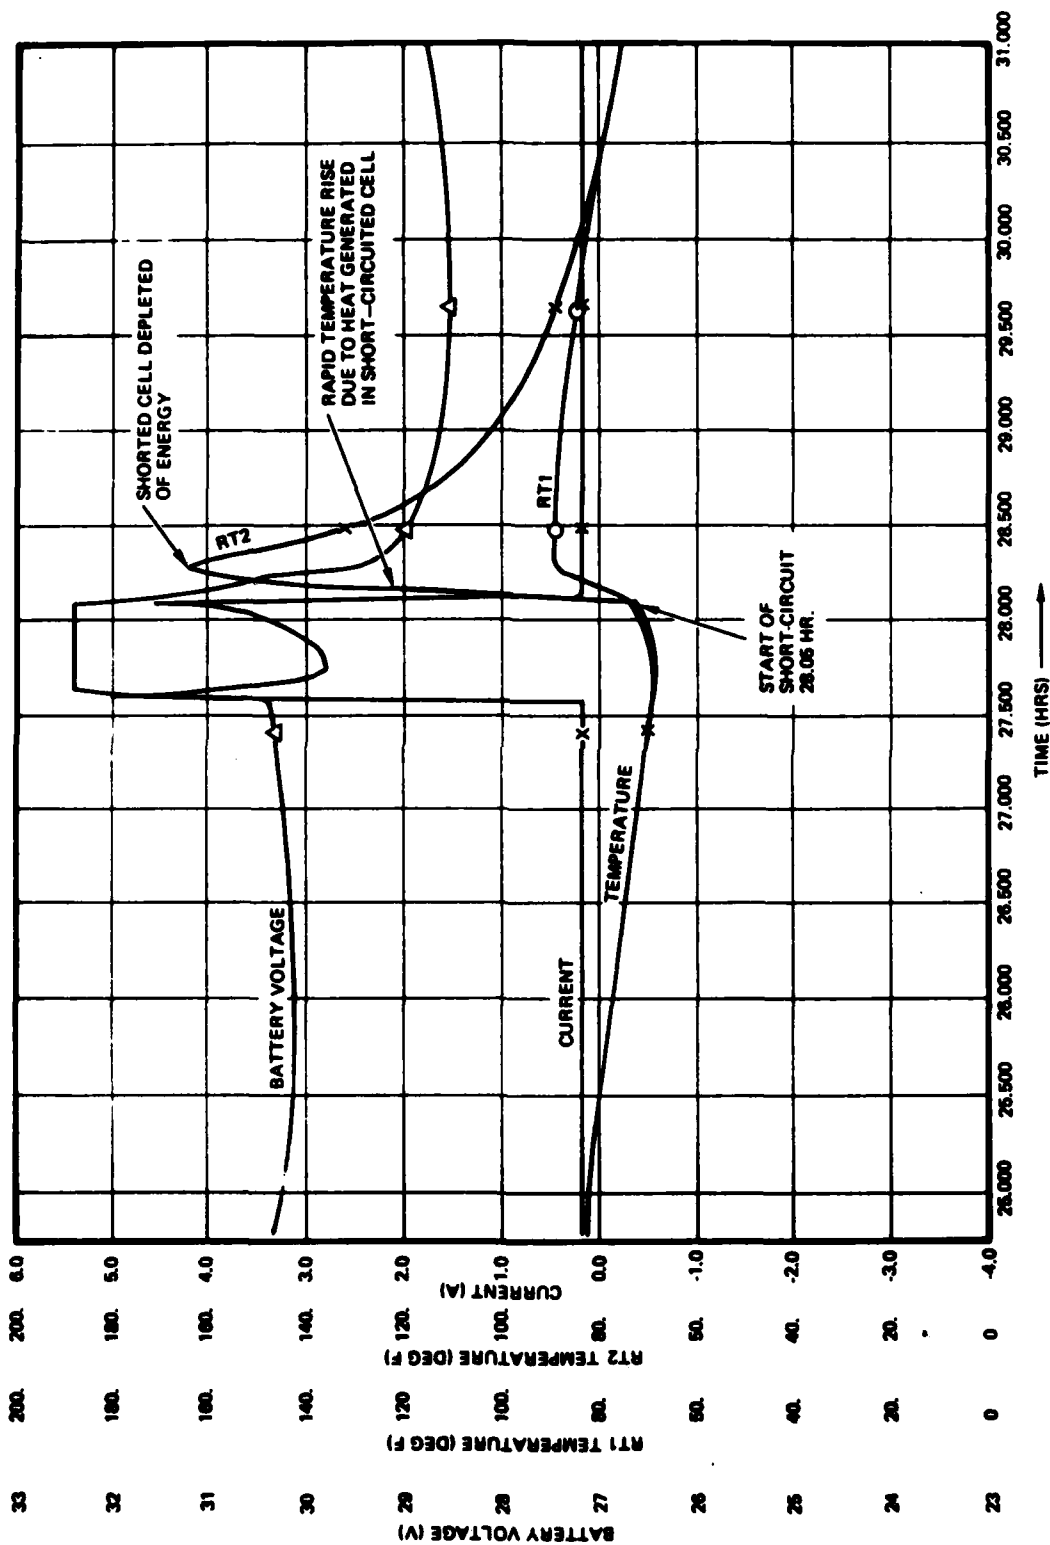
Figure 4-1. Battery S/N 3-6 - Season 3, Cycle 3 - Short Circuit Event - Battery Data

A laboratory test was conducted in which one flight-configuration battery was subjected to a simulation of cycling conditions observed on Satellites 9437 and 9438 and another to the anticipated conditions of Satellites 9441 and 9442. The 9437/9438 simulation used a bus voltage limit of 32.4 V. The 9441/9442 simulation used a lower voltage limit of 31.8 V. During this test, Battery S/N 3-6, which was tested under Satellite 9437/9438 conditions, developed a permanently short-circuited cell during Cycle 9 of Season 3 (in-flight failures occurred between Cycles 1 and 20 of Season 3 in Satellites 9437 and 9438). It was also observed that permanent cell short-circuits were preceded by a period of anomalous operation and, upon occasion, by self-clearing short circuits. The onset of a short-circuit is clearly seen as an abrupt drop in cell voltage to zero volts, and is confirmed (in centrally located cells) by a rapid rise in temperature of the RT2 thermistor which is centrally located on one of the two cell blocks (see Figure 2-1). This rapid temperature rise results from internal heat dissipation due to self-discharge of the shorted cell through the internal short-circuit (as shown in Figures 4-1 and 4-2).

Inspection of the voltage data reveals that the defective battery voltages are lower than those of the normal batteries by slightly less than

the voltage of one cell. The charging current of the low-voltage battery is slightly higher than that of the normal-voltage battery. This is consistent with the presence of a short-circuited cell in the low-voltage battery. The higher current caused by the lower battery voltage increases the voltage drop across the unfailed cells of the battery, offsetting, in part, the loss of the one-cell-voltage. This higher current is also consistent with the depressed voltages observed generally. These voltage losses are not recoverable by reconditioning.

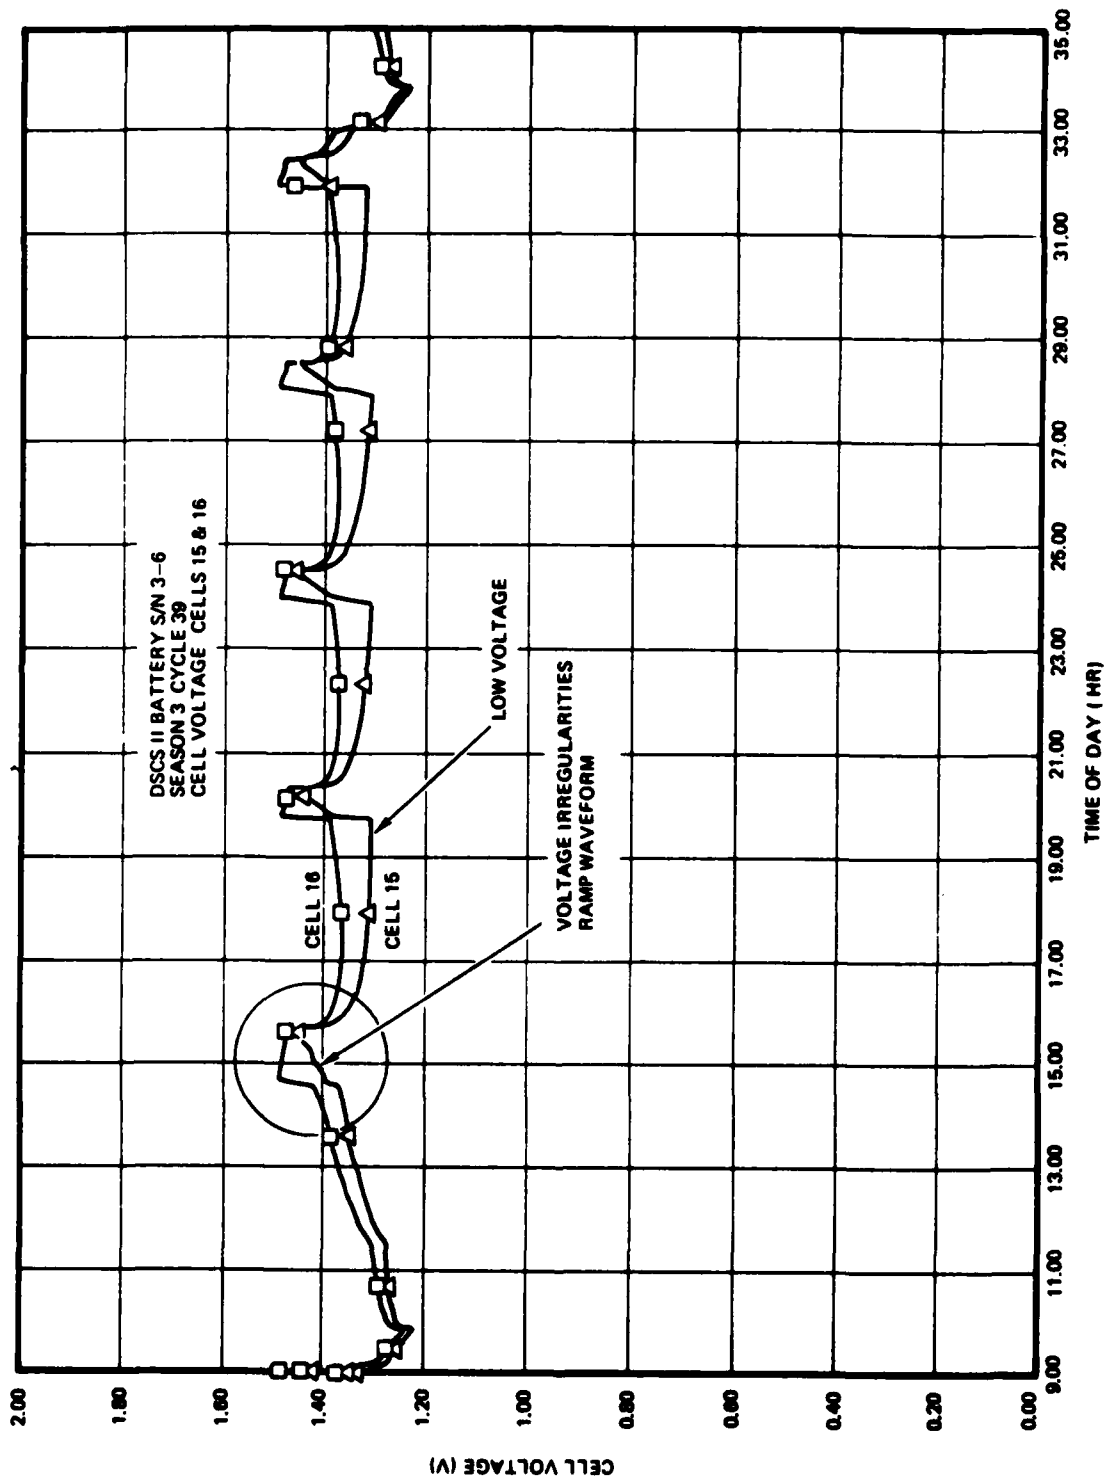
Figure 4-4. Battery S/N 3-6 - Preshort Signature - Cells 15 and 16

Two additional cell anomalies were observed during Battery S/N 3-6, Season 5 operation. However, in both instances the cells exhibited preshort signatures during Season 3. The presence of the signature prior to the change in charge mode is interpreted as evidence that the damage had occurred before the switch to the more benign trickle charge mode. There are no indications of anomalies initiated subsequent to the switch to trickle charge.

The clear disparity between S/N 3-6 and S/N 3-3 test results indicates a direct relationship between overcharge stress and failure incidence.

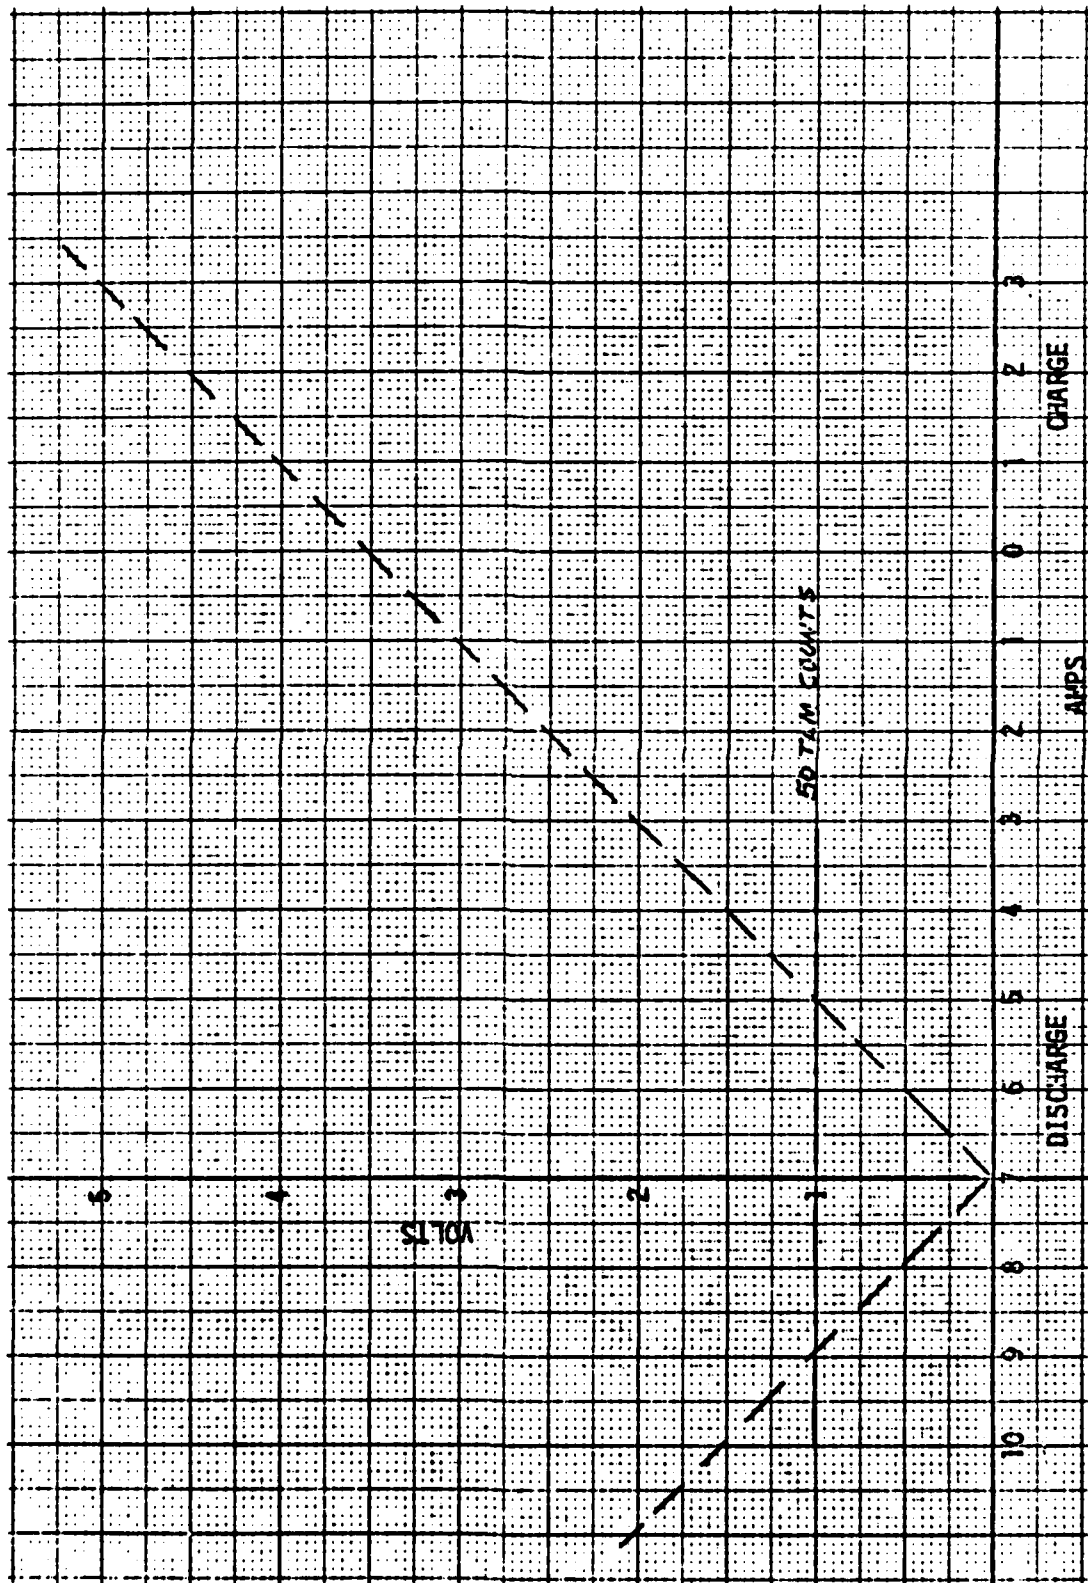
Figure A2-1. Battery Current Monitor Characteristic Curve

The current sensors used in Satellites 9437 and 9438 power subsystem are of the biased saturable reactor type, having an output voltage versus current characteristic as shown in Figure A2-1. The design operating range of the sensor is from -7 amperes (discharge) to +3 amperes (charge). At discharge currents beyond -7 amperes, however the output voltage of the sensor is not single-valued and can be interpreted as either of two current values. The imbalance in battery currents caused by the existence of short-circuited cells caused a misinterpretation of the current sensor output. A 1 V (50 telemetry counts) output was interpreted as -5 amperes when it actually should have been interpreted as -9 amperes.

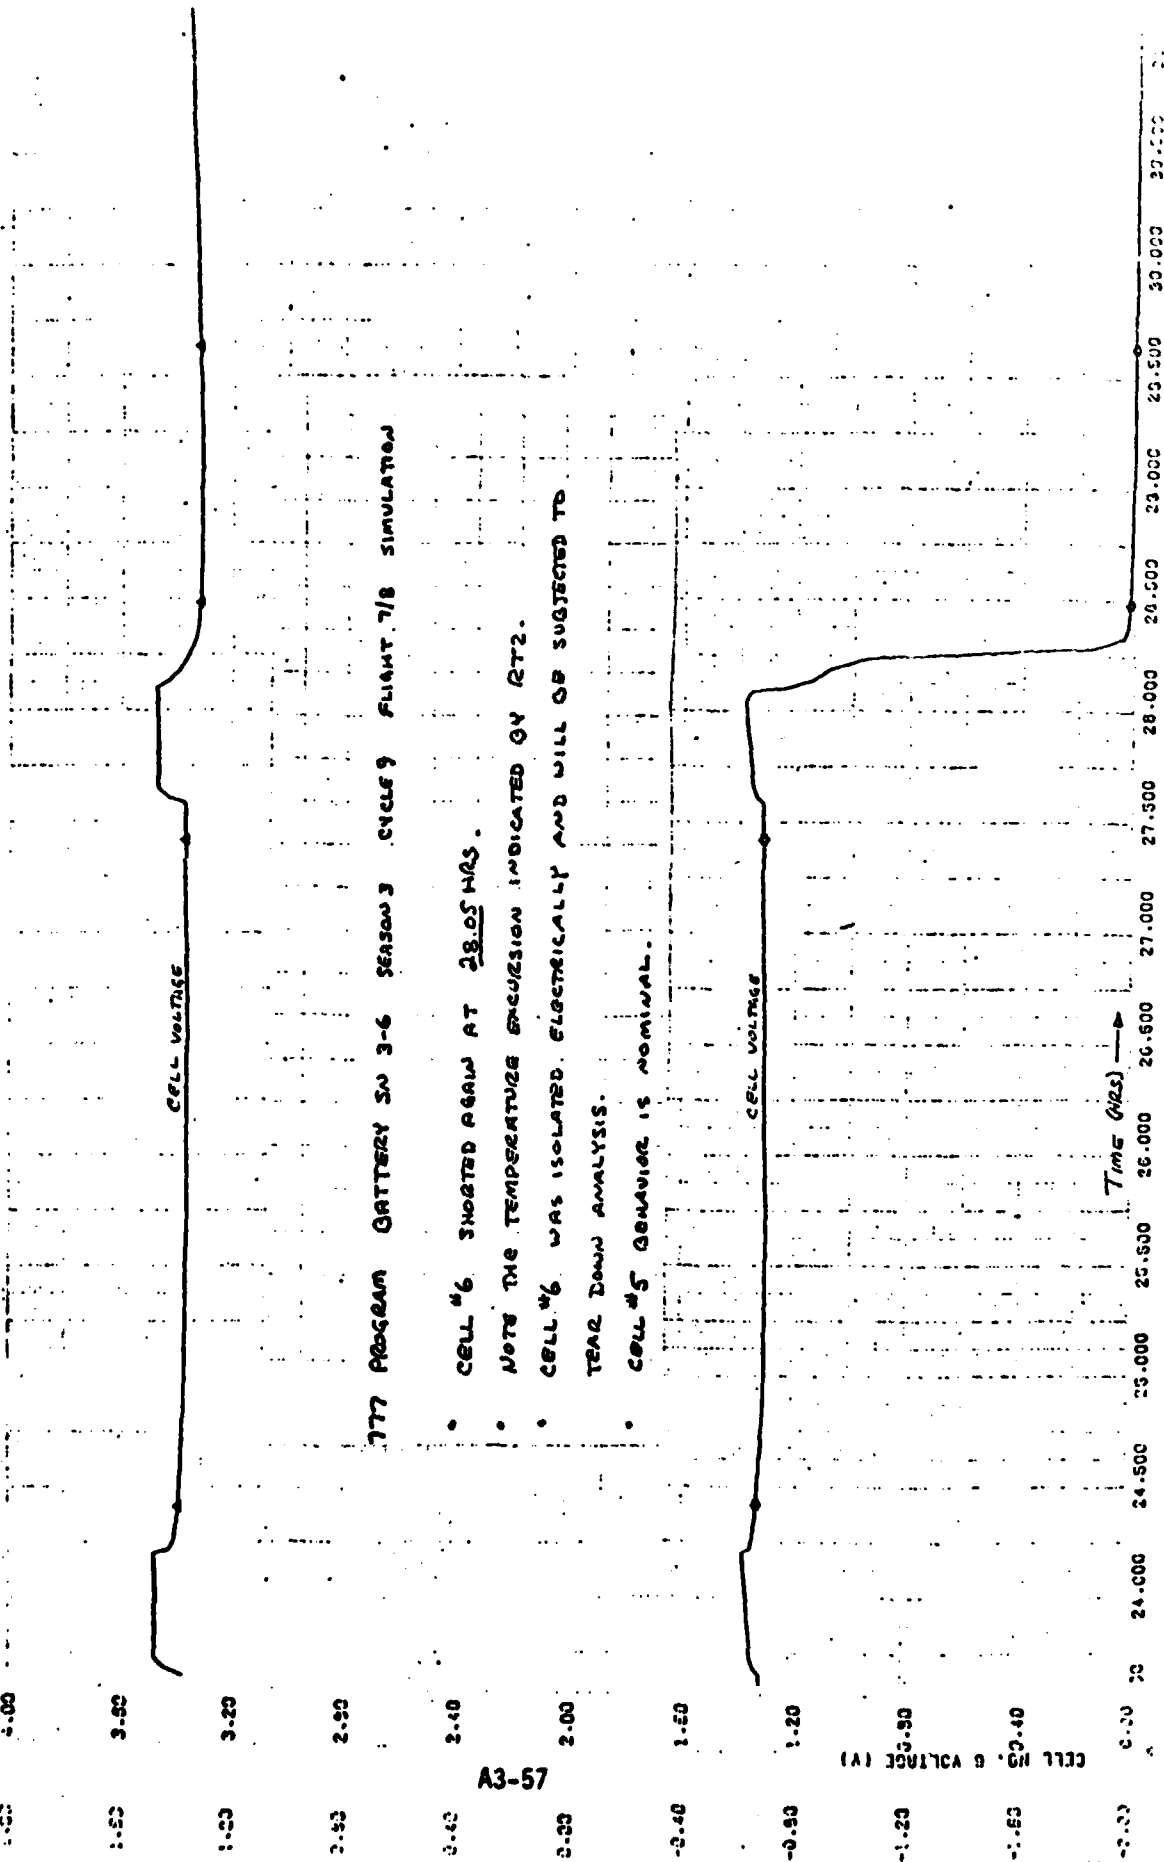
777 PROGRAM BATTERY SN 3-6 SEASON 3 CYCLE 9 FLIGHT 7/8 SIMULATION

- CELL #6 SHORTED AGAIN AT 28.05 HRS.
- NOTE THE TEMPERATURE EXCURSION INDICATED BY RT2.
- CELL #6 WAS ISOLATED. ELECTRICALLY AND WILL BE SUBJECTED TO TEAR DOWN ANALYSIS.
- CELL #5 BEHAVIOR IS NOMINAL.

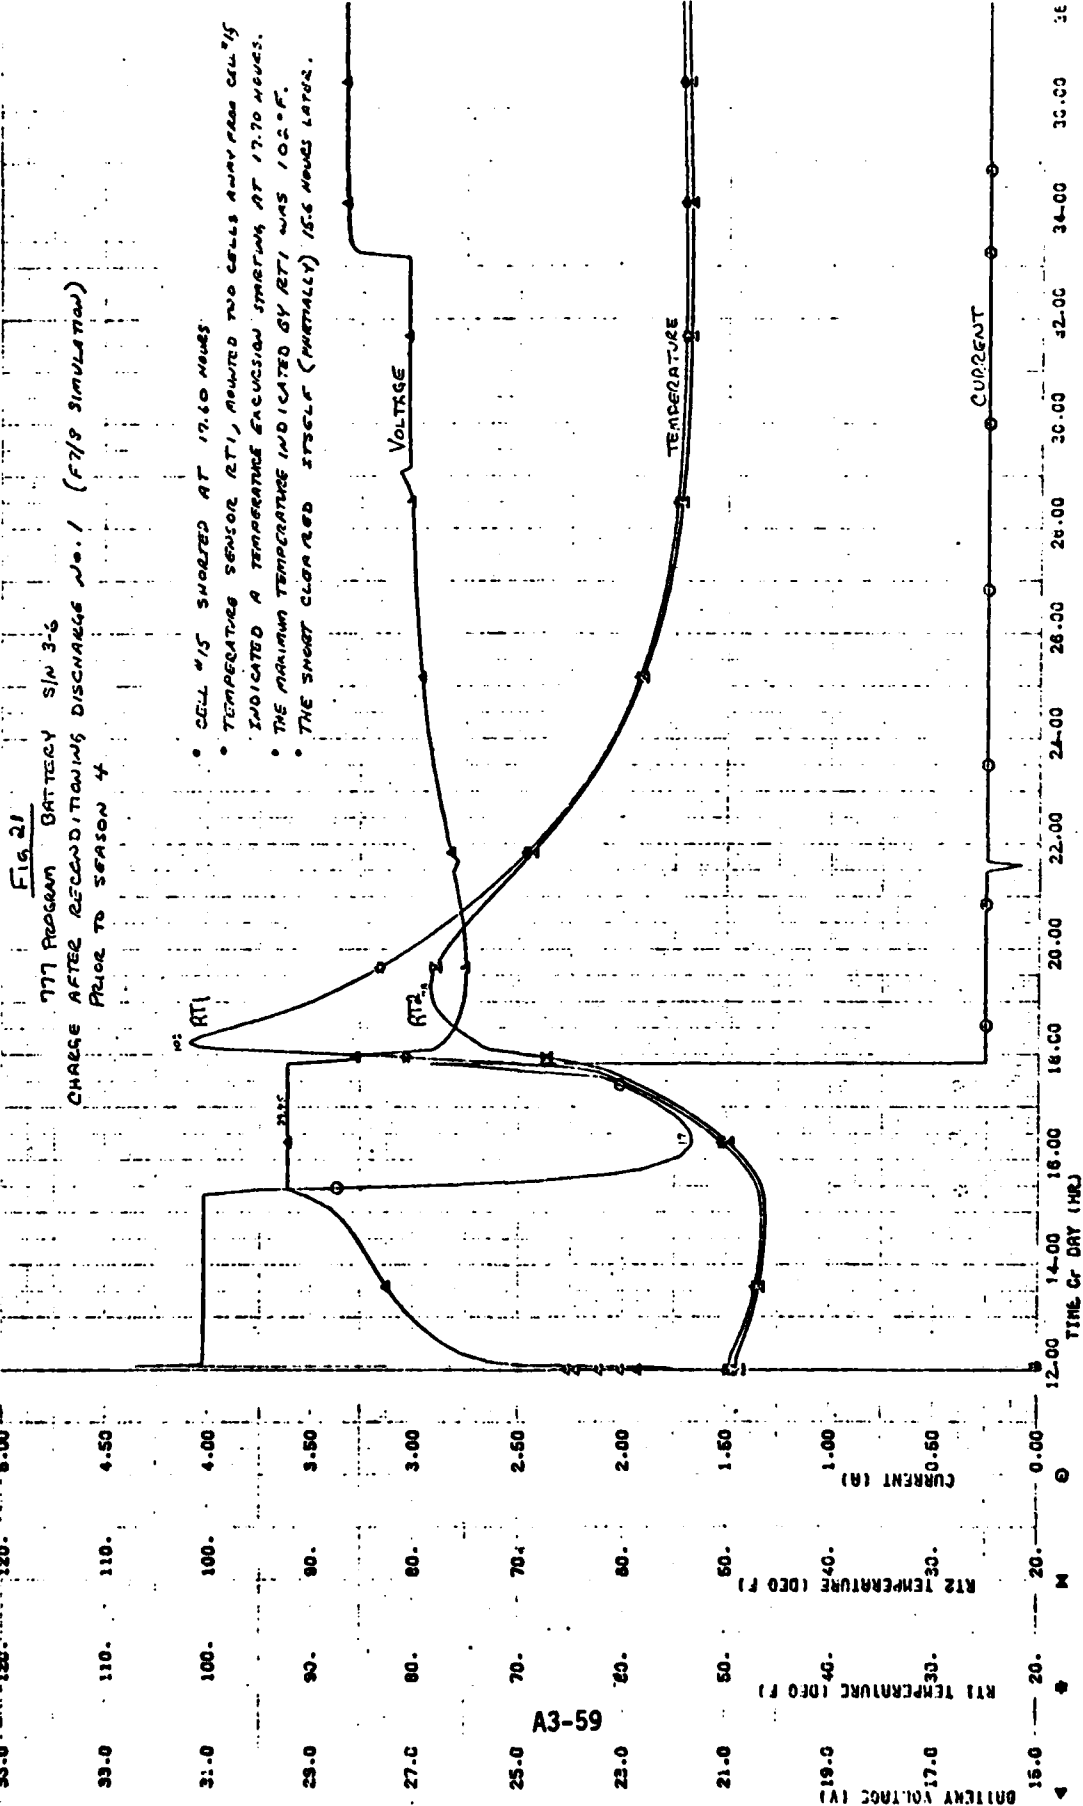
777 PROGRAM BATTERY SIN 3-6  
CHARGE AFTER RECONDITIONING DISCHARGE NO. 1 (F719 SIMULATION)  
PRIOR TO SEASON 4

- CELL #15 SHORTED AT 17.60 HOURS
- TEMPERATURE SENSOR RT1, MOUNTED TWO CELLS AWAY FROM CELL #15 INDICATED A TEMPERATURE EXCURSION STARTING AT 17.70 HOURS.
- THE MINIMUM TEMPERATURE INDICATED BY RT1 WAS 102°F.
- THE SHORT CLEARED ITSELF (PARTIALLY) 15.6 HOURS LATER.
