# CONDITION SURVEY, DYESS AIR FORCE BASE, TEXAS

R. D. Jackson

June 1973

2. The purpose of this report is to present the results of a condition survey performed at Dyess Air Force Base (DAFB), Texas, during 11-14 December 1972. The following two major areas of interest were considered in this condition survey:

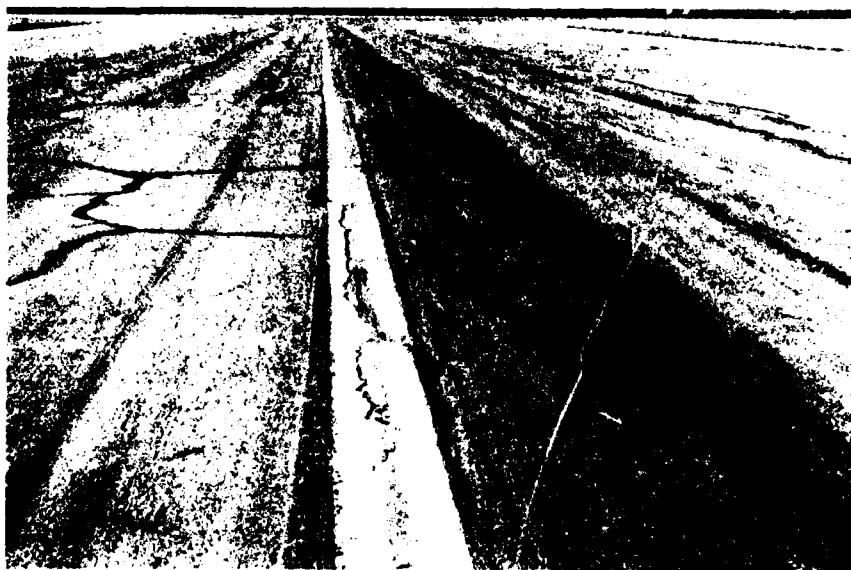
14. The primary taxiways, 1, 5, and 7 (features T1A, T2A, T3B, T7A, T8A, T10B, and T11B), were in conditions ranging from good to excellent based on the percentages of the slabs containing major defects. The taxi lane on taxiway 7 had been moved and a 26-in. inlay constructed at the present location of the taxi lane. Using only the 75 ft at the present location for the condition rating of this feature would have resulted in a rating of very good to excellent; however, using the 150-ft width resulted in a condition rating of good. Taxiway 2, which is 16- and 18-in. PCC, was in very good condition. Taxiways 3 and 4, which are AC, were in only fair condition (see photos 6 and 7).

Photo 7. General view of taxiway 4
