LAKE WANDA DAM (NJ00510)

PHASE I INSPECTION REPORT  
NATIONAL DAM SAFETY PROGRAM

Name of Dam: Lake Wanda Dam  
Identification No.: FED ID No. NJ00510  
State Located: New Jersey  
County Located: Sussex  
Stream: Tributary to Wawayanda Creek  
River Basin: Hudson  
Date of Inspection: November 7, 1979

LAKE WANDA DAM N.J. NO. 22-154 FED NO. NJ00510

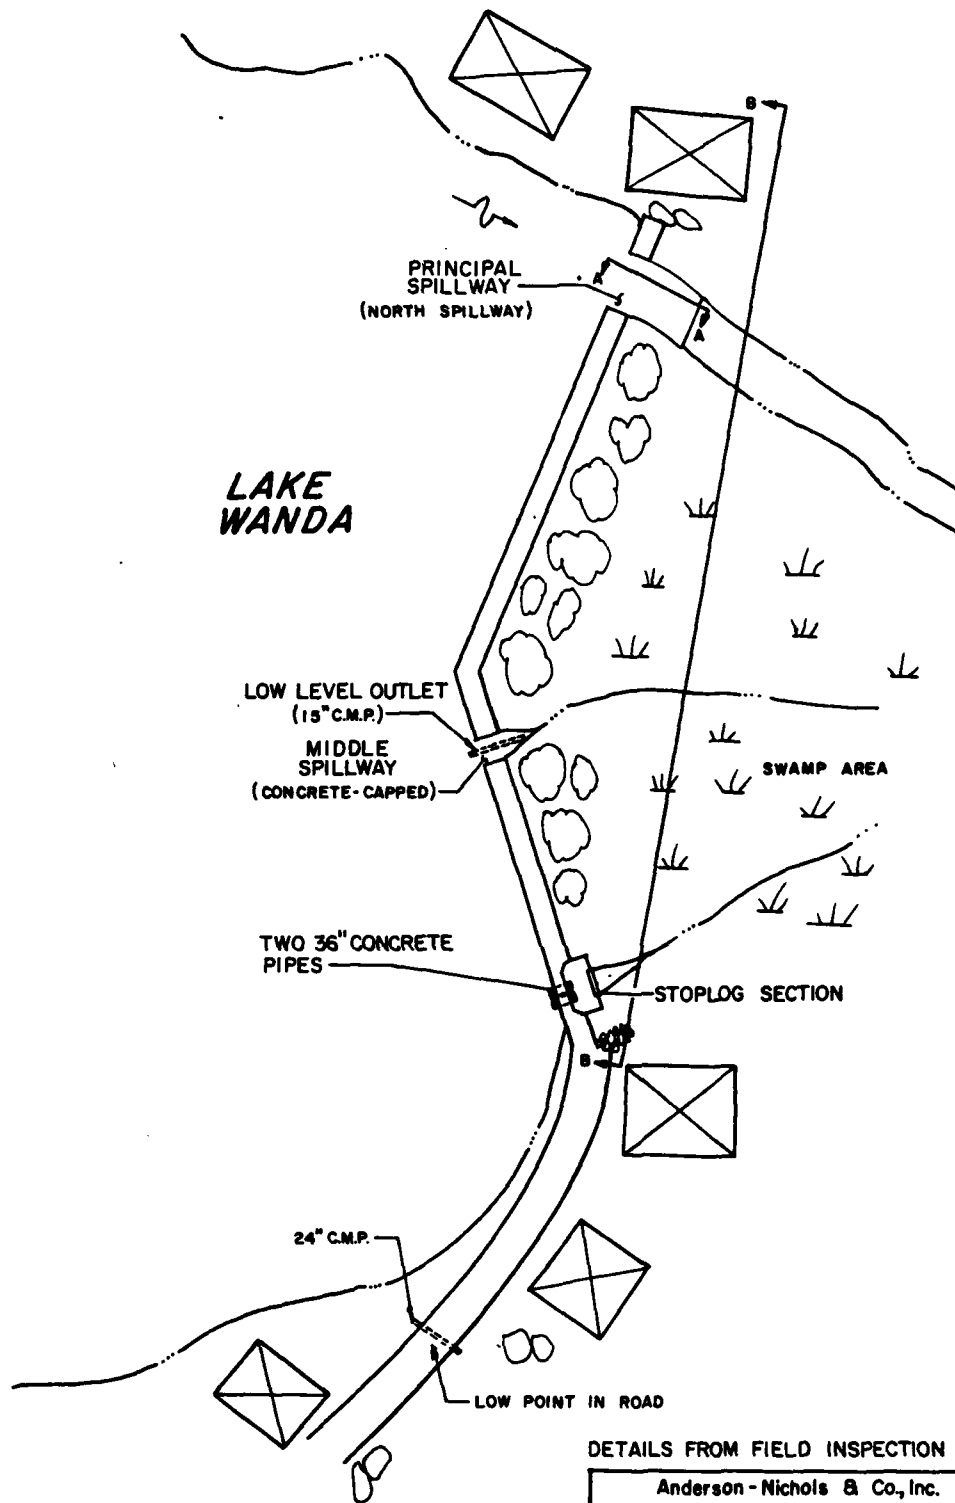
FIGURE 1

DETAILS FROM FIELD INSPECTION NOV. 7, 1979

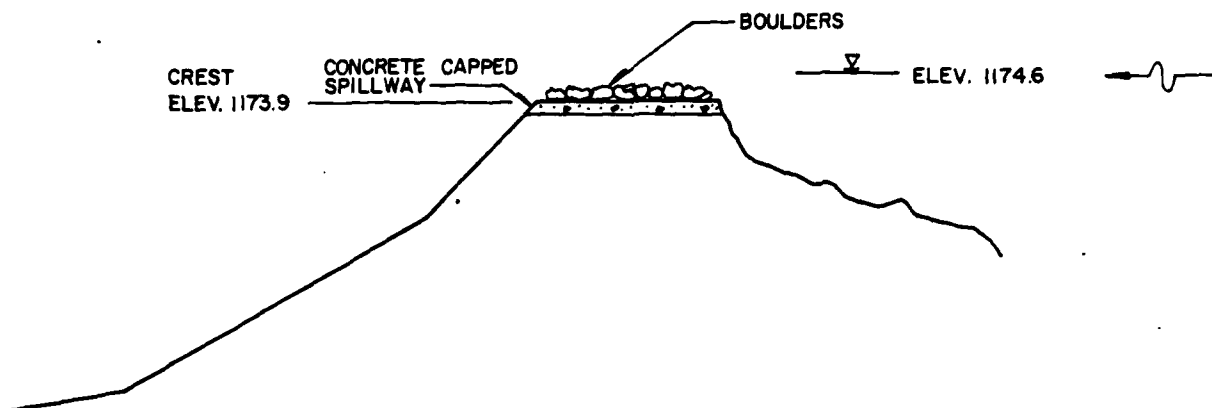
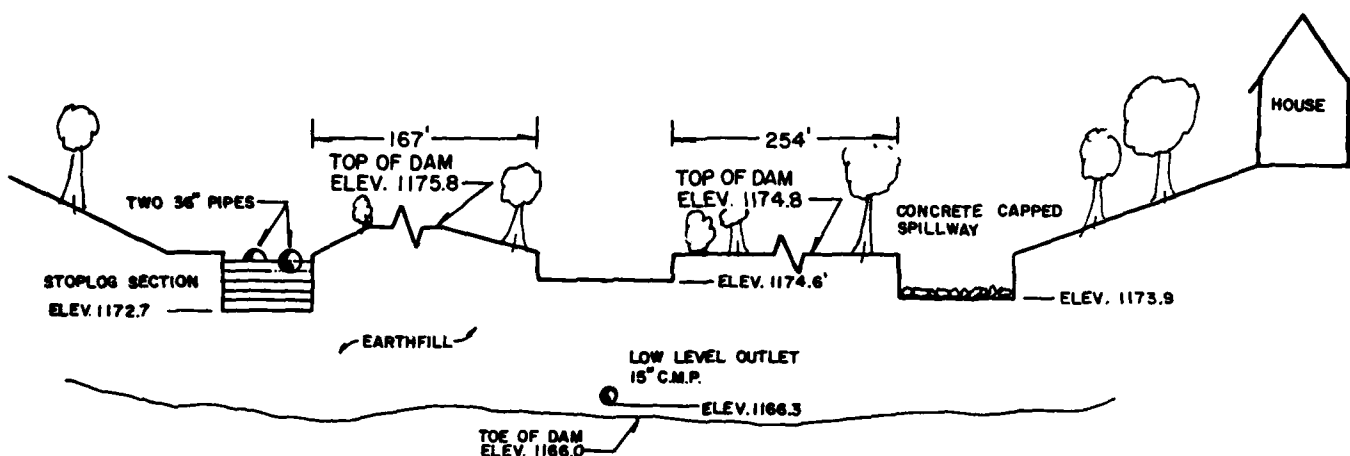
FIGURE 2

## SECTION A-A

## ELEVATION B-B
