PHASE I INSPECTION REPORT
NATIONAL DAM SAFETY PROGRAM

Name of Dam: Cozy Lake Dam
Identification No.: FED ID No. NJ00309
State Located: New Jersey
County Located: Morris
Stream: East Branch of Rockaway River
River Basin: Passaic
Date of Inspection: November 8, 1979

CONTENTS
PHASE I INSPECTION REPORT
COZY LAKE DAM N.J. NO. 22-33 FED ID NO. NJ00309

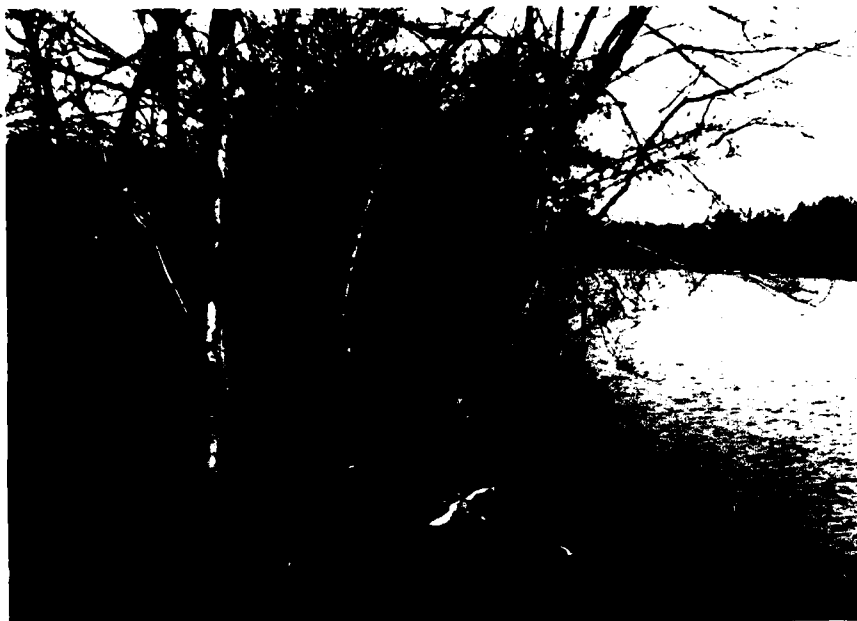
LOOKING NORTHEAST ALONG CREST OF DAM FROM THE SPILLWAY.

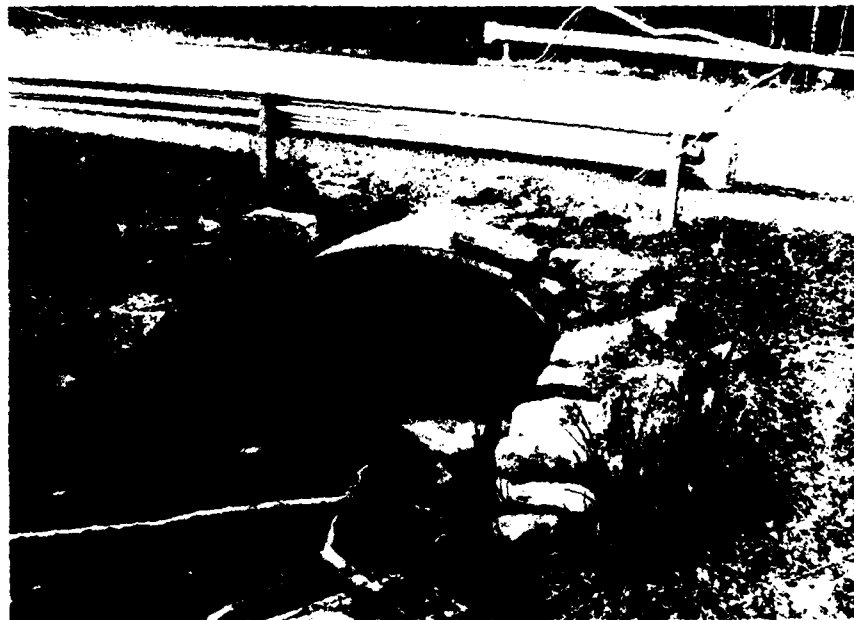
NOVEMBER 8, 1979
CULVERT UNDER THE HIGHWAY VIEWED FROM THE NORTHEAST
SIDE OF THE SPILLWAY.
