# LAKE STOCKWELL DAM

## NJ 00422

### PHASE 1 INSPECTION REPORT NATIONAL DAM SAFETY PROGRAM

FEBRUARY 1980

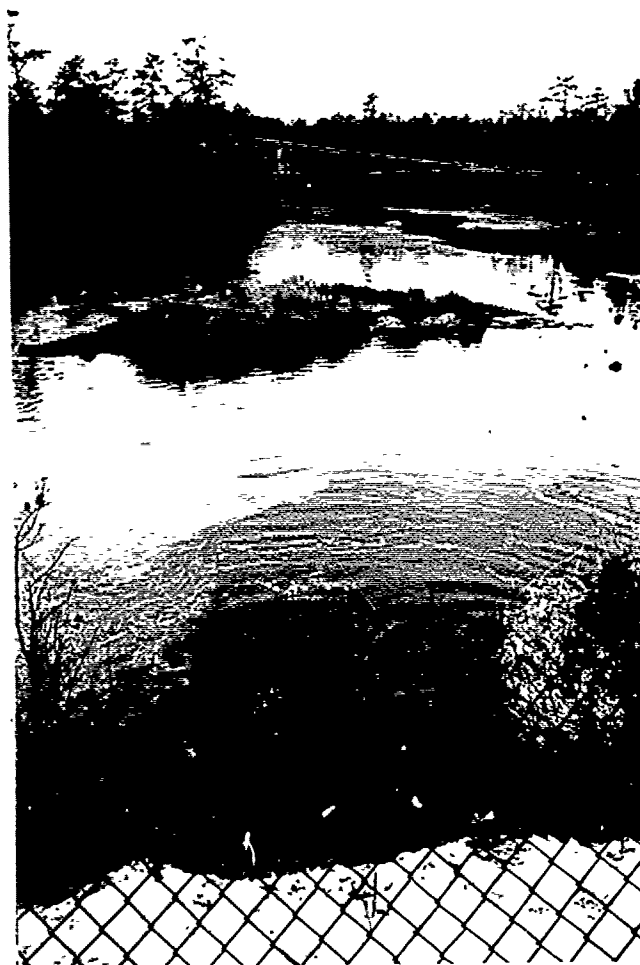
View Looking Downstream
