PASSAIC RIVER BASIN  
TROY BROOK, MORRIS COUNTY  
NEW JERSEY

# WILDWOOD LAKE DAM

## NJ 00562

### PHASE 1 INSPECTION REPORT NATIONAL DAM SAFETY PROGRAM

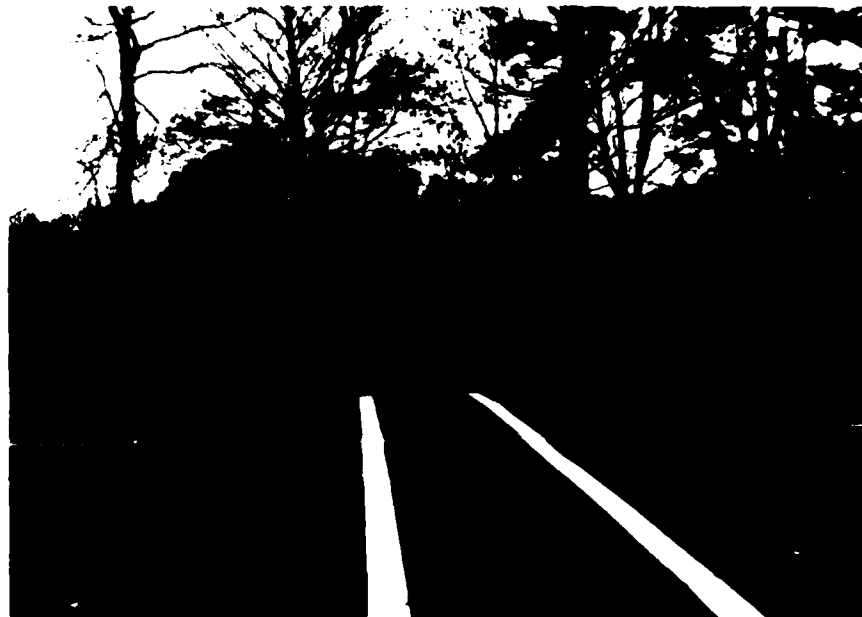
| VISUAL EXAMINATION OF | OBSERVATIONS | REMARKS OR RECOMMENDATIONS |
|---|---|---|
| ANY NOTICEABLE SEEPAGE | Small wet area on downstream slope<br>near left abutment. | Investigate the cause, design and implement<br>appropriate remedial measures if required. |

NOVEMBER 08 1979  
DOWNSTREAM FACE OF THE DAM LOOKING FROM  
THE SCHOOL.

4. Investigate the cause of the wet area at the toe of the dam near the left abutment and design remedial measures, if needed.
