COLONIAL DAM No. I

REDSTONE WATER COMPANY

PHASE I INSPECTION REPORT  
NATIONAL DAM INSPECTION PROGRAM

MAY 1980

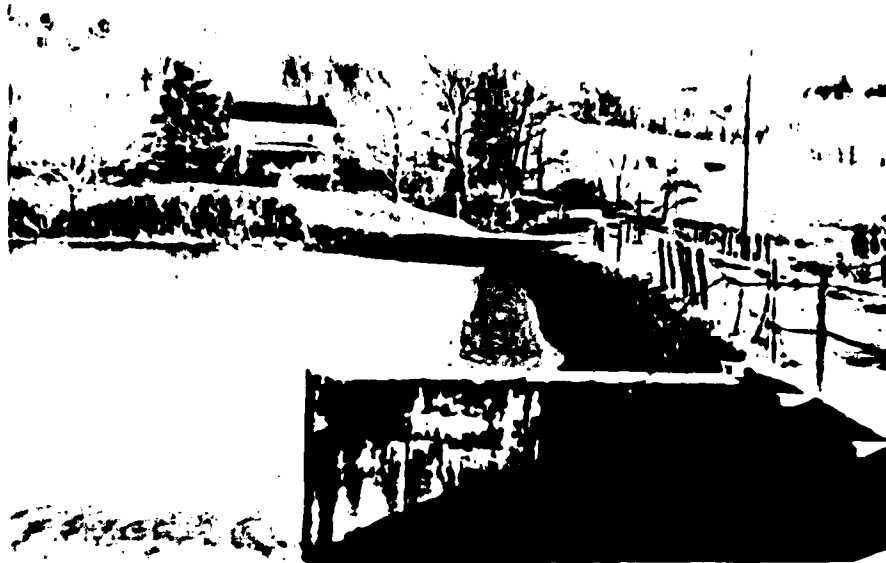
PHOTO 1. EMBANKMENT CREST AND SPILLWAYS

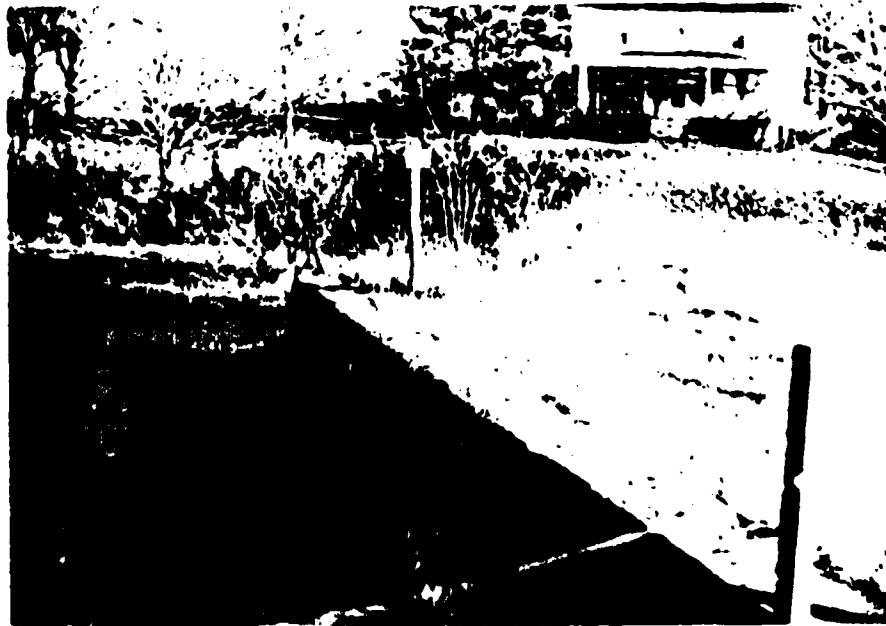
a. Embankment: The Colonial Dam No. 1 embankment is considered to be in good condition, with only minor deficiencies observed. These include wheel ruts on the crest containing standing water, erosion of the upstream slope at two locations and an erosional cavity behind the left spillway's left wall.

PHOTO 2. LEFT SPILLWAY TRAINING WALL AND EMBANKMENT

c. Replace eroded material behind the left spillway's left wall.

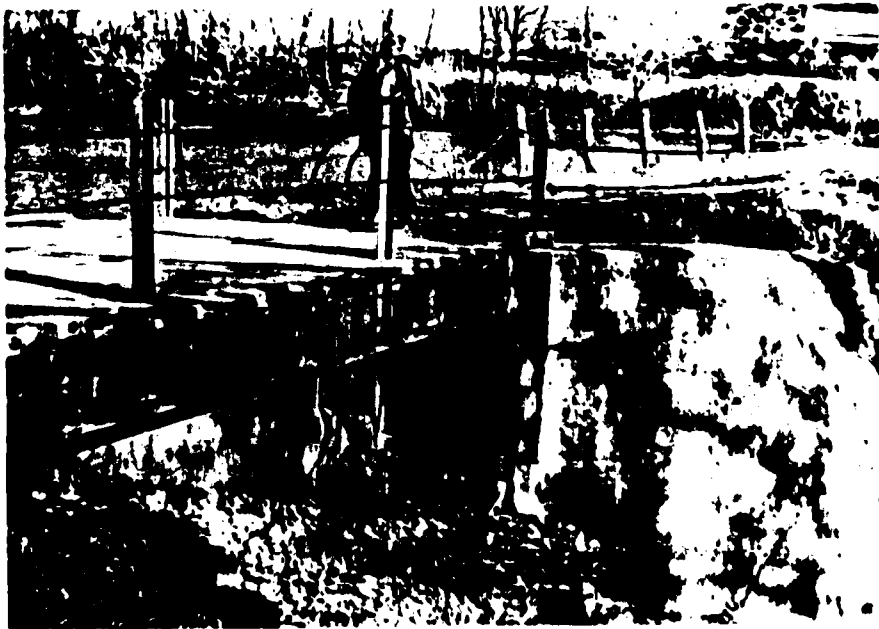
The massive concrete wall along the embankment side of the spillway has a large crack about two thirds of the way down the channel, and spalling and deterioration has occurred. Below this, numerous calcium deposits were observed on the wall.

A large crack has developed in the right wall near the stilling pool.

PHOTO 4. RIGHT SPILLWAY TRAINING WALL

c. Provide recommendations on improving the physical condition of deteriorated spillway components.
