NDI No. PA 00482

**KENNAMETAL RESERVOIR DAM**

KENNAMETAL INC.

**PHASE I INSPECTION REPORT  
NATIONAL DAM INSPECTION PROGRAM**

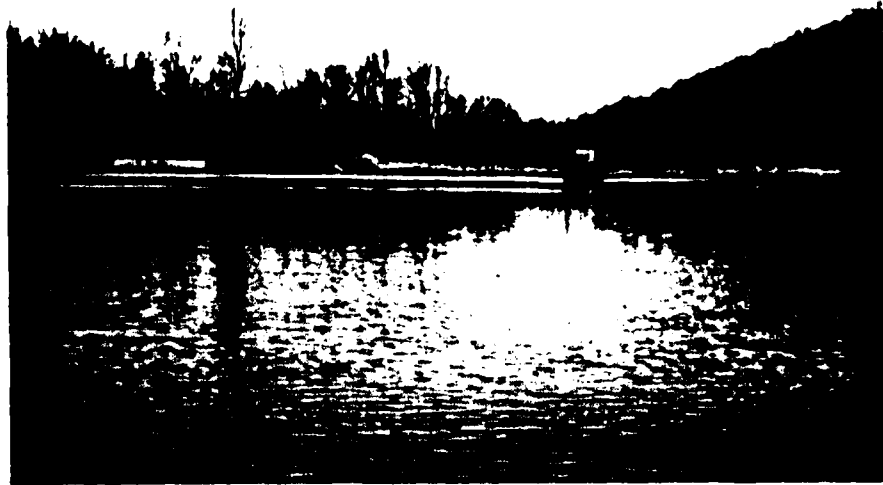
The crest had considerable barren area and some minor erosion was visible. Possible severe erosion was indicated by the difference in elevation between the crest and spillway training wall. No cracks were observed.

PHOTO 1. EMBANKMENT CREST AND SPILLWAY

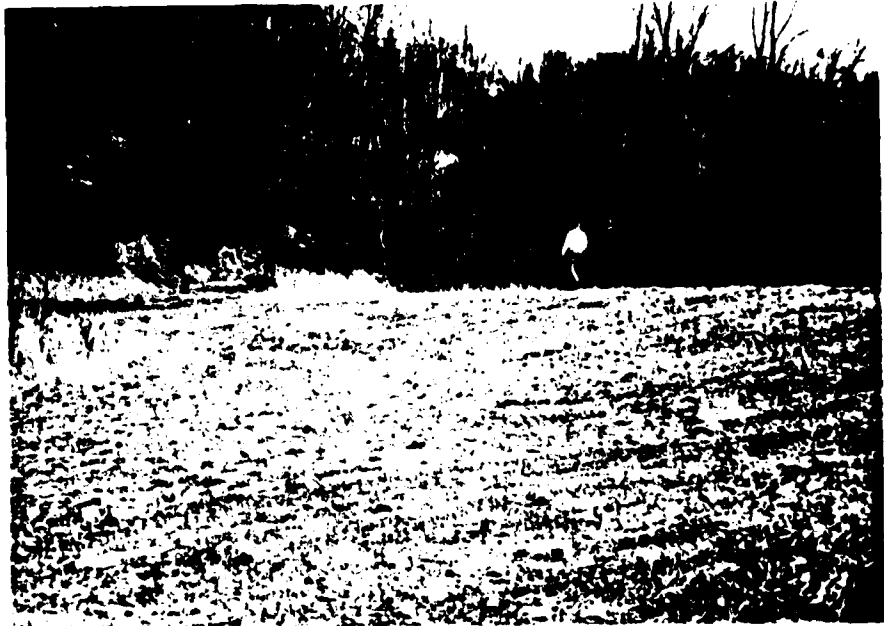
(3) Downstream Slope: The downstream slope was observed to be very flat and mostly barren. Some erosion has occurred near the right groin as a result of drainage from the jeep trail.

a. Embankment: The embankment is considered to be in good condition. Minor deficiencies include erosional distress that is the result of a lack of vegetal cover and surface drainage from the right abutment (jeep trail) that is causing minor erosion of both of the upstream and downstream slopes.

PHOTO 3 DOWNSTREAM EMBANKMENT SLOPE

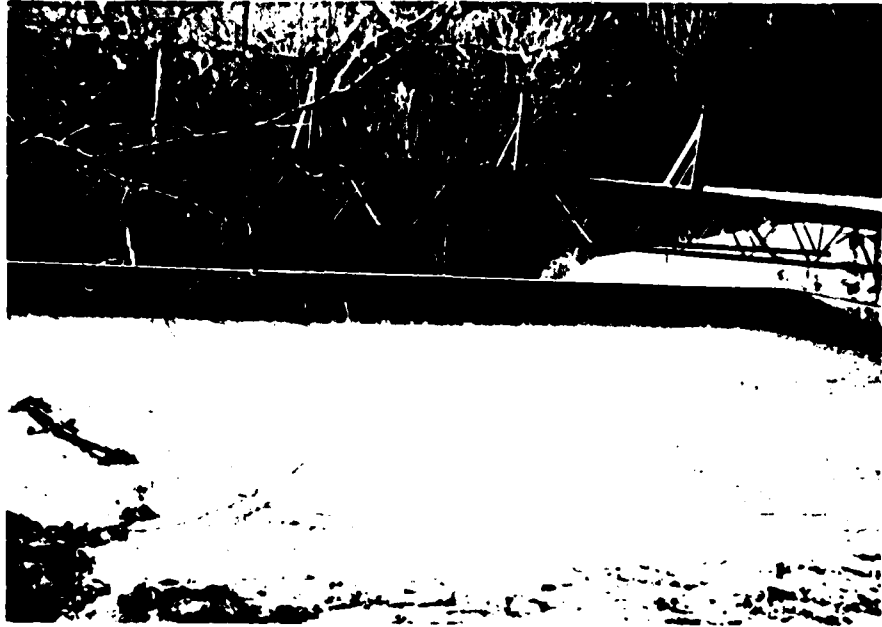
No cracks, spalling or deterioration were observed in the weir or adjacent training walls and flow over the weir was of uniform depth, indicating a level surface.

d. Principal (Ungated) Spillway: The principal spillway is considered to be in very good condition. Concrete members were not deteriorated and the structure appeared to be capable of full design performance.

PHOTO 7. PRINCIPAL SPILLWAY WEIR

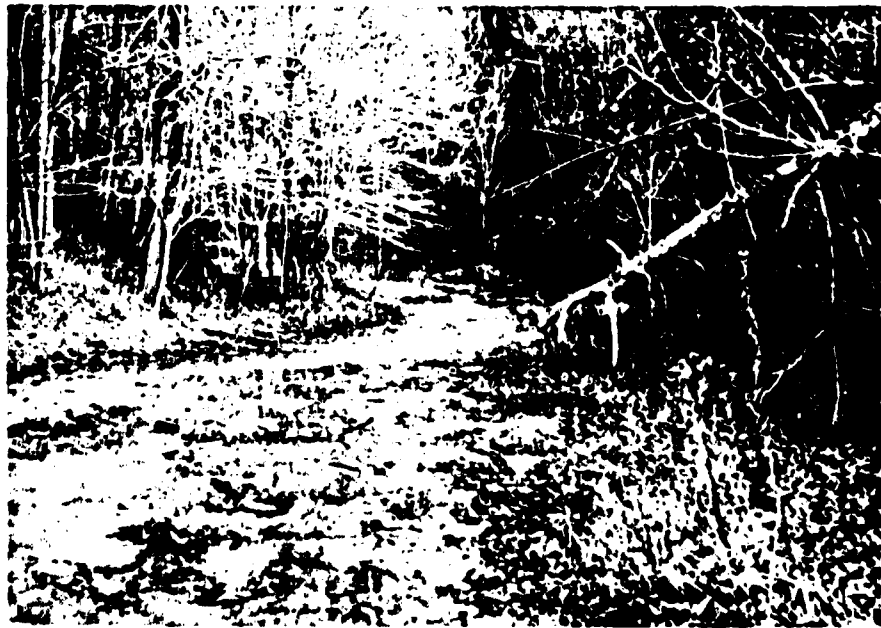
The unformed slab was approximately 40 feet wide and terminated at a three foot high waterfall where the channel below had been eroded. The slab was observed to have numerous cracks and holes. "Squirting" water was observed at several locations indicating pressure from beneath the slab. The pressure head for the "squirts", however, was very small.

(1) Downstream Channel: Water flowing beneath the unformed concrete slab is considered to be a problem. Continued underflow could lead to significant erosion of the slab's foundation and resultant destruction of the slab.

PHOTO 8. DOWNSTREAM CHANNEL

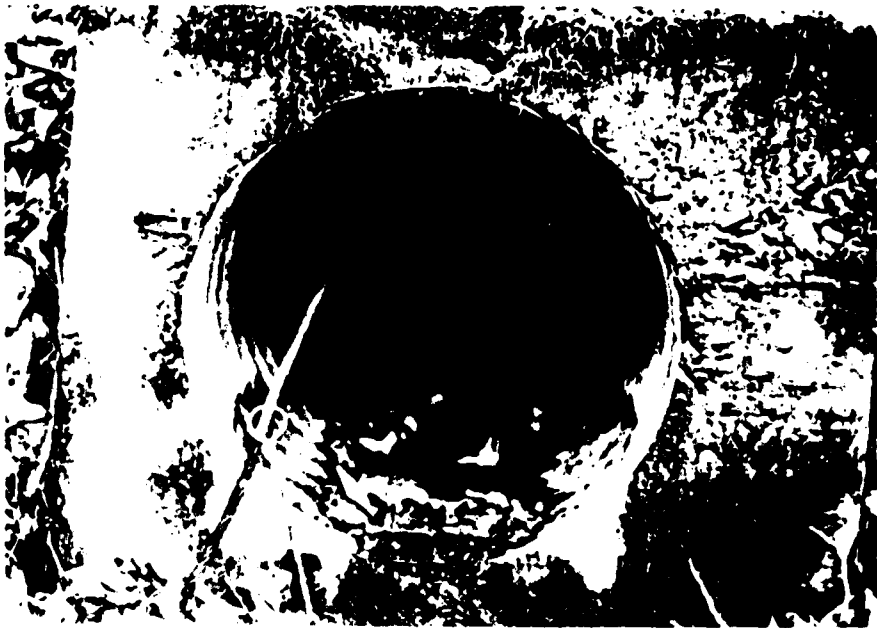
On 3 April 1980 considerable seepage was observed in the channel. A significant portion of the seepage was occurring along the channel's right bank near the base of the slope. This seepage showed some minor iron staining at the outlet point. The origin of this water is questionable, as observations

on 27 November 1979 did not reveal seepage conditions of this magnitude. Based on surface runoff and site wetness conditions it is possible that this is natural ground water. A small flow was observed alongside the pond drain concrete headwall and some seepage was noted in the channel bottom immediately below the pond drain outlet. An approximate estimate of seepage discharge in the outlet channel was 10 to 15 gallons per minute on 3 April 1980.

(2) Outlet Channel: The seepage observed near the outlet of the pond drain and along the pond drain discharge channel is considered to be a deficiency. Also, the sinkholes observed on the terrace above the pond drain channel are considered to be a problem.

PHOTO 10. POND DRAIN OUTLET

- b. Evaluate the operability of the upstream flow controls for the water supply and pond drain pipelines.
  - c. Inspect the seeps in the pond drain discharge channel and at the pond drain outlet and inspect the sinkholes on the terrace above the pond drain discharge channel and provide recommendations for monitoring and/or control.
