REYNOLDSVILLE STORAGE DAM

(NDI I.D. PA-01130
DER I.D. 33-5)

PHASE I INSPECTION REPORT
NATIONAL DAM INSPECTION PROGRAM

NAME OF DAM: Reynoldsville Storage Dam (Upper Dam)
STATE LOCATED: Pennsylvania
COUNTY LOCATED: Jefferson
STREAM: Pitchpine Run, a Tributary of Sandy Creek
SIZE CLASSIFICATION: Small
HAZARD CLASSIFICATION: High
OWNER: Borough of Reynoldsville
DATE OF INSPECTION: April 23, 1980 and April 30, 1980

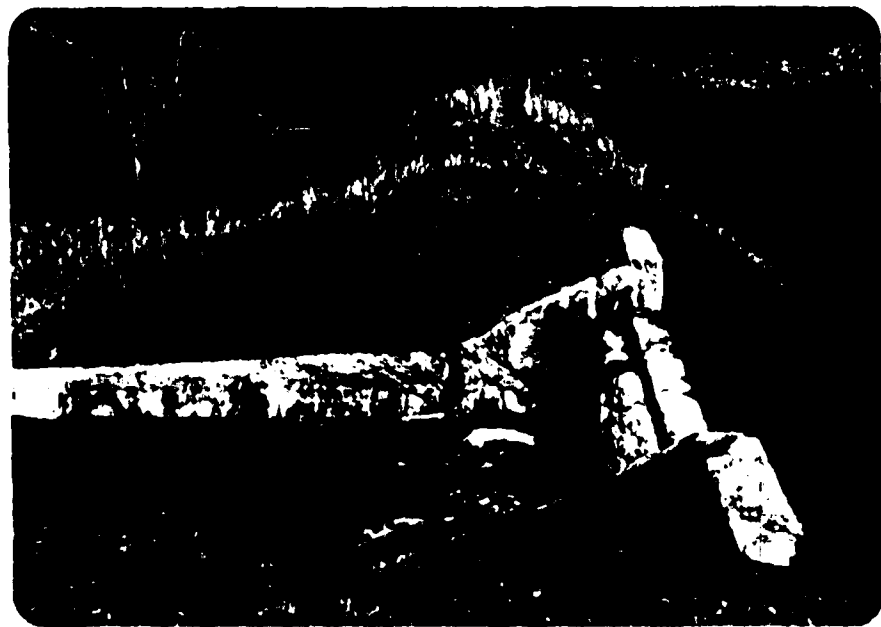
Photograph No. 2
Spillway and dam crest (looking west).

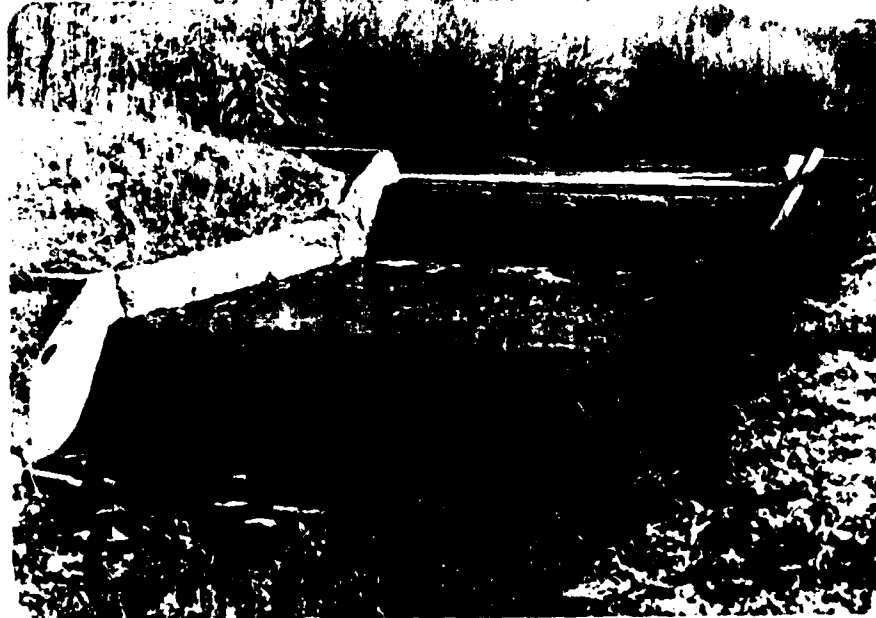
c. Appurtenant Structures. The spillway structures were examined for deterioration and other signs of distress and obstructions that would limit flow. The spillway structures were found to be in poor condition. The concrete spillway abutment walls were found to be seriously deteriorated. Large seeps were observed along

the interface of the abutment walls and the slab forming an apron downstream from the overflow section. Seeps were also observed discharging through the cracks of the apron slab. As previously noted, the tops of the spillway abutment walls were constructed approximately two feet below the mean dam crest elevation, leaving a portion of the abutment and the embankment unprotected if the lake level were to rise to the dam crest level. Repair and restoration of the spillway structures with provisions to provide adequate erosion protection on the embankment and abutment sides of the spillway above the spillway wall level are required.

(2) Appurtenant Structures. The spillway structures were found to be in poor condition with extensive concrete deterioration and underseepage. Repair and restoration of the spillway structures and implementation of necessary measures to control the underseepage are considered to be advisable.

Photograph No. 3
Spillway (note deteriorating concrete).

1. The owner should immediately retain an experienced professional engineer to conduct additional studies and to prepare and execute plans for the repair and restoration of the spillway structures and to evaluate the integrity of the embankment as a water retention structure. Repairs and restoration and additional studies should include, but not be limited to, the following work:

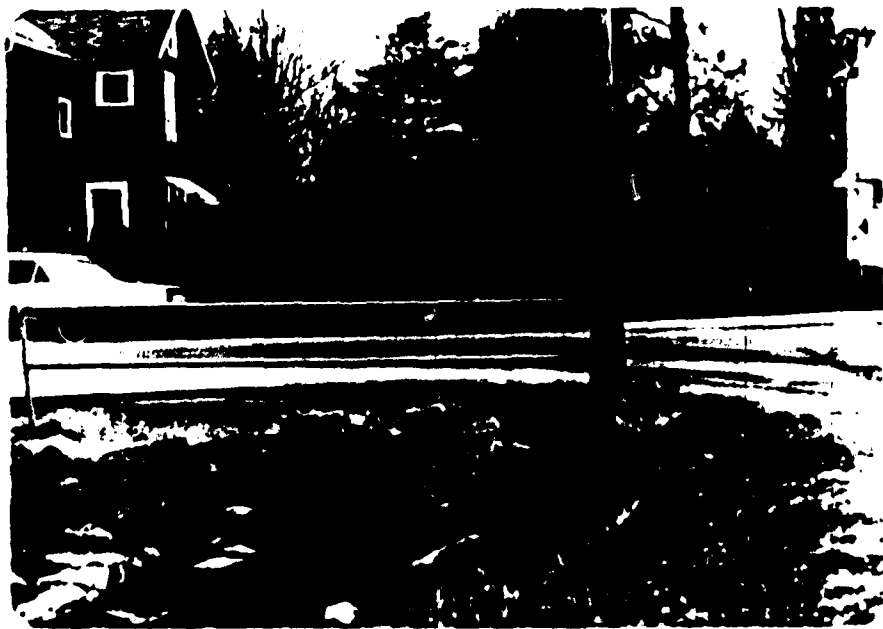
Photograph No. 6

Flat Run at Reynoldsville (approximately 1/2 mile downstream).
