BERGER ASSOCIATES INC HARRISBURG PA  
NATIONAL DAM INSPECTION PROGRAM. LAKE LATTIMORE DAM (NDI-ID NUM--ETC(U)  
JUN 80 DACW31-80-C-0019  
NL

**PHASE I INSPECTION REPORT  
NATIONAL DAM INSPECTION PROGRAM**

OVERVIEW  
LAKE LATTIMORE DAM  
Photograph No. 1

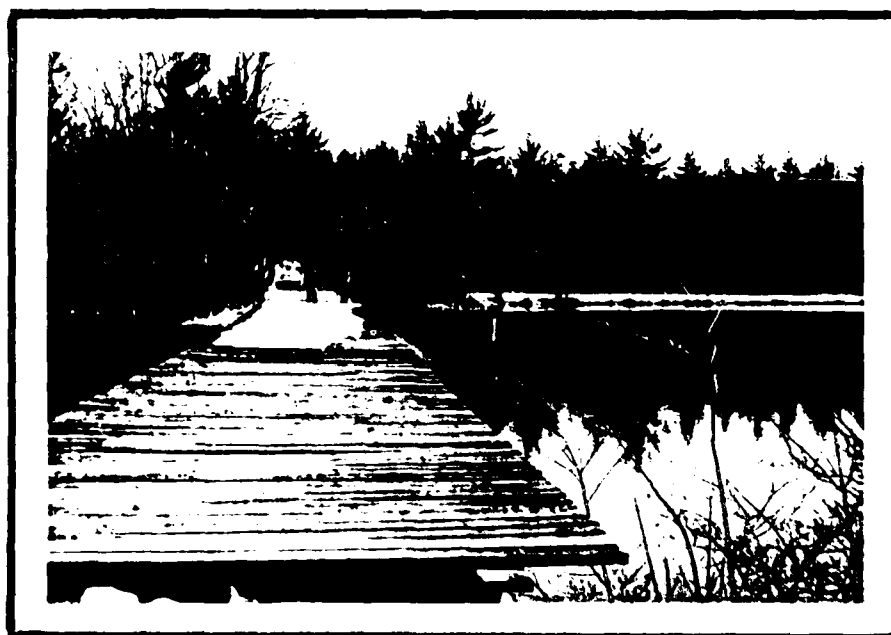
FOOTBRIDGE, EMBANKMENT IN BACKGROUND - NO. 3

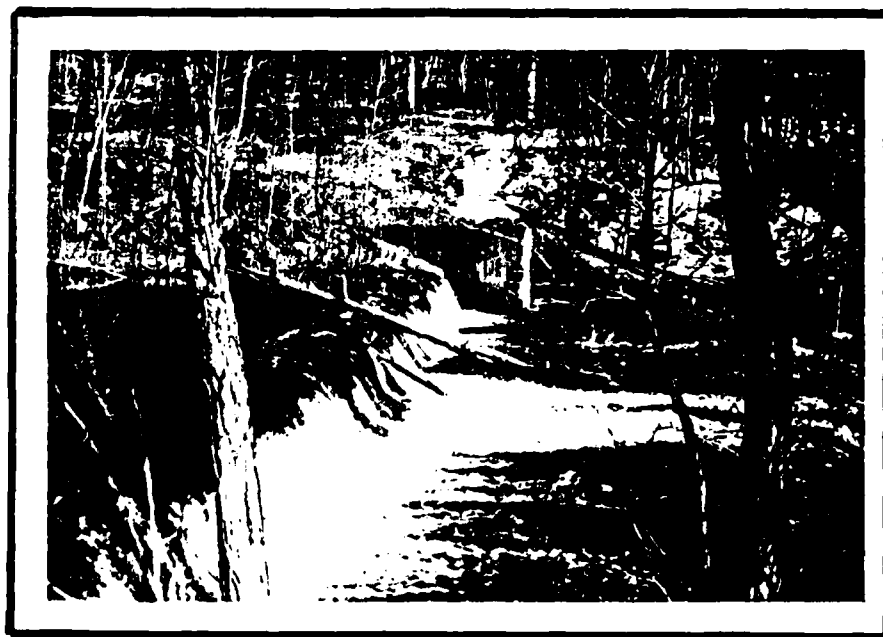
The spillway section is a 110 foot long ogee nearly perpendicular to the centerline of the dam. The ogee section shows some deterioration consisting of exposed aggregate and spalling of a few corners at construction joints. Although the spalling is not serious,

| | OBSERVATIONS AND REMARKS |
|---|---|
| B. WEIR:<br>Crest Condition<br>Cracks<br>Deterioration<br>Foundation<br>Abutments | The spillway is an ogee type section. Its condition is fair as indicated by exposed aggregate and the loss of some spots along the crest. The walls are in good condition showing only slight cracks. They are vertical and do not appear to have settled or otherwise been displaced. |

SPILLWAY - NO. 5

preventive maintenance is recommended. The weir has a small notch located near the center of its length for low flow. The slab below the ogee section consists of grouted riprap and is in fair condition.
