MC CONNELL LAKE DAM

NDI NO. PA-00398
DER NO. 52-91

PIKE COUNTY, PENNSYLVANIA

**PHASE I INSPECTION REPORT
NATIONAL DAM INSPECTION PROGRAM**

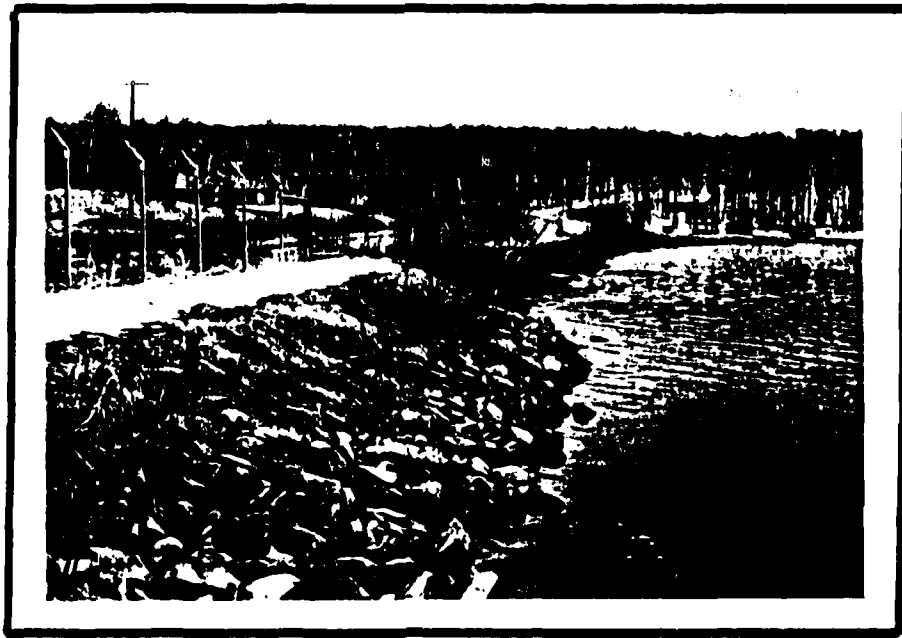
UPSTREAM SLOPE - NO. 3

The upstream slope is in fair condition. Good riprap protection is on the upstream slope to prevent damage from wave action. Some heavy brush and small trees are growing on this slope.

2. That all brush and trees be removed from the embankment slopes and that this maintenance be repeated on a regular basis.
3. That at least the two top valves be greased and operated on an annual basis.
4. That a formal surveillance plan and downstream warning system be developed for implementation during periods of high or prolonged precipitation.
5. That an operation and maintenance manual be prepared for guidance in the operation of the dam during normal and emergency conditions, and that a schedule be developed for the annual inspection of the dam and its appurtenant structures.

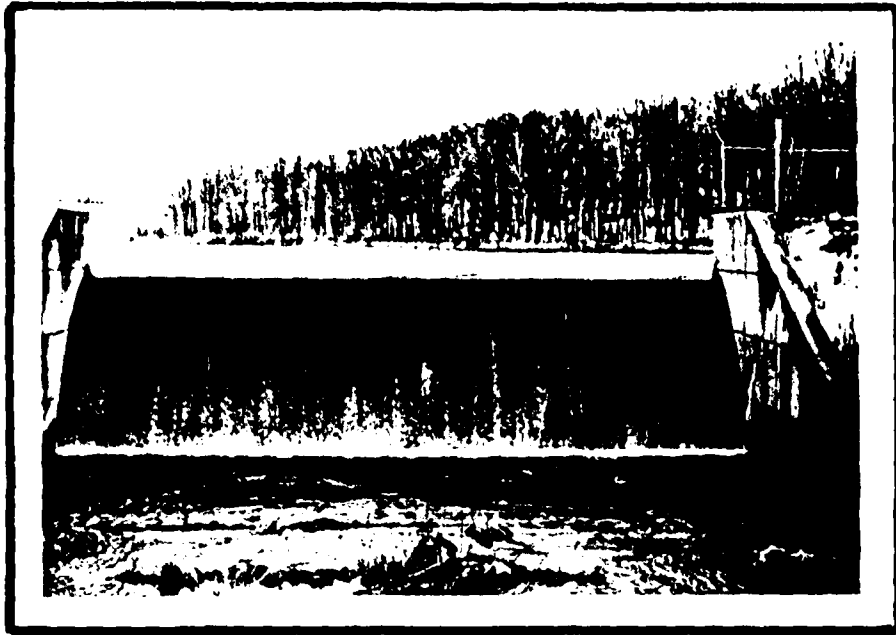
OGEE SPILLWAY - NO. 4

The concrete ogee section appeared to be in good condition with no signs of deterioration of the concrete. The abutment walls had some minor cracking (Photographs No. 1 and No. 4). There was, however, no movement or deflection and the cracking is not considered to be serious at the present time.

The ogee spillway and wingwalls are founded on a 1.5 foot thick slab which is shown to be supported on 20 foot long timber piles. The maximum height of the wingwalls is 19 feet with a footing width of 8.33 feet. This width appears to be small, but there is no apparent stability problem. The abutment walls adjacent to the ogee section appear to have no footings at the right side and only a partial footing at the left side. This condition could contribute to some of the observed cracking.

B. WEIR: Crest Condition Cracks Deterioration Foundation Abutments	Ogee section in good condition. Walls are plumb and also in good physical condition. A wet area was noted on the left wall about 8'± from the top. Some vertical cracking in abutment walls due to unequal stresses.

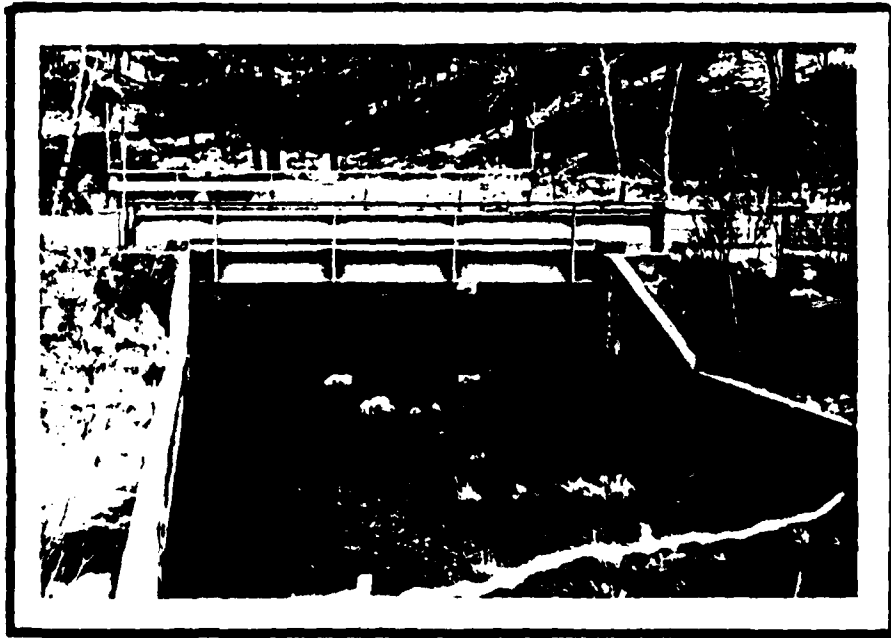
BRIDGE OVER CHANNEL BELOW SPILLWAY - NO. 5

The spillway discharge channel is a U-shaped channel with concrete walls and slab. The concrete was in good condition. A steel beam highway bridge crosses the discharge channel about 110 feet downstream from the ogee section (Photograph No. 5).
