D'APPOLONIA CONSULTING ENGINEERS INC PITTSBURGH PA  
NATIONAL DAM INSPECTION PROGRAM. CLOVER DAM (NDI ID NUMBER PA-4--ETC(U)  
JUN 80

PHASE I REPORT  
NATIONAL DAM INSPECTION PROGRAM

NAME OF DAM: Clover Dam  
 STATE LOCATED: Pennsylvania  
 COUNTY LOCATED: Jefferson  
 STREAM: Clover Run, a Tributary of the East Branch of Mahoning  
 Creek  
 SIZE CLASSIFICATION: Small  
 HAZARD CLASSIFICATION: High  
 OWNER: Western Pennsylvania Water Company  
 DATE OF INSPECTION: April 22, 1980 and April 30, 1980

CLOVER DAM  
NDI I.D. PA-420  
DER I.D. 33-4  
APRIL 22, 1980

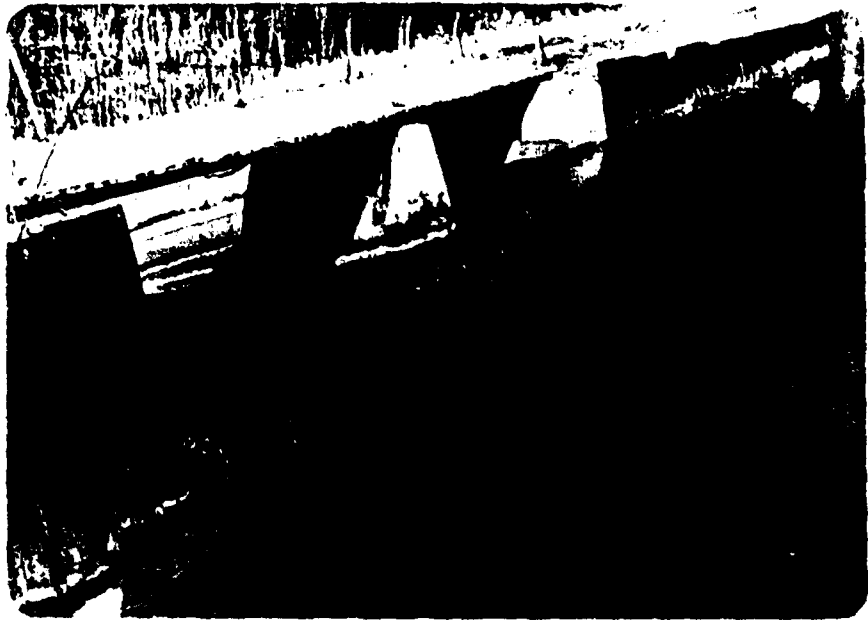
Photograph No. 3  
Spillway crest.

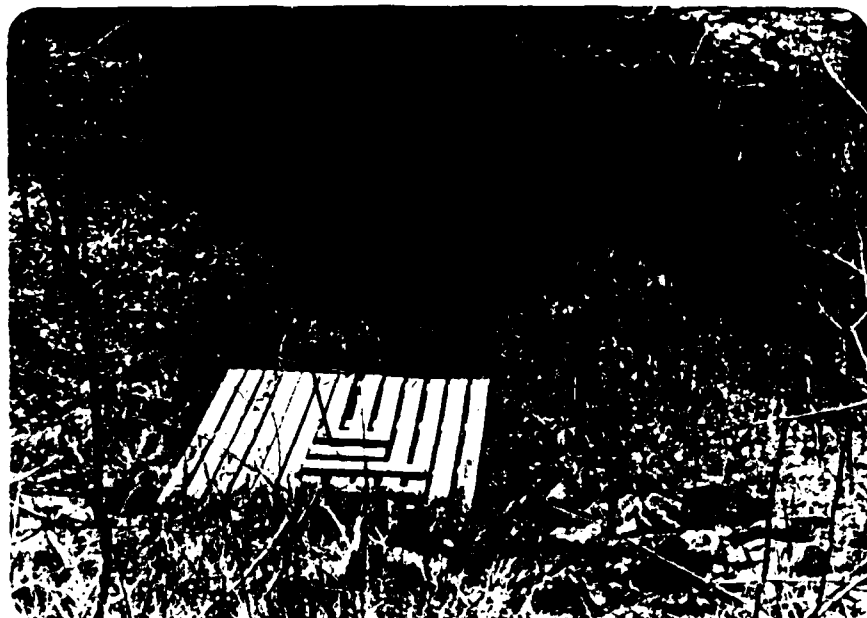
4.3 Maintenance of Operating Facilities. The intake towers have been abandoned and include no operating facilities. The only operable facility of the dam as it exists is the blow-off valve at a chamber at the downstream toe of the dam. The blow-off valve was operated by water company personnel during this inspection and was observed to be functional.

Photograph No. 5  
Outlet pipe valve chamber.

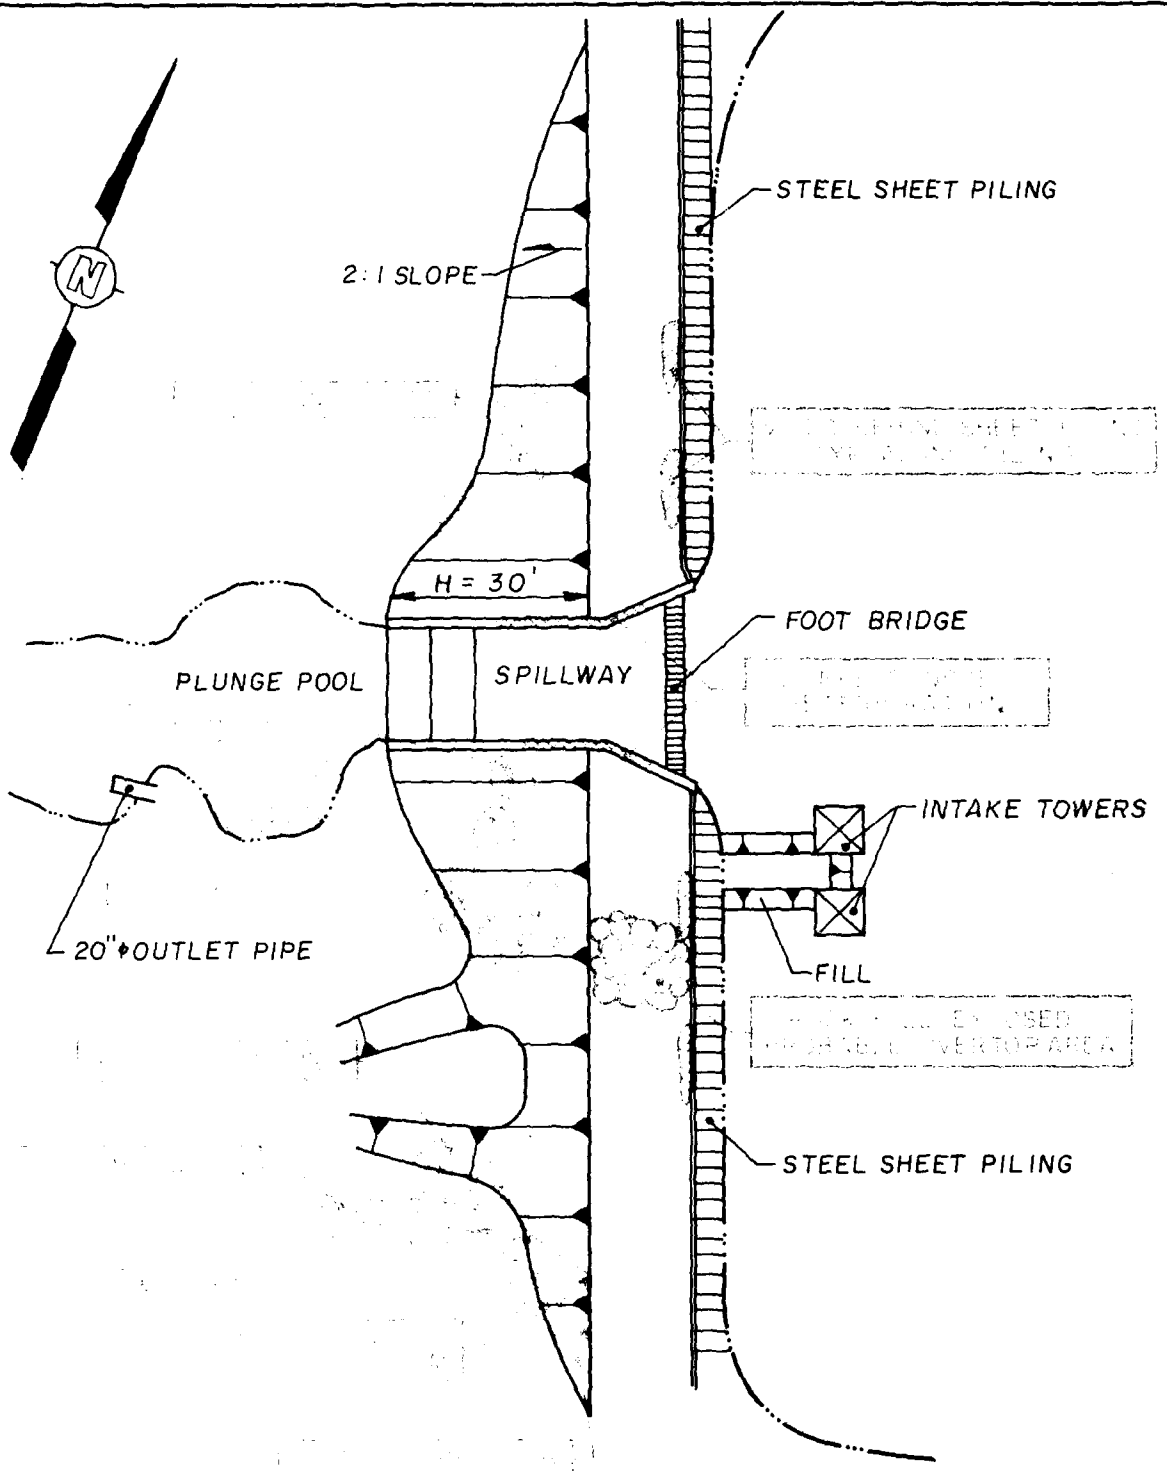
VISUAL EXAMINATION OF	OBSERVATIONS	REMARKS OR RECOMMENDATIONS
JUNCTION OF EMBANKMENT AND ABUTMENT, SPILLWAY AND DAM	No signs of distress.	
ANY NOTICEABLE SEEPAGE	A seepage point and swampy area is located near the left abutment. See Plate 4 for location.	
STAFF GAGE AND RECORDER	None	
DRAINS	None

VISUAL EXAMINATION OF	OBSERVATIONS	REMARKS OR RECOMMENDATIONS
CONDITION (OBSTRUCTIONS, DEBRIS, ETC.)	There is a scar on the left side of the spillway in the downstream channel. See Plate 4 for location.	
SLOPES	No features pertinent to the safety of the dam.	
APPROXIMATE NUMBER OF HOMES AND POPULATION	A water treatment plant is located 2-1/2 miles downstream from the dam. The community of Big Run is located 3-1/2 miles downstream. Population: approximately 10.

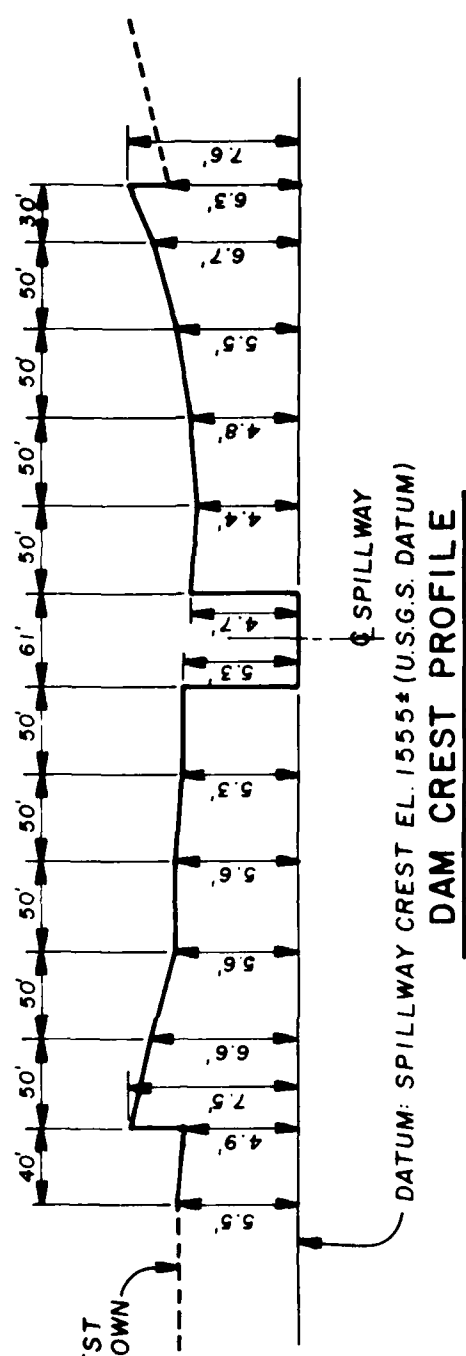
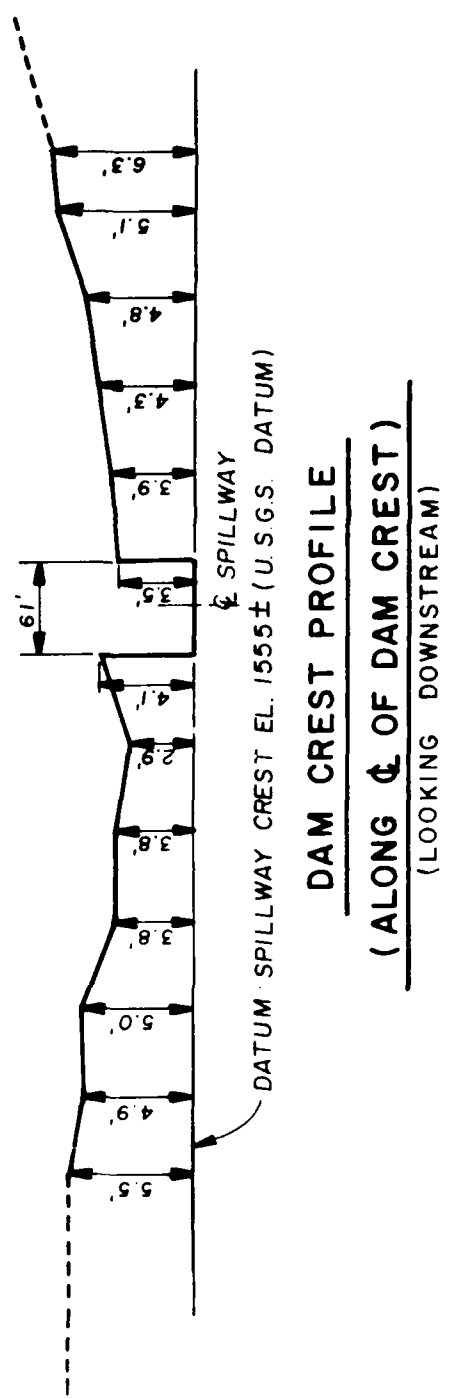
**DAM CREST PROFILE**  
**(ALONG TOP OF UPSTREAM SHEET PILING)**  
(LOOKING DOWNSTREAM)

The crest of the dam was surveyed relative to the spillway crest elevation and the middle of the embankment was found to be on the order of 2 to 3 feet below the abutment levels. Plate 5 illustrates the longitudinal profile of the dam crest along the top of the upstream sheet piling and along the center of the embankment. The
