GRACETON DAM

NDI I.D. NO: PA-00279

PHASE I INSPECTION REPORT
NATIONAL DAM INSPECTION PROGRAM

D'APPOLONIA CONSULTING ENGINEERS
DACW31-80-C-0022

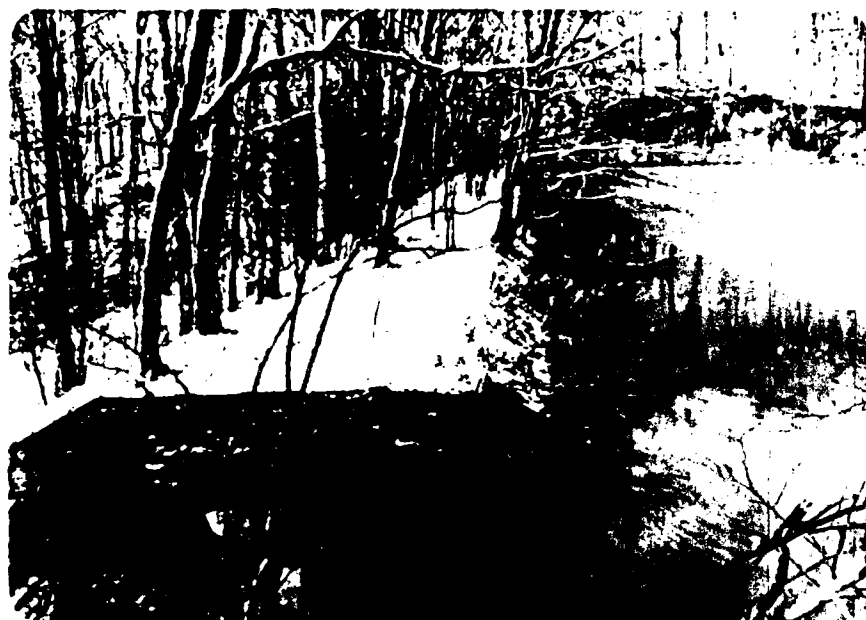
Photograph No. 1
Crest (looking west).

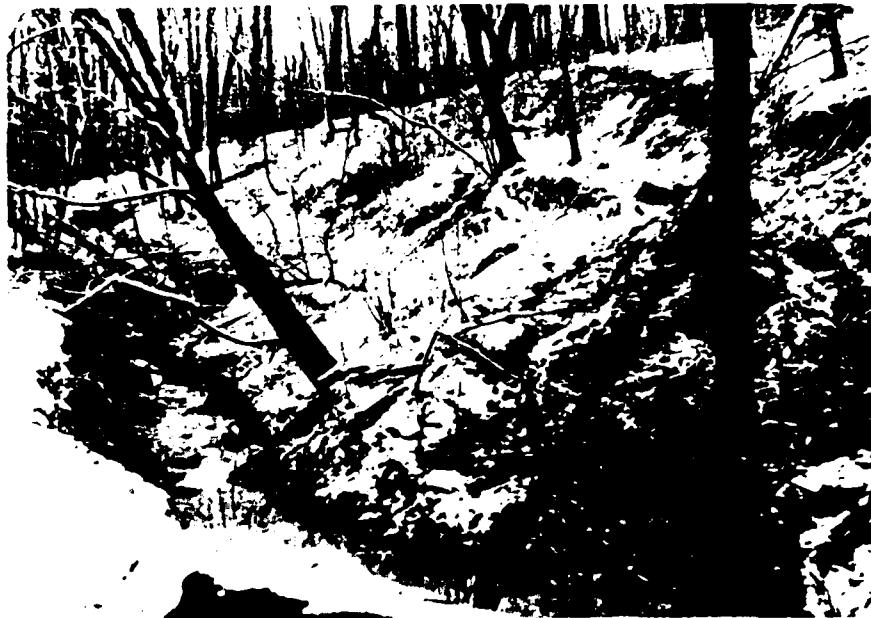
Photograph No. 3

separating the spillway discharge channel from the embankment. An active landslide was observed on the left abutment side of the spillway discharge channel, threatening to block the spillway discharge channel. Two railroad rail sections were found installed in the spillway crest extending from the crest level to the top of the spillway wall. Apparently, these rails were installed with the intention of placing flashboards across the spillway. The presence of these steel sections in the overflow section is considered to pose a potential for the blockage of the spillway with debris in the event of a major flood.

VISUAL EXAMINATION OF	OBSERVATIONS	REMARKS OR RECOMMENDATIONS
JUNCTION OF EMBANKMENT AND ABUTMENT, SPILLWAY AND DAM	There is an active landslide on the left abutment approximately 100 feet downstream from the dam which is threatening to block the spillway discharge channel.	Necessary steps should be taken to prevent blockage of the spillway discharge channel.
ANY NOTICEABLE SEEPAGE	There are swampy areas and ponded water below the toe of the dam. However, no isolated point of seepage was located.	
STAFF GAGE AND RECORDER	None	
DRAINS	None

Small discharge channel (looking upstream).
Note tilting trees (landslide).

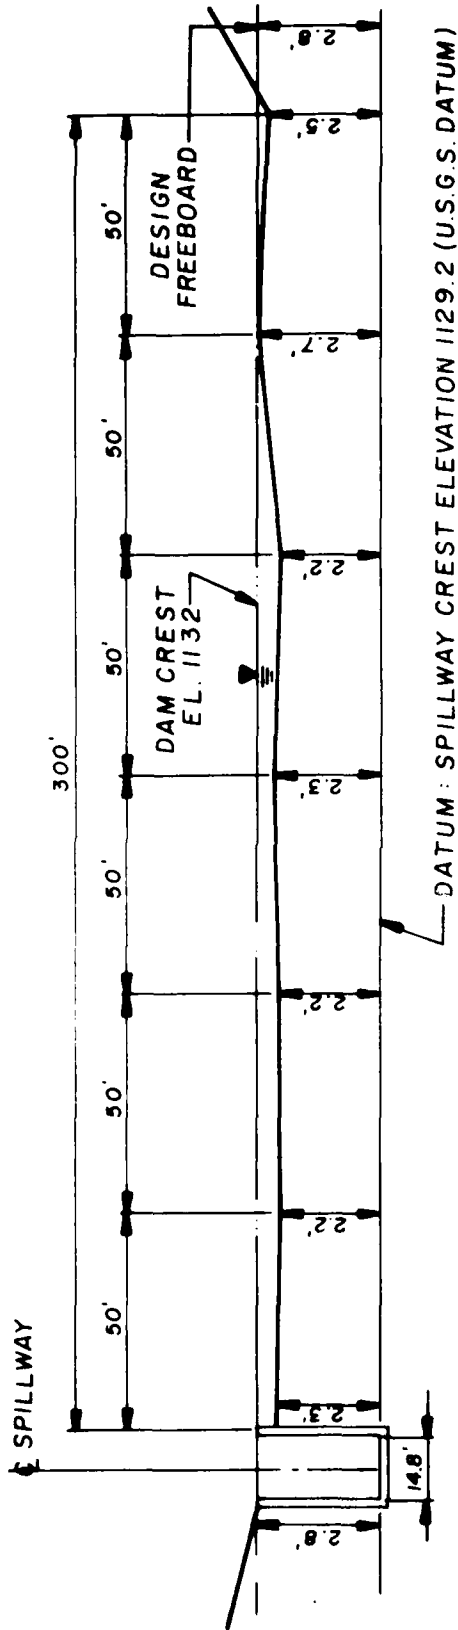
DAM CREST PROFILE
(LOOKING DOWNSTREAM)

The crest of the dam was surveyed relative to the spillway crest elevation and it was found to be on the order of 0.5 to 0.8 foot below the top of the spillway wall, which appears to be the design crest level for the embankment. The dam crest profile is illustrated in Plate 4. The downstream slope was surveyed and the slopes were found to be reasonably within the design slopes which are 1.5H to 1V above the berm and 2.5H to 1V below the berm level.
