**PHASE I REPORT  
NATIONAL DAM INSPECTION PROGRAM**

**NAME OF DAM:** Brookville Water Works Dam  
**STATE LOCATED:** Pennsylvania  
**COUNTY LOCATED:** Jefferson  
**STREAM:** North Fork Creek, a Tributary of Red Bank Creek  
**SIZE CLASSIFICATION:** Small  
**HAZARD CLASSIFICATION:** Significant  
**OWNER:** Borough of Brookville  
**DATE OF INSPECTION:** April 24, 1980 and April 30, 1980

BROOKVILLE WATER WORKS DAM  
NDI I.D. PA-422  
DER I.D. 33-2  
APRIL 24, 1980

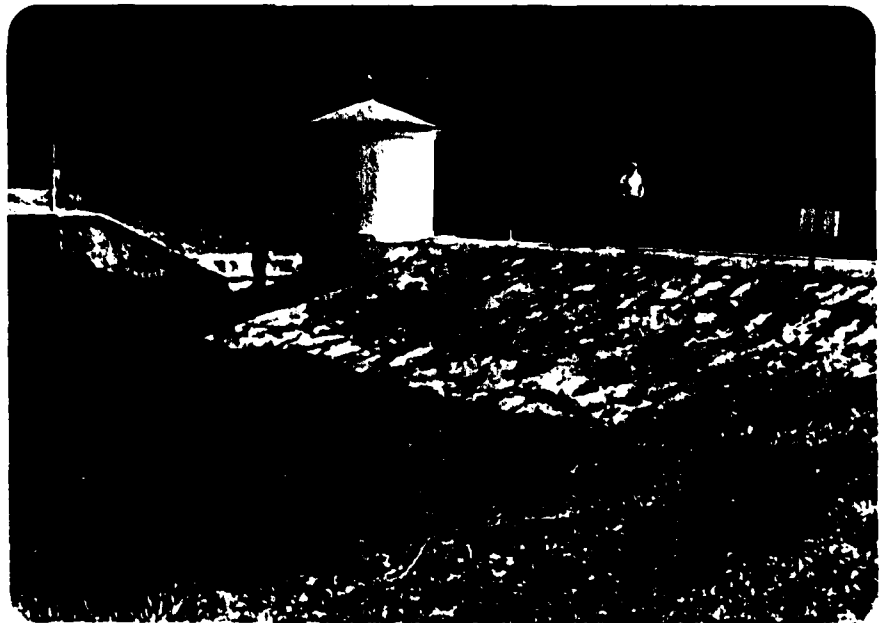
Photograph No. 2  
Upstream face (looking east).

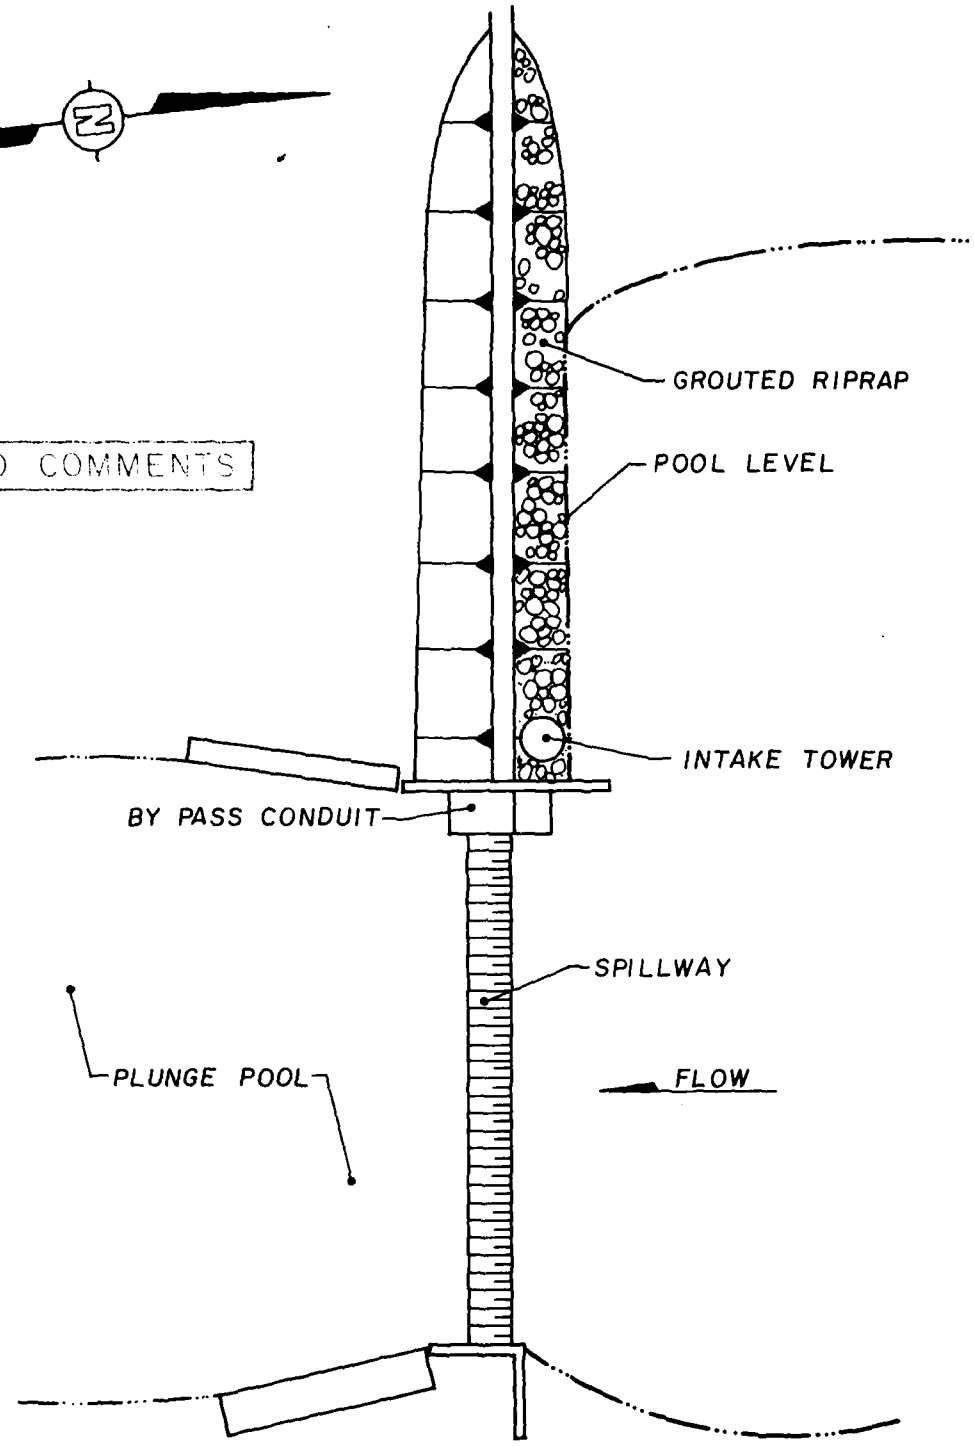
The crest of the dam was surveyed relative to the spillway crest elevation and it was found that the dam crest was essentially at the design crest level with a minor low spot located at the right abutment embankment interface. The dam crest profile is illustrated in Plate 6. The downstream and upstream slopes were surveyed and were found to be reasonably within the design slope of 2H to 1V.

1. POOL LEVEL DATE OF INSPECTION:  
1.0 FT. ABOVE SPILLWAY CREST
