National Dam Inspection Program

LOWER DAM

(NDS ID NO. PA-697,
DER ID NO. 54-47)

PHASE I INSPECTION REPORT.

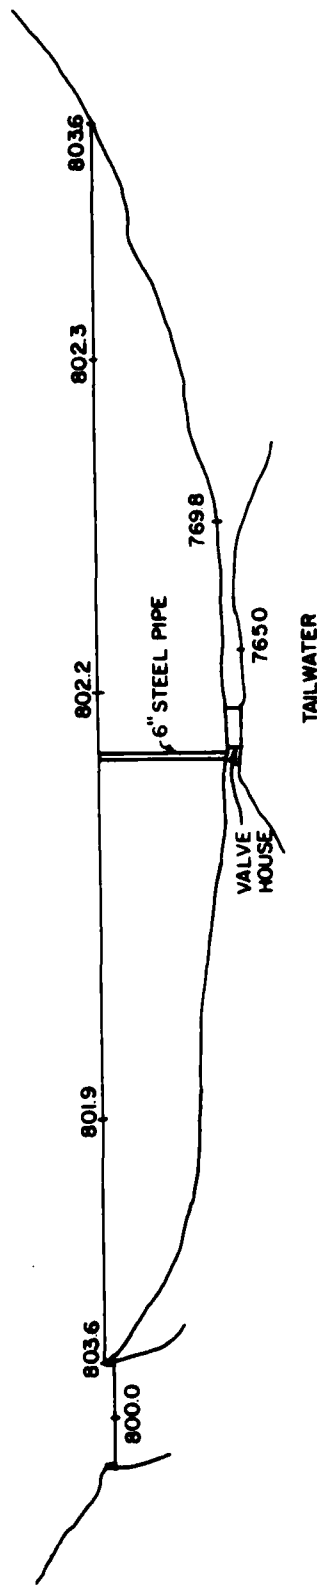
**PROFILE
LOOKING UPSTREAM**
(Scale: 1"=50')

A low spot (801.9 feet) was noted on the embankment near the right abutment.
