POTOMAC RIVER BASIN  
TOMS CREEK, ADAMS COUNTY

PENNSYLVANIA  
NDS ID PA. 01135  
DER ID 1-86

## SECTION F DAM

### PHASE I INSPECTION REPORT NATIONAL DAM INSPECTION PROGRAM

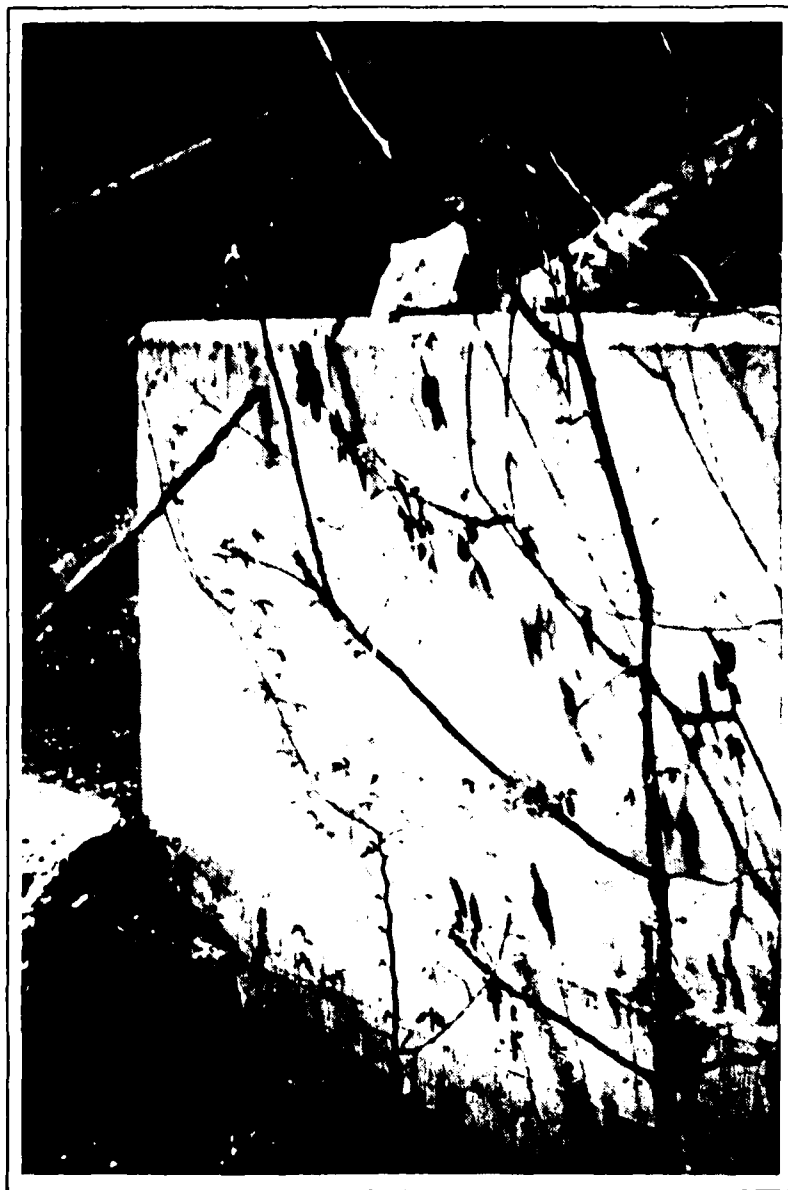
PHOTOGRAPH NO. 12

DOWNSTREAM END OF SPILLWAY.  
NOTE LARGE TREE.
