**DELAWARE RIVER BASIN
OWL CREEK, SCHUYLKILL COUNTY**

**PENNSYLVANIA
NDS ID PA. 00674
DER ID 54-2**

LOWER OWL CREEK DAM

**PHASE I INSPECTION REPORT
NATIONAL DAM INSPECTION PROGRAM**

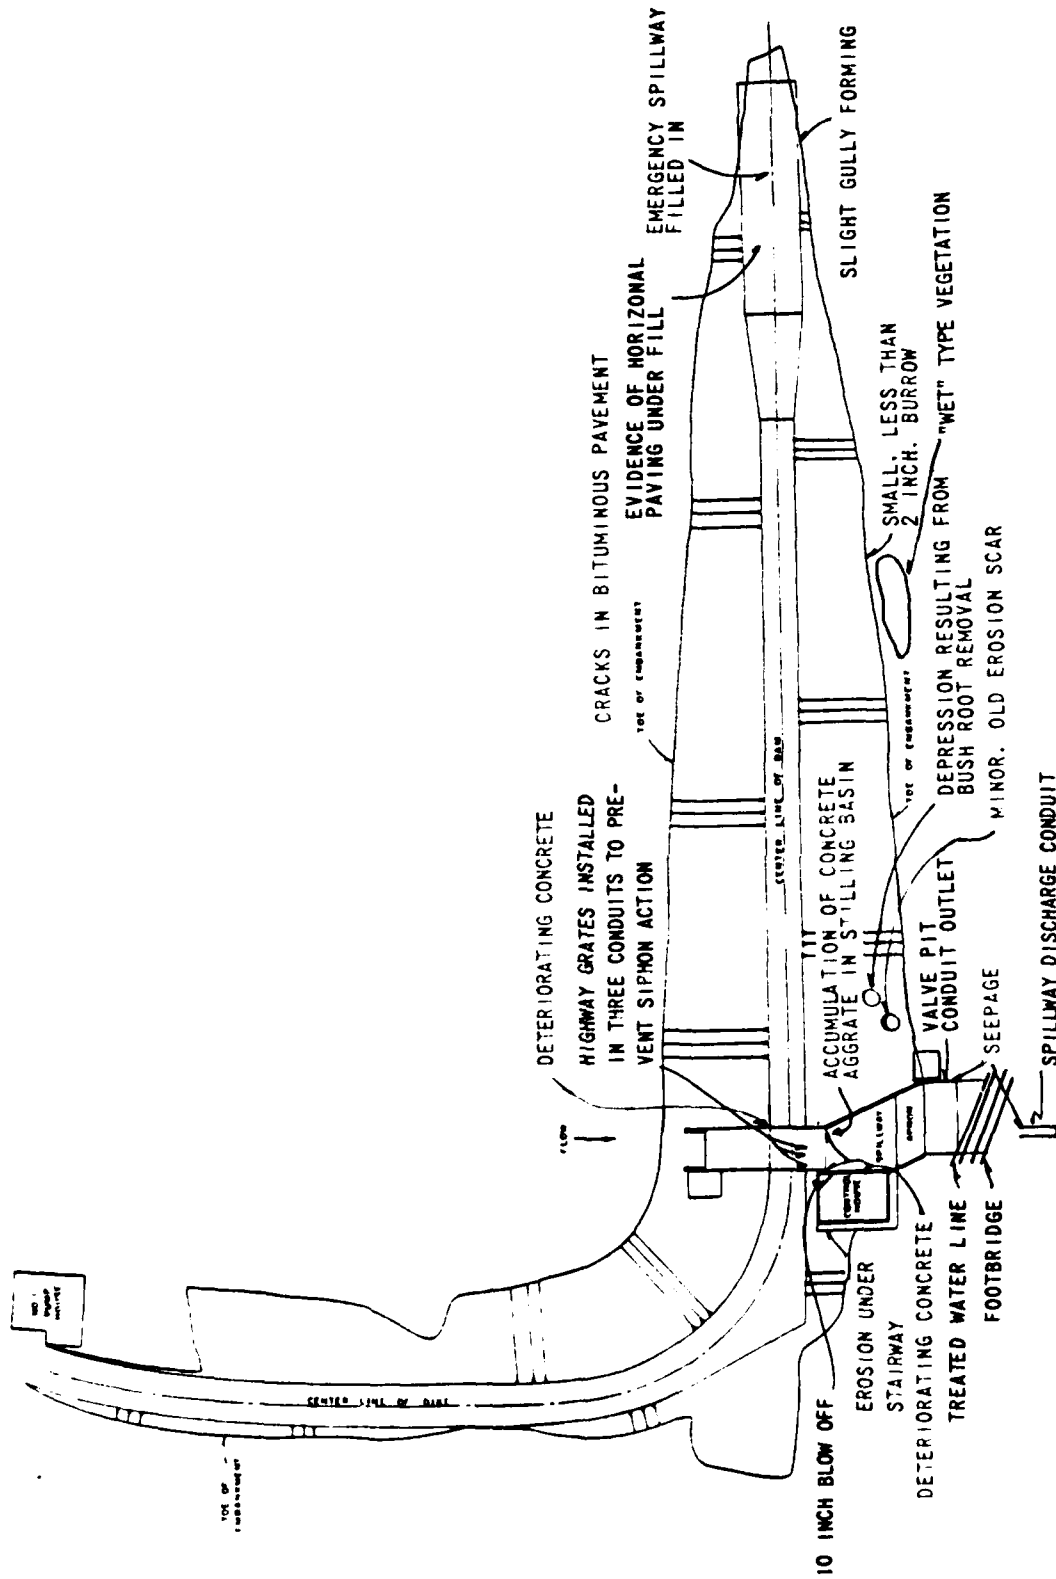
FIELD OBSERVATION PLAN
 LOWER OWL CREEK DAM
 SHEET 5A OF 11

The spillway conduits discharge into a paved channel. Normal flow is collected and piped under the channel floor. Spalling and deterioration of concrete has occurred as shown on Sheet 5A of 11. Some water seepage at base of left channel wall downstream from embankment toe.

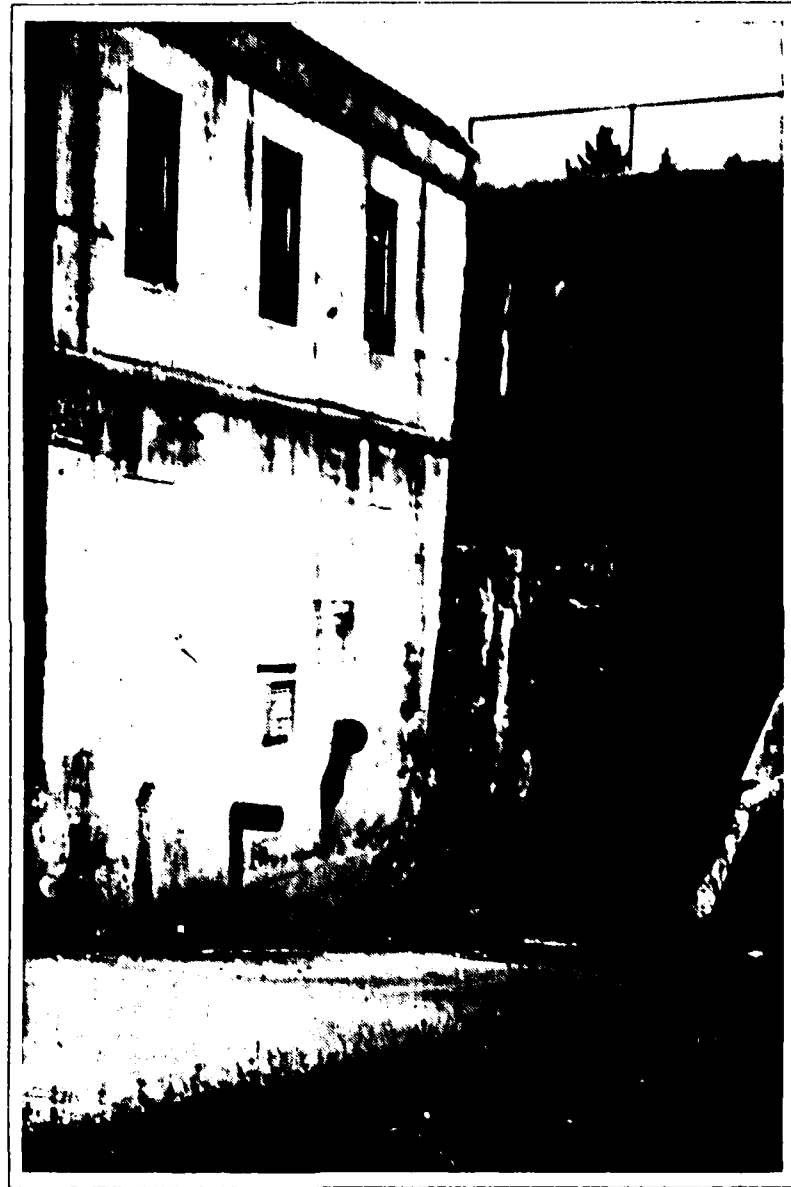
PHOTOGRAPH NO. 3

CONTROL HOUSE AND DOWNSTREAM SIDE
OF SPILLWAY STRUCTURE. NORMAL FLOW
ENTERS GRATE AND IS CONVEYED DOWNSTREAM
UNDER CHANNEL FLOOR.
