WALLKILL RIVER BASIN
LONG HOUSE CREEK,
PASSAIC COUNTY
NEW JERSEY

**JPPER GREENWOOD
LAKE DAM
NJ 00186**

**PHASE 1 INSPECTION REPORT
NATIONAL DAM SAFETY PROGRAM**
DACW61-79-C-0011

4. TITLE (and Subtitle) Phase I Inspection Report National Dam Safety Program Upper Greenwood Lake Dam NJ00186 Passaic County, New Jersey		5. TYPE OF REPORT & PERIOD COVERED FINAL

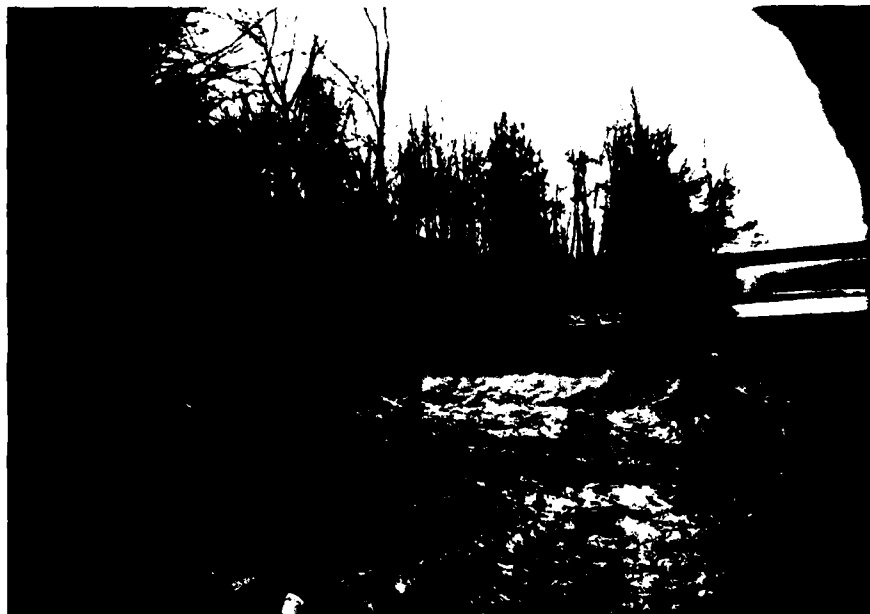
Photo 1 - View of spillway from downstream. Note remains of bridge's wood deck at left. Dam and low level outlet is out of view on right.

1. The two steel I-beams that span the spillway and their pier supports should be removed. These I-beams, during high flow, could entrap and collect debris causing a reduced spillway capacity. A reduced capacity could increase the frequency of overtopping.
2. Repair all cracked and spalled concrete with epoxy cement within twelve months.
3. All brush and trees should be removed from the downstream and upstream slopes to avoid problems which may develop from roots. The embankment face should then be seeded to develop a growth of grass for surface erosion protection. This program should be started within 12 months.
4. Investigate embankment for animal burrows and fill in any burrow holes with impervious material.
5. Remove debris from downstream channel within twelve months.

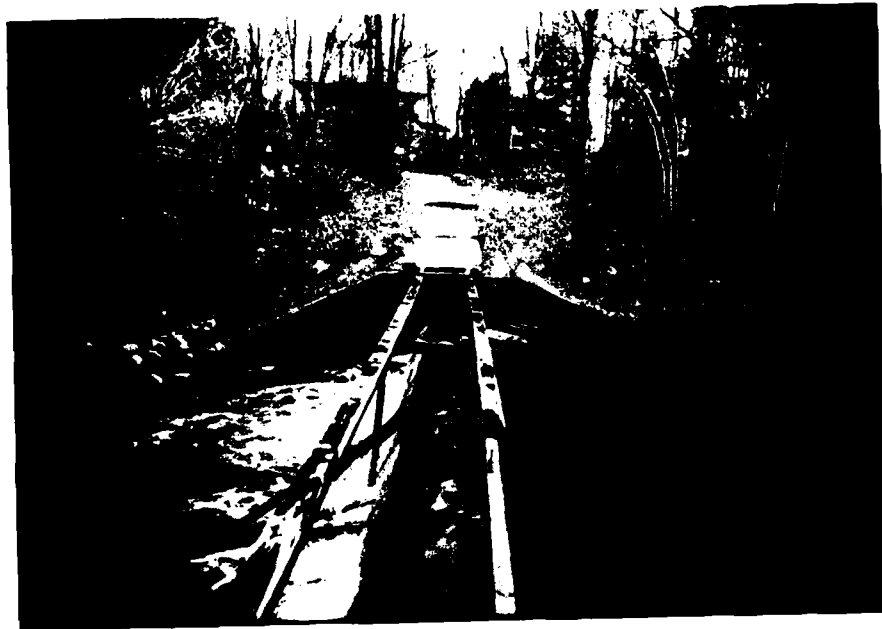
Photo 4 - View from left abutment. Note vertical cracks in abutment.

(1) Repair all cracked and spalled concrete.

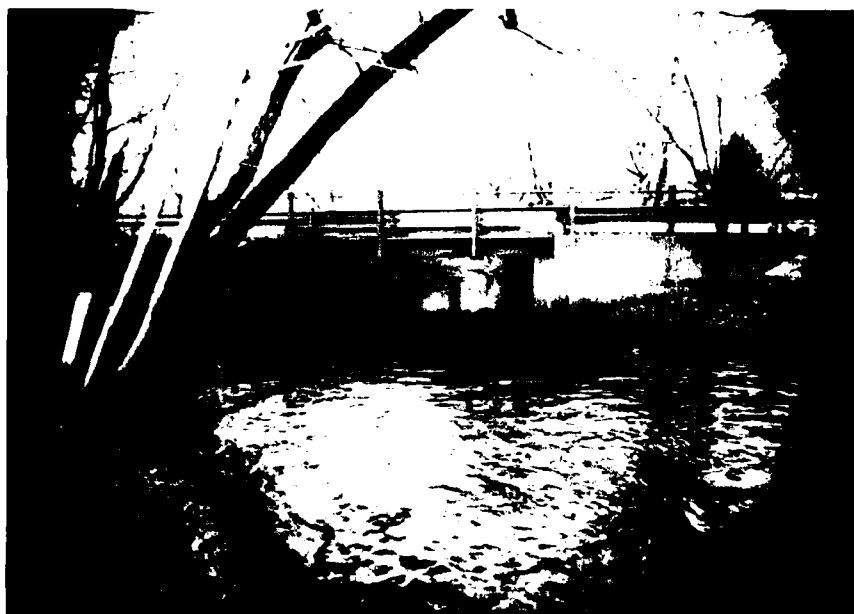
The downstream channel is in good condition. Cobblestones and boulders are on the bottom of the channel. There were wood planks, fallen trees, and other debris in the channel. A roadway bridge crosses over the channel approximately 200 feet from the spillway. The channel's slopes are moderate. Two houses are on the right side of the channel, located approximately 250 feet from the spillway or about 50 feet beyond the roadway bridge.

Photo 9 - View of roadway bridge (Upper Greenwood Road) crossing over channel approximately 200 feet downstream from the spillway.

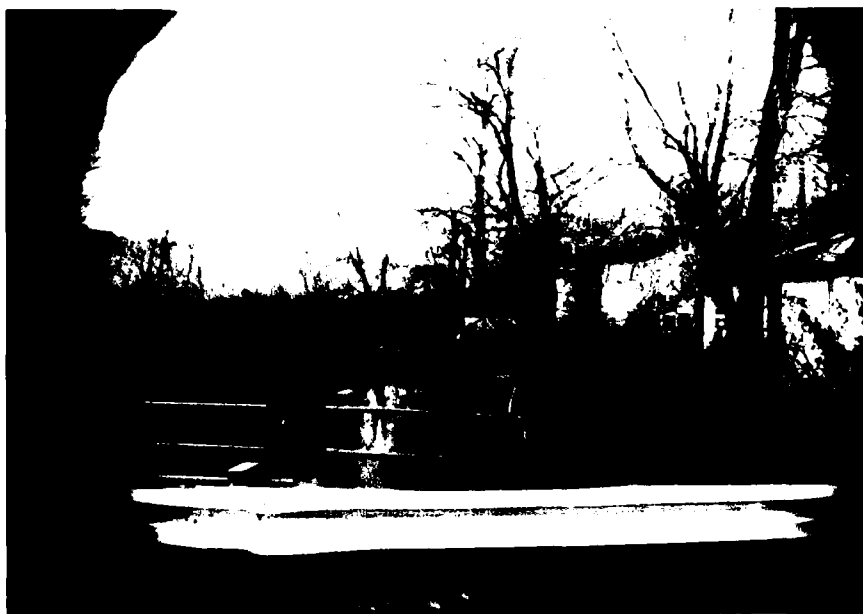
Photo 10 - View of two houses approximately 50 feet downstream of roadway bridge mentioned above or about 250 feet downstream from the spillway.

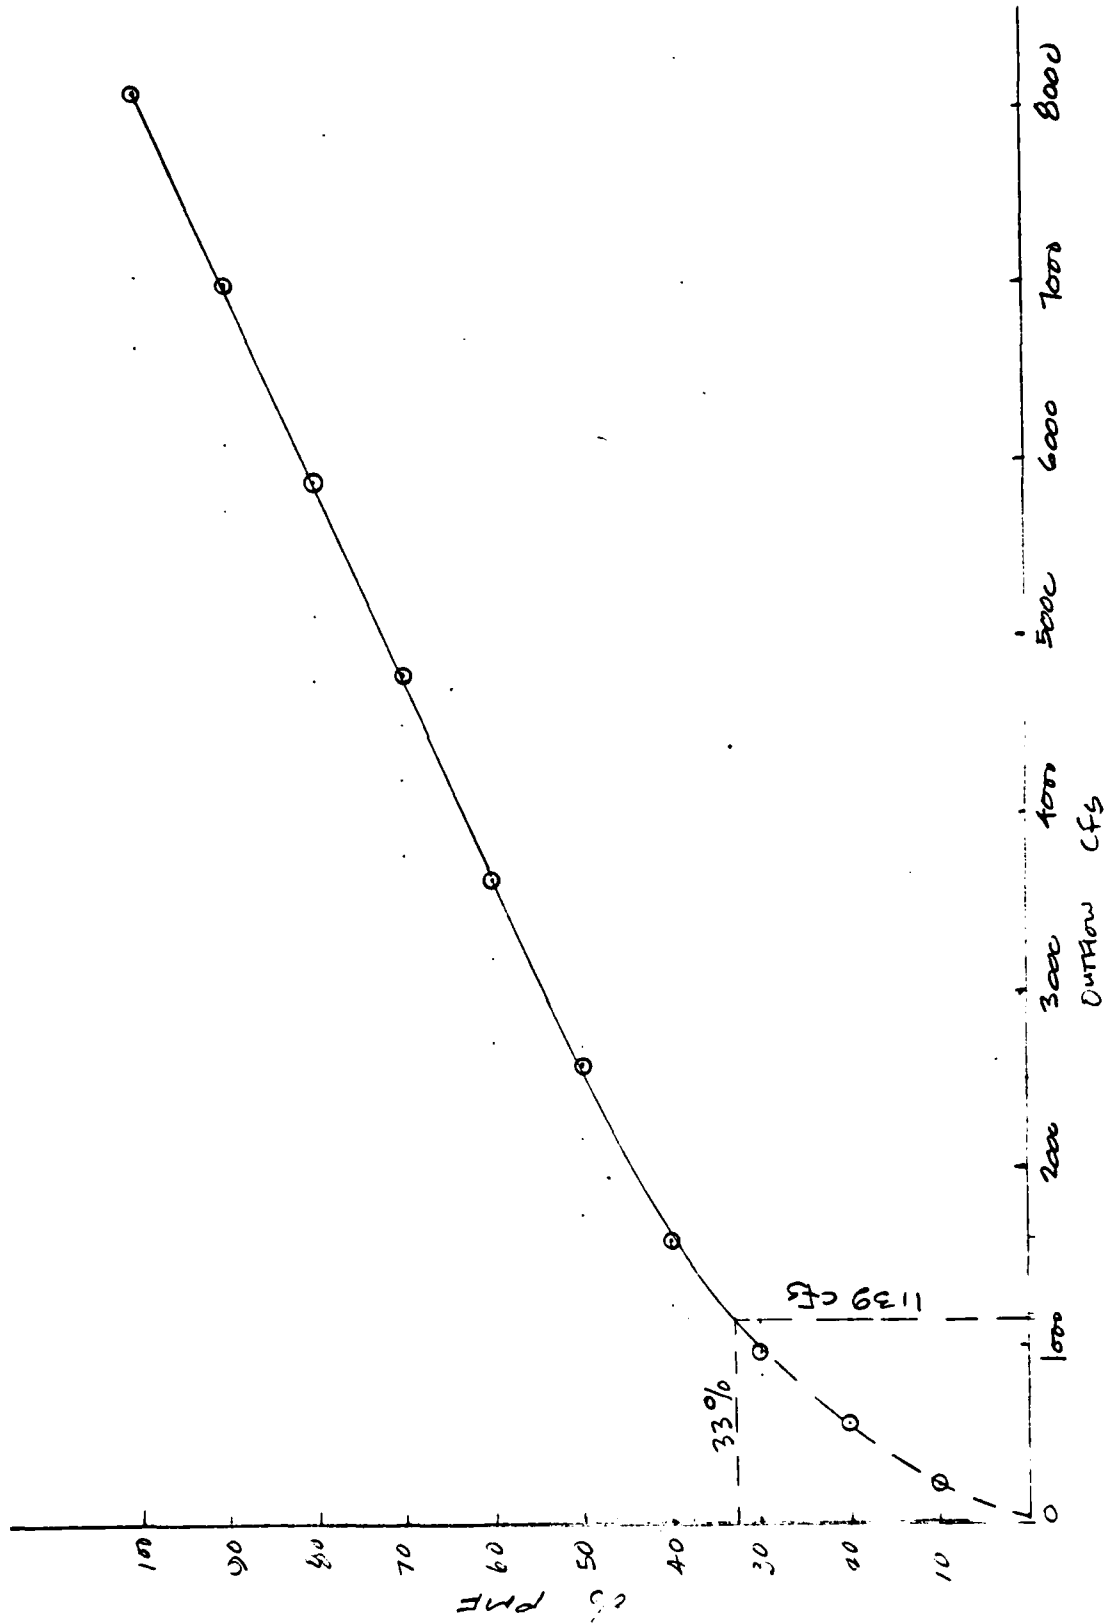
OVERTOPPING POTENTIAL

Overtopping of Dam Occurs at Ele. 1104 with $Q = 1139$ cfs ($\sim 33\%$ PMF)
