PASSAIC RIVER BASIN  
BRANCH OF POST BROOK,  
PASSAIC COUNTY  
NEW JERSEY

**N.J. NO NAME DAM  
NO. 40**

**NJ 00208**

**PHASE 1 INSPECTION REPORT  
NATIONAL DAM SAFETY PROGRAM**

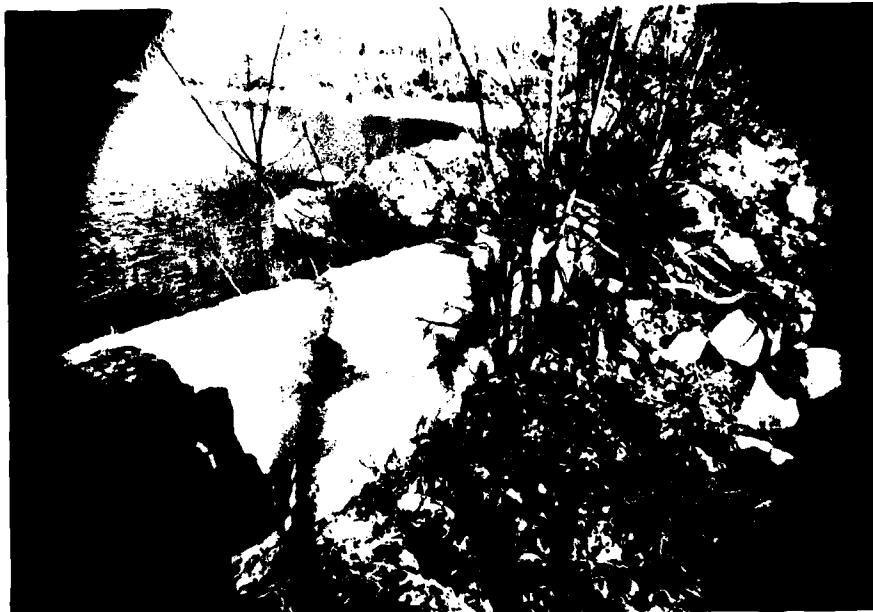
VISUAL EXAMINATION OF	EMBANKMENT OBSERVATIONS	REMARKS AND RECOMMENDATIONS
SURFACE CRACKS None noticed.		
UNUSUAL MOVEMENT OR CRACKING AT OR BEYOND THE TOE Cracking and spalling of the concrete wall were observed. The wall is on the upstream side of embankment and the cracking and spalling is just left of the former spillway.		Repair cracking and spalling.
SLOUGHING OR EROSION OF EMBANKMENT AND ABUTMENT SLOPES Erosion was observed on the downstream side of the embankment opposite the former spillway.		Refill eroded area.
VERTICAL & HORIZONTAL ALIGNMENT OF THE CREST Crest of the existing embankment has been covered over with rocks and dirt to form the dirt road. Therefore, the vertical and horizontal alignment of the original embankment could not be ascertained, but the alignment of the road is uneven.		
RIPRAP FAILURES N/A

Photo 3 - Detail of concrete wall, shown in Photo 2, depicting cracking and spalling.

5. Repair all cracked and spalled concrete within twelve months.
6. All brush and trees should be removed from the downstream and upstream slopes to avoid problems which may develop from roots. The embankment face should then be seeded to develop a growth of grass for surface erosion protection. This program should be started within twelve months.

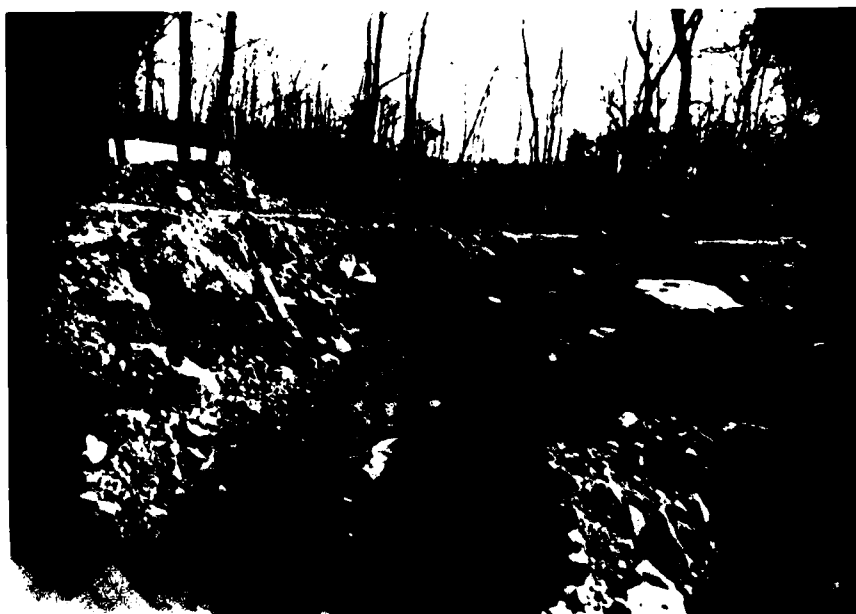
Photo 7 - View of spillway from the lake. The spillway, a 48-inch corrugated metal pipe, crosses under the embankment at its left side.

6. Provide a headwall and side slope and channel bottom protection for both the approach and discharge channels. Extend the protection for the discharge channel to beyond the embankment toe of the slope. This should be completed within twelve months, providing the pipe is not required to be replaced as a result of the hydrologic and hydraulic analysis of the dam. (Ref. Item 1).
