LAKE JAMIE DAM

NDI ID NO. PA-00778  
DER ID NO. 45-220

PHASE I INSPECTION REPORT  
NATIONAL DAM INSPECTION PROGRAM

JUNE 1980

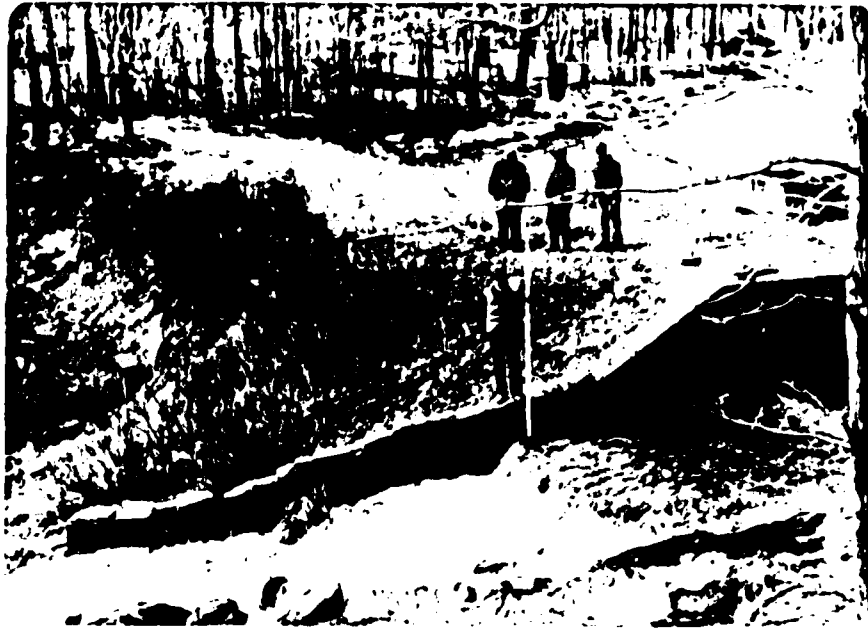
b. Embankment. The embankment is in fair condition. The upstream slope is protected by riprap, which is in good condition. Above normal pool elevation, the riprap is covered with grass (Photograph B). The top of the dam is covered with grass. The downstream slope is covered with grass and thick brush (Photograph A). A foot trail on the downstream slope just to the left of the outlet works is eroded. The erosion is very shallow. At the junction of the embankment and the right spillway wall, behind the stone masonry training wall, the downstream embankment slope is eroded severely (Photograph D). The erosion extends about half-way up the slope.

A. Downstream Slope

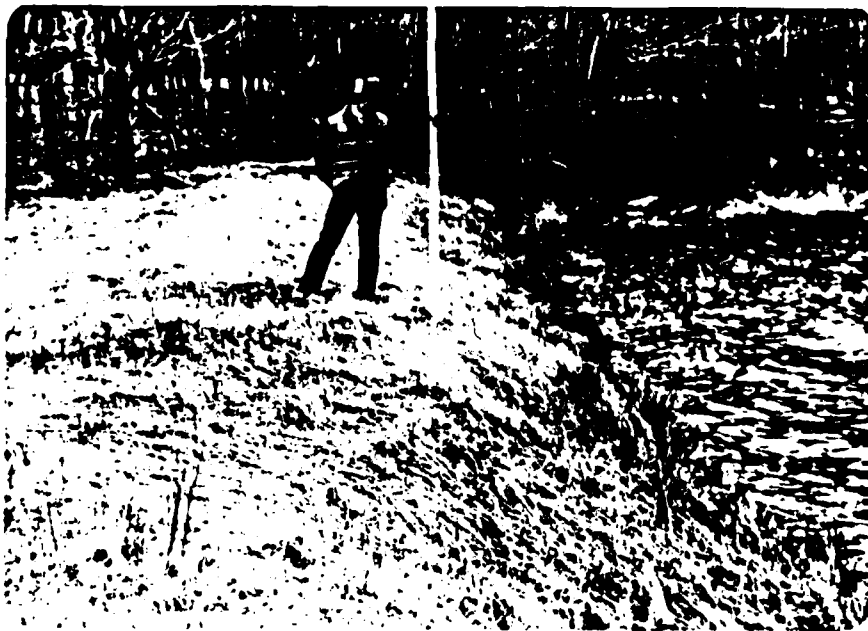
B. Upstream Slope

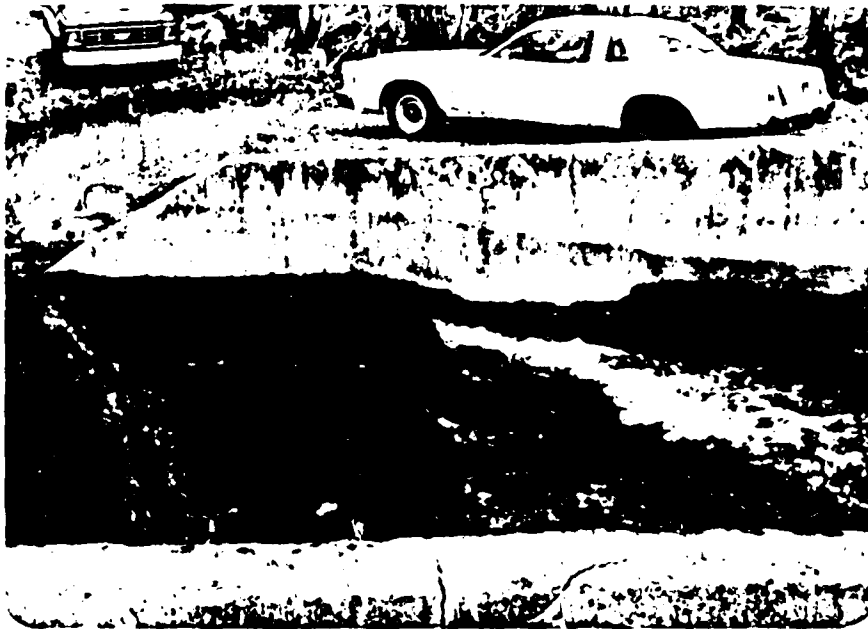
c. Appurtenant Structures. The spillway is in fair condition. A massive log, larger than a telephone pole and about the length of the weir, was floating in the approach channel just upstream of the weir (Photograph C). The weir itself is in good condition but the length of its crest measures 0.4 foot less than the design drawings indicate. The spillway sidewalls are slightly bowed. Cracks about 1/8-inch wide extend vertically through the walls just downstream of the weir (Photograph C). The spillway apron is in good condition. There is evidence of concrete patching on the apron and on the lower part of the cracks in the sidewalls. The patching appears to be rough but effective. The stone masonry training wall, which was added downstream of the right spillway wall after the dam was constructed, is in poor condition. The mortar is very deteriorated and daylight is visible through much of the wall. With the flow conditions on the day of the inspection, a significant amount of water was flowing through the wall. The erosion behind the wall, which reportedly occurred shortly after the dam was constructed, has never been repaired (Photograph D).

C. Spillway

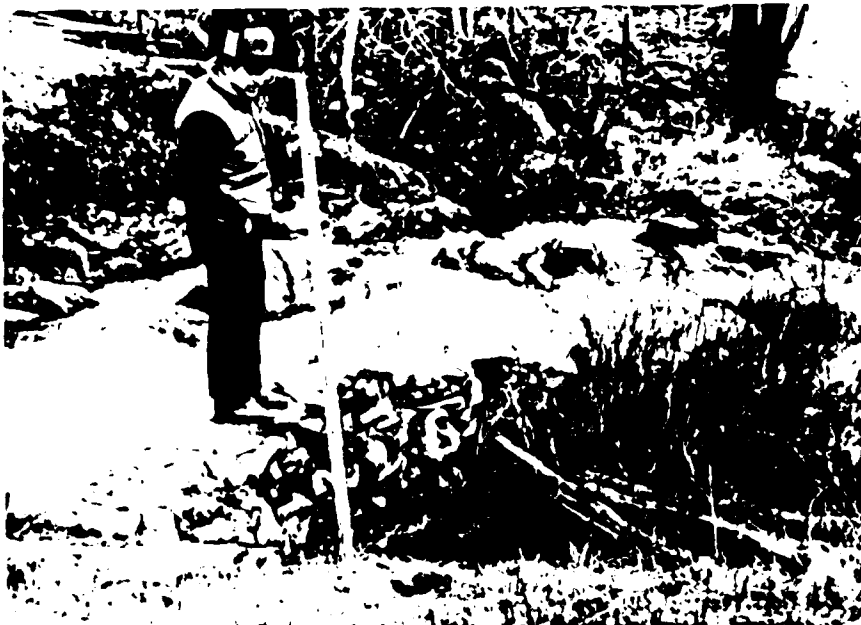
(3) Appurtenant Structures. Plate E-2 indicates that the spillway walls are founded on rock. The cracks in the walls are probably shrinkage cracks that have been widened slightly by freeze-thaw action. At present, the cracks prevent the walls from acting as an impervious barrier during periods of high pools. The concrete patching at the lower part of the cracks and on the apron is satisfactory.

D. Spillway Inspection Wall

(6) Repair the cracks in the spillway walls. Visually monitor the cracks. If the cracks enlarge or if other cracks appear, have the condition assessed by a professional engineer.

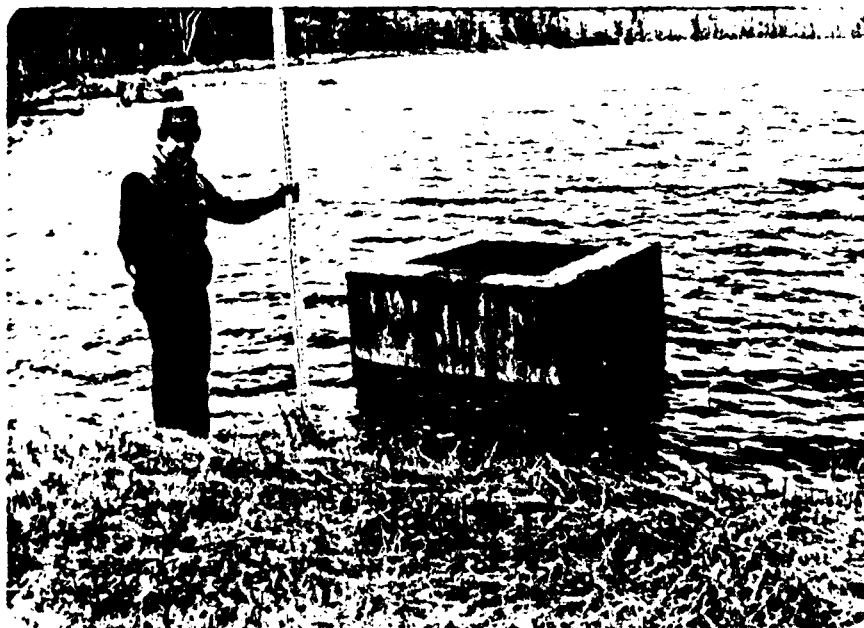
The outlet works is in fair condition. Minor spalling was observed on the endwall and intake structure (Photographs E and F). The intake structure tilts toward the dam (Photograph F). The gate operating mechanism on the intake structure is rusty. The Owner stated that it has not been operated since the dam was constructed; he reported that he had been instructed shortly after the dam was built by a representative of the Commonwealth to never operate the gate. He felt that the intake structure was partially silted, which would hinder the gate operation. Therefore, he declined to attempt to operate it for the inspection team.

If the intake structure was constructed out-of-plumb, there would be no concern for its integrity. However, if the tilting is caused by differential settlement, there would be serious concern for the structure because Plate E-2 indicates it is founded on rock, which should allow for no settlement. The Owner confirmed that the cutoff wall is founded on rock. There would also be concern for the junction of the pipe and the intake structure.

F. Outlet Works Intake Structure

(4) Perform studies to determine the cause of the tilting of the intake structure. Take appropriate action as necessary.
