BROWN'S LAKE DAM

NDI ID NO. PA-00630
DER ID NO. 45-108

PHASE I INSPECTION REPORT
NATIONAL DAM INSPECTION PROGRAM

JUNE 1980

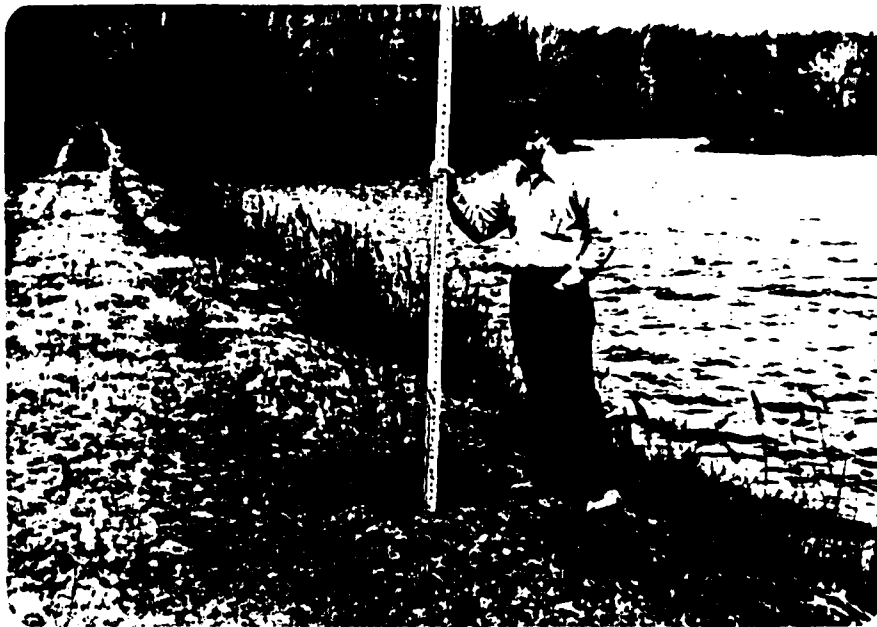
The depression on the top of the dam indicates that potentially hazardous conditions might exist within the embankment. The caretaker stated that the depression developed about 5 years ago, and that it has not increased in size since then. The most likely explanation for the depression is that piping of the upstream earthfill into the downstream rockfill was initiated by seepage through or over the timber corewall. It is not known whether the pool level was above normal when the depression developed. The piping, if it occurred, probably stopped either by a self-healing process or by a return to normal pool level.

B. Depression on Top of Dam.

(1) Perform detailed investigations as required to assess the stability of the dam. The investigations should include assessment of seepage conditions and piping potential. Take appropriate action as required.

(2) Until the investigations recommended above are complete, the Owner should institute a monitoring program to detect any significant change in the condition of the dam. If conditions change, take appropriate action as required.

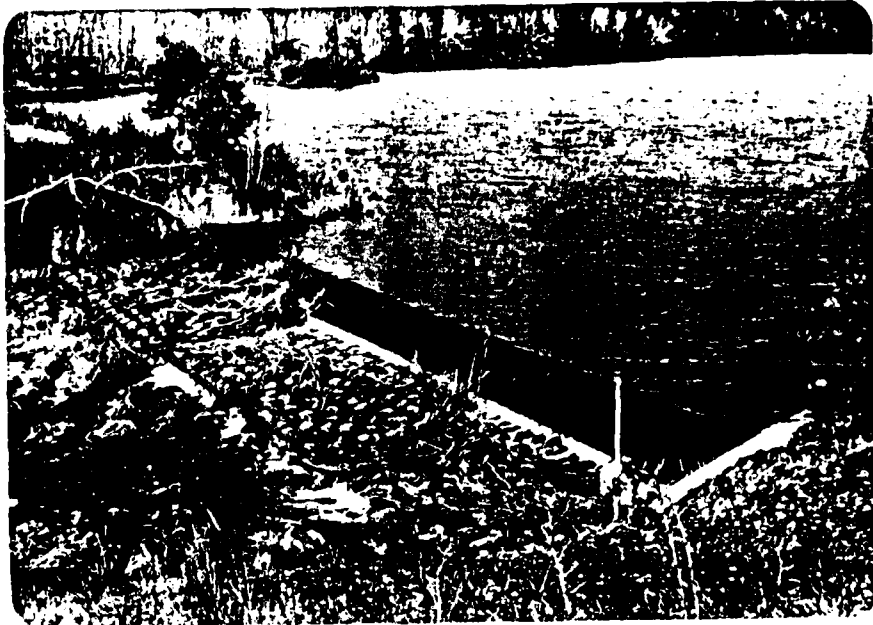
c. Appurtenant Structures. The spillway is in fair condition (Photograph I). The left abutment wall has a slight, inward tilt, two cracks, and minor spalling at its base adjacent to the spillway weir. The spillway weir is a low, triangular, concrete weir. A concrete apron extends downstream from the weir for a distance of about 10 feet. Some debris was on the spillway on the day of the inspection. The weir has two areas where the concrete has cracked and spalled. Both areas are near the right end of the weir. The right abutment wall has trees and brush growing behind it. The spillway outlet channel is an excavated earthen channel (Photograph J). It appears that the channel has been subject to retrogressive erosion.

(3) Appurtenant Structures. The cracking, spalling, and slight inward tilt of the left spillway wall do not appear to be significant hazards at the present time. Even if the left wall were to fail, failure of the dam would not necessarily occur. The condition of the spillway outlet channel is such that retrogressive erosion might eventually endanger the spillway structures.

I. Spillway.

(6) Remove debris from the spillway and visually monitor the condition of the spillway structures. Maintain the structures as required.
