MOUNTAIN LAKE DAM

NDI ID NO. PA-00546
DER ID NO. 40-50

PHASE I INSPECTION REPORT
NATIONAL DAM INSPECTION PROGRAM

JUNE 1980

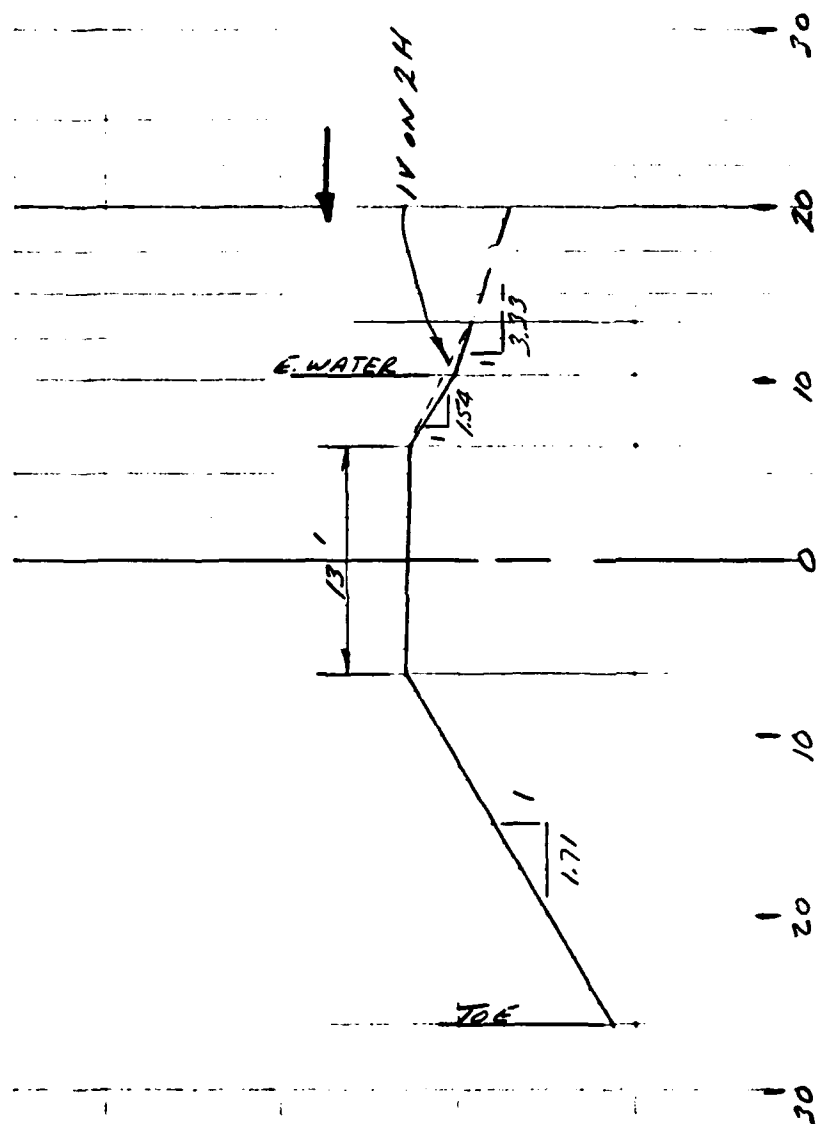
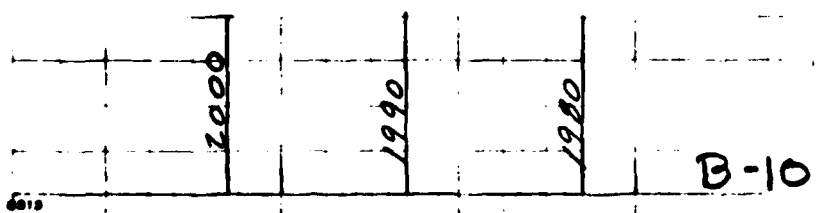
SECTION @ STA 2+85

THE UPPER PART OF THE UPSTREAM SLOPE AND THE DOWNSTREAM SLOPE ARE STEEPER THAN THE REPORTED DESIGN.

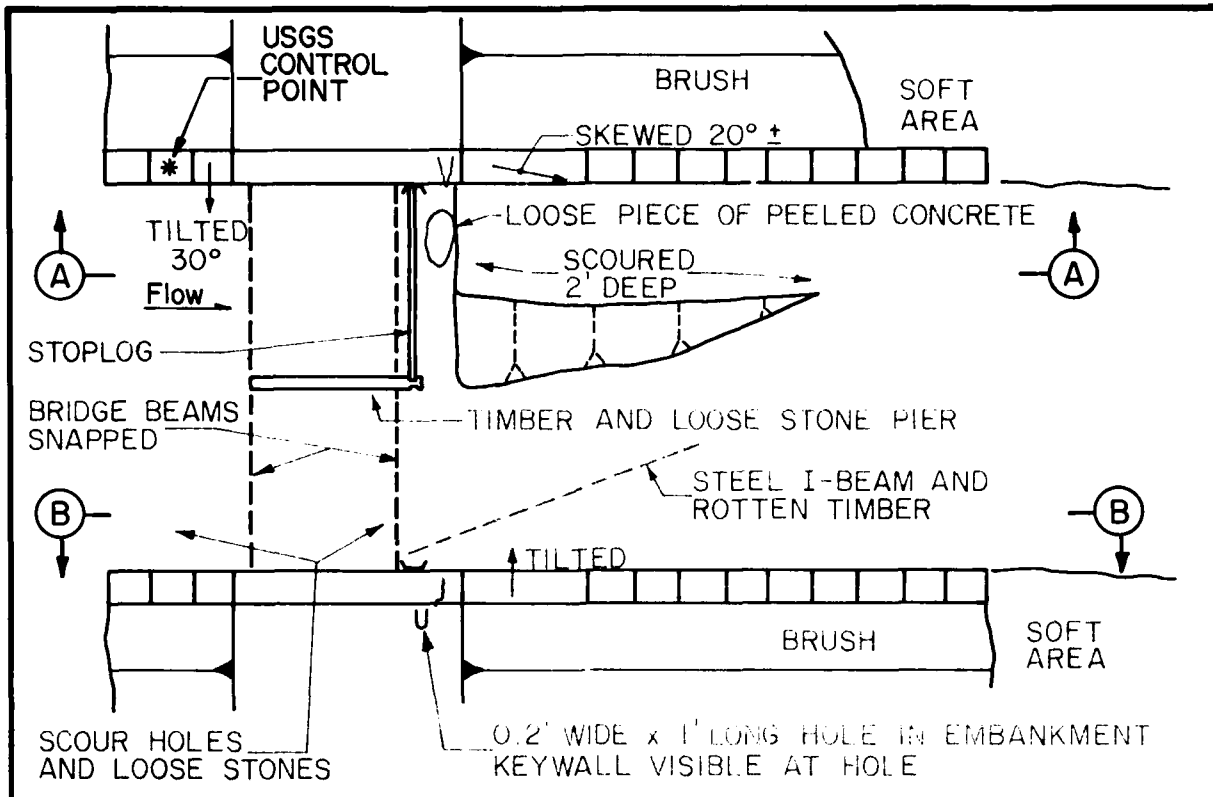
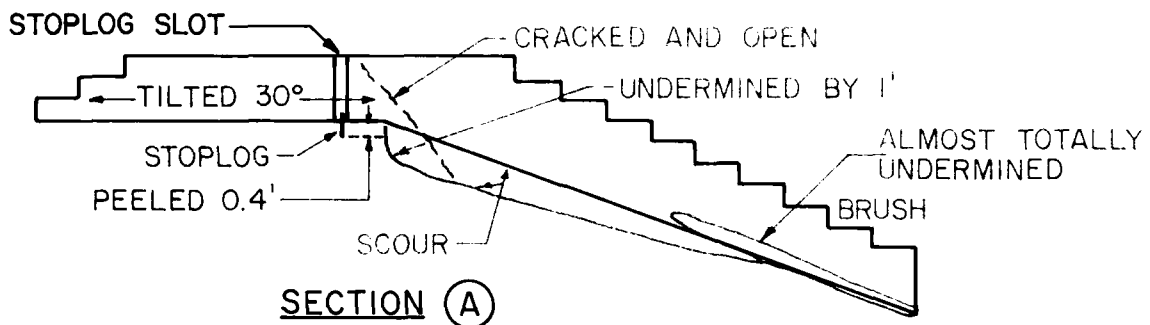
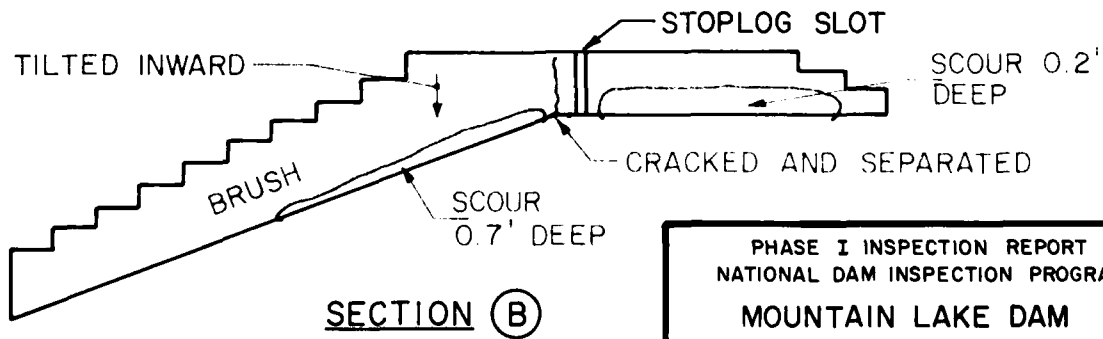
PHASE I INSPECTION REPORT
 NATIONAL DAM INSPECTION PROGRAM
 MOUNTAIN LAKE DAM
 ELEANOR TAYLOR
 RESULTS OF VISUAL
 INSPECTION AT SPILLWAY
 JUNE 1980 EXHIBIT B-2

VISUAL EXAMINATION OF	OBSERVATIONS	REMARKS OR RECOMMENDATIONS
CONCRETE WEIR	<p style="text-align: center;">↑ SEE EXHIBIT B-2</p>	
APPROACH CHANNEL	<p style="text-align: center;">ENTIRE STRUCTURE ALMOST TOTALLY DETERIORATED</p>	
DISCHARGE CHANNEL	<p style="text-align: center;">↓</p>	
BRIDGE AND PIERS

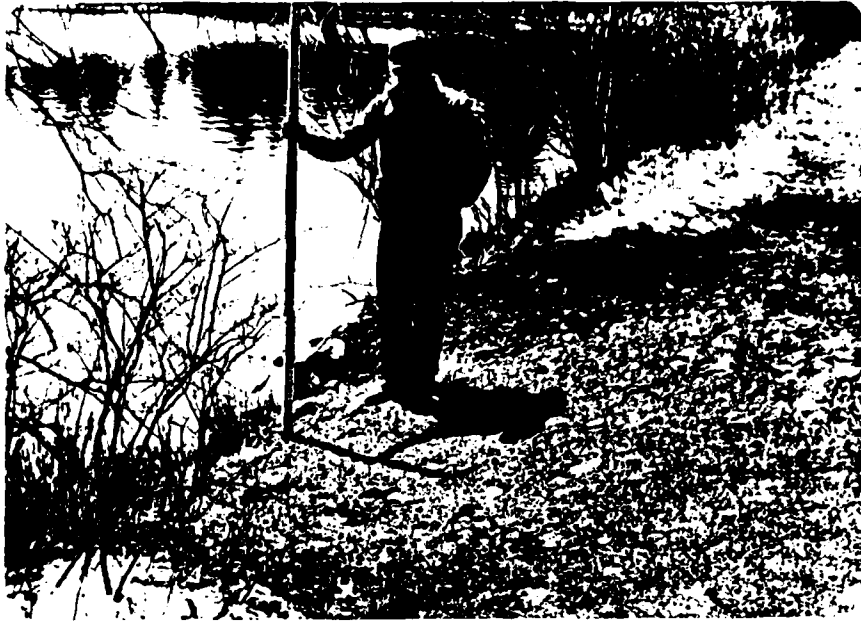
A. Upstream Slope

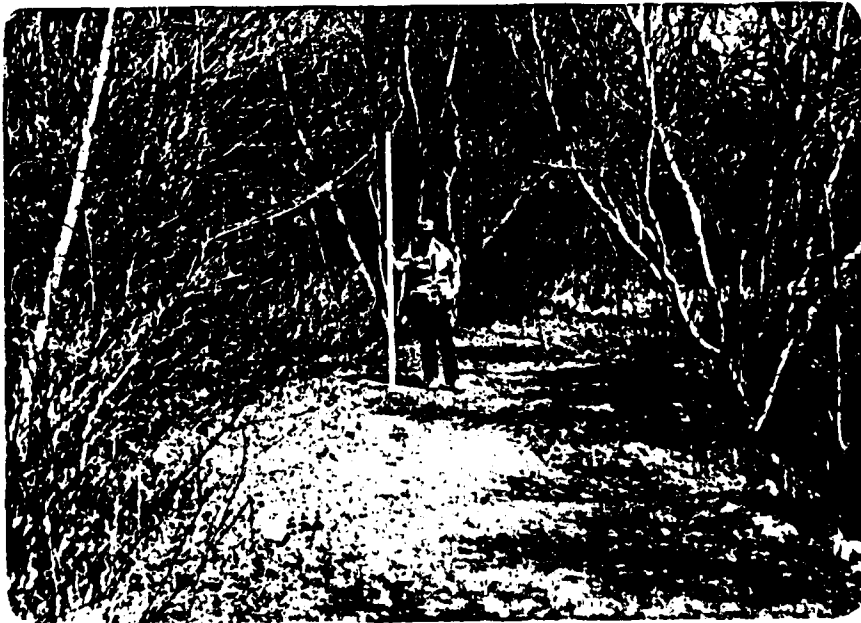
B. Top of Dam

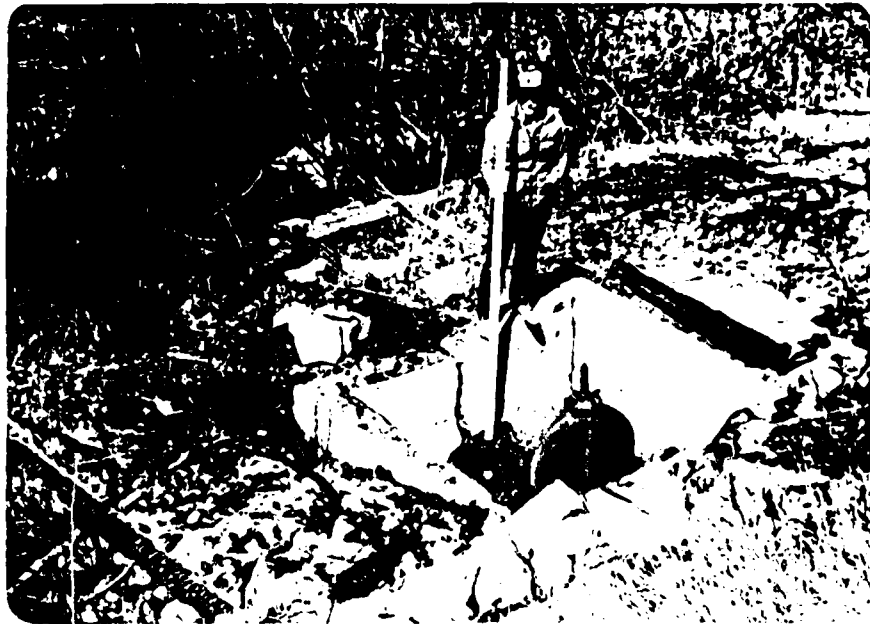
E. Outlet Works

c. Appurtenant Structures. The valve pit at the outlet works is sheared and broken throughout (Photograph E). The nuts securing the gate housing are severely rusted. The Owner's agent offered to operate the outlet works until he discovered that there was no operating mechanism. He did not recollect it ever being operated.

(3) Appurtenant Structures. The valve pit at the outlet works is obviously structurally inadequate. The upstream wall of the pit is at the toe of the embankment. The sheared wall leaves the toe with no support in this area. Because of the severely rusted nuts, it is possible that the gate housing would not be securely attached to the valve, if it were operated. There would then be no effective means of closing the valve. Because there is no protective structure, the valve is susceptible to freezing during the winter.

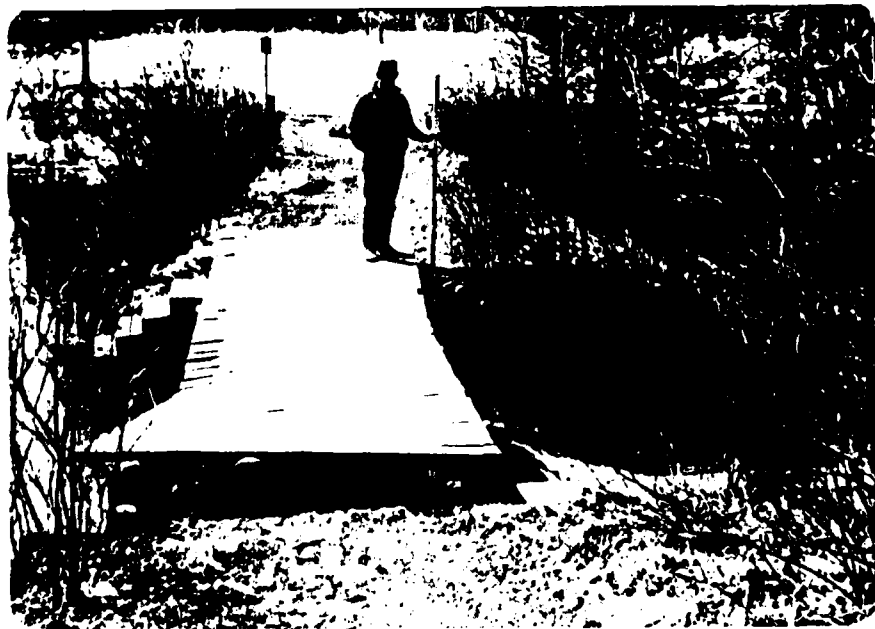
F. Spillway Bridge

The spillway is in very poor condition. The wooden beams supporting the timber spillway bridge have snapped, leaving the bridge bowed (Photograph F). The bridge is partially supported in the center by a pier constructed of timber and loose stones. To the left of the pier, a 0.9-foot high stoplog extends across the crest (Photograph H). The top 0.4-foot thick layer of concrete has peeled off the crest to the left of the pier. Portions of the peeled concrete lie loosely on the crest. To the right of the pier, a steel I-beam and a rotten log lie skewed to the crest (Photograph G). Upstream from the crest, the left spillway wall is tilted about 30° towards the centerline of the spillway. At the crest, the left wall is cracked through and open. Just downstream, the wall is skewed about 20°. Further downstream, the wall is almost totally undermined along its entire length. The right wall is in slightly better condition, although the part that is just downstream from the crest is skewed about 10° and tilted inward. The right wall upstream of the crest is scoured from 0.1 to 0.2 foot deep. Downstream of the crest, the scoured area is about 1.2 feet high and 0.7 foot deep. At the crest, the wall is cracked and separated.

The conditions at the spillway indicate a lack of maintenance. They are of major concern because the spillway walls are on the verge of collapse. It is unlikely that the spillway could withstand any flood of significant duration. The open section of the embankment is probably caused by the movement of the spillway walls.

(1) Remove the spillway bridge. Also remove brush and debris from the spillway. Until the recommendations below are completed, provide temporary measures to ensure the structural stability of the spillway.
