LAKE-IN-THE-CLOUDS DAM

NDI ID NO. PA-00741  
DER ID NO. 52-125

PHASE I INSPECTION REPORT  
NATIONAL DAM INSPECTION PROGRAM

JUNE 1980

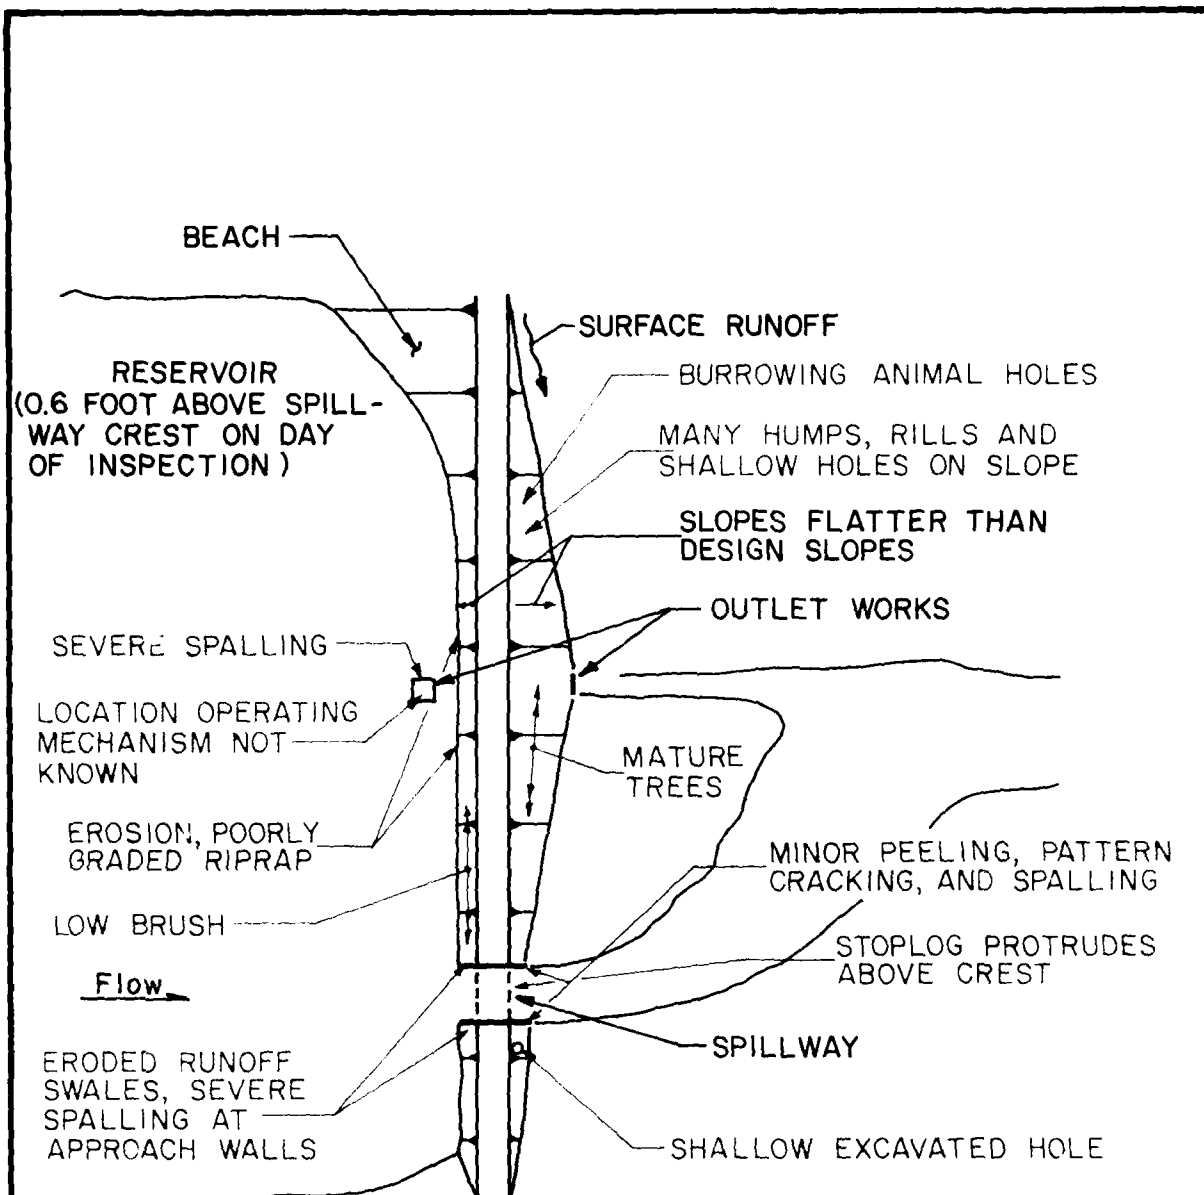
EXHIBIT B-1

a. General. The overall appearance of the dam is fair. Deficiencies were observed as noted below. A sketch of the dam with the locations of deficiencies is presented on Exhibit B-1 in Appendix B. Survey information acquired for this Report is summarized in Appendix B. Datum for the survey was taken at the spillway crest, Elevation 1830.0, as shown on USGS mapping. The Owner uses a different datum. To convert the elevations on the Plates in Appendix E, 1725.0 feet must be added to the elevations on those Plates. On the day of the inspection, the pool was 0.6 foot above the spillway crest level.

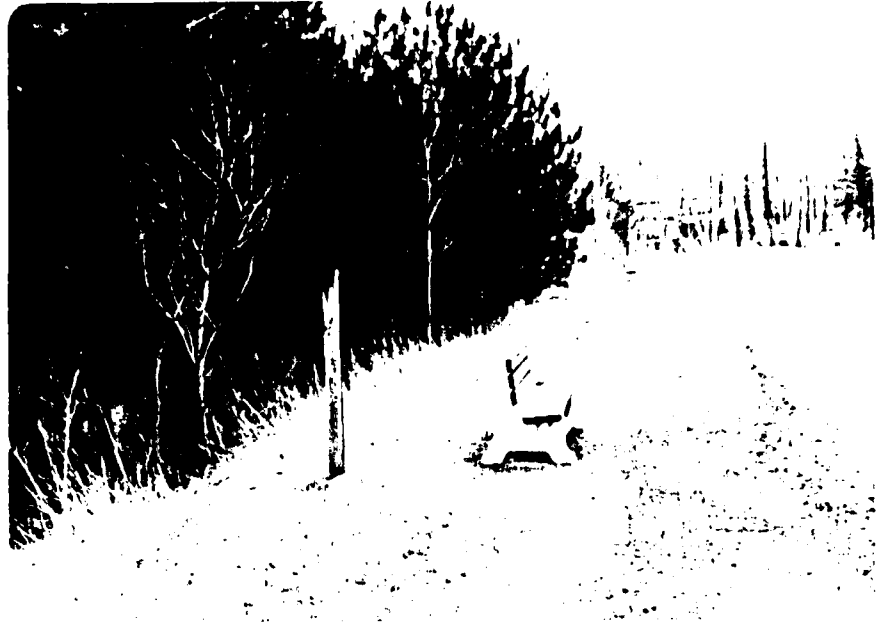
A. Top of Dam

A relatively narrow path along the top of the dam is paved with asphalt. The downstream slope has many mature trees growing in it. The slope is very uneven, with many shallow holes, humps, and rills (Photographs C and D). A few burrowing animal holes were observed in the downstream slope. To the right of the spillway, a shallow 2-foot diameter hole has been excavated in the slope. A property owner who lives near the right abutment stated that he had just excavated the hole; he did not divulge the reason.

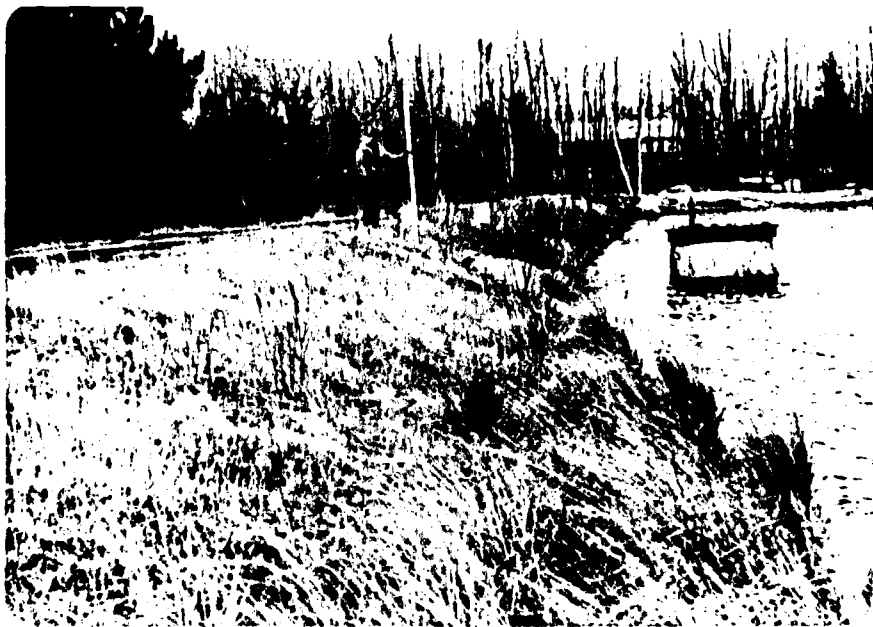
B. Upstream Slope

The erosion on the upstream slope is also minor at present. It is caused by a combination of surface runoff and wave action. The poorly graded riprap has probably worsened the situation. Further erosion is likely if remedial measures are not taken.

- (6) Design and construct erosion protection for the upstream slope of the embankment.
- (7) As part of the maintenance program recommended below, fill burrowing animal holes, cut brush on the upstream slope, and prevent unauthorized changes at the embankment.

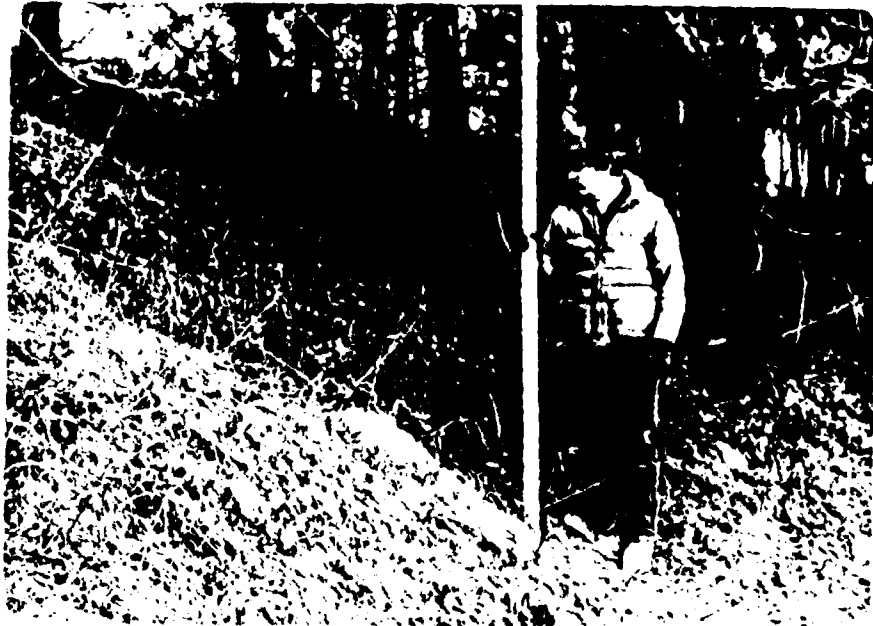
C. Downstream Slope

(2) Embankment. The growth of the trees on the downstream slope is a hazard to the dam. Root systems of large trees can loosen embankment material, displace slope protection, and create paths along which seepage and piping (internal erosion) might occur. The brush on the upstream slope is minor at present.

The cause of the lumps, holes, and rills on the downstream slope is not readily apparent. The condition could be caused by erosion before slope protection was established or by removal of tree stumps. As noted in Section 5, the dam may have been overtopped during Tropical Storm Diane in 1955; this would account for the condition of the downstream slope. The condition does not appear to be a stability problem.

- (4) Remove trees and brush growing on or near the embankment.
- (5) Design and construct repairs for the spalled concrete at the spillway approach walls and outlet works intake structure.

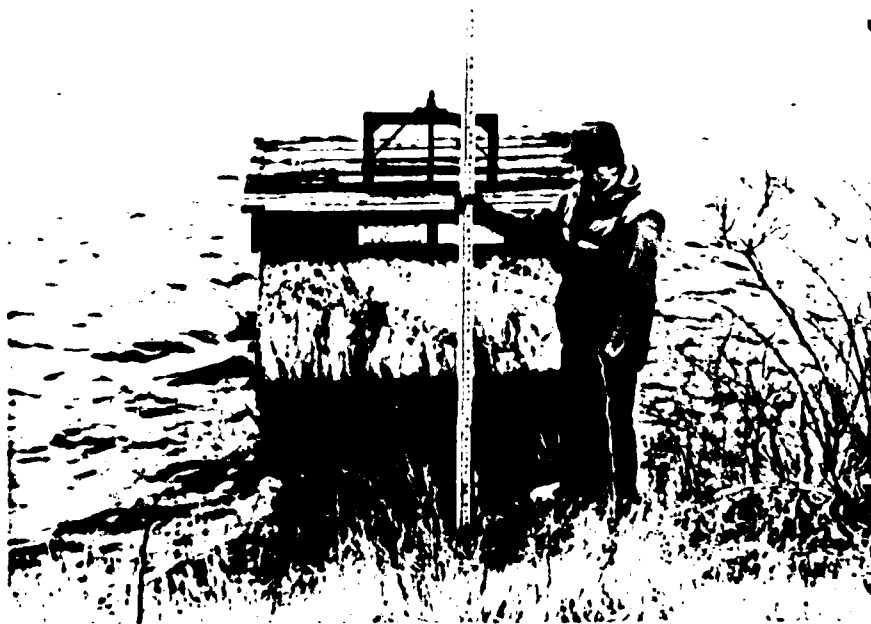
Fig. 1. Intake structure.

c. Appurtenant Structures. The concrete at the outlet works intake structure is badly spalled (Photograph E). The gate stem is badly rusted. No deficiencies were observed at the endwall, which was partially submerged (Photograph F). The streambed at the outfall is above the invert of the outlet works pipe (Photograph F). No representative of the Owner was present during the inspection, so the operation of the outlet works could not be observed. When subsequently contacted, the Owner stated that the outlet works had not been operated since he acquired the dam. He did not know where the operating mechanism was located; it is not on the intake structure (Photograph E).

(3) Appurtenant Structures. The spalled concrete on the outlet works intake structure appears to be severe. The structure is in the reservoir and access to it could not be obtained during the visual inspection. The spalling is probably caused by long-term exposure to the weather.

Uncertain operation of emergency drawdown facilities; operating mechanism missing; badly spalled concrete on intake structure.

(5) Design and construct repairs for the spalled concrete at the spillway approach walls and outlet works intake structure.

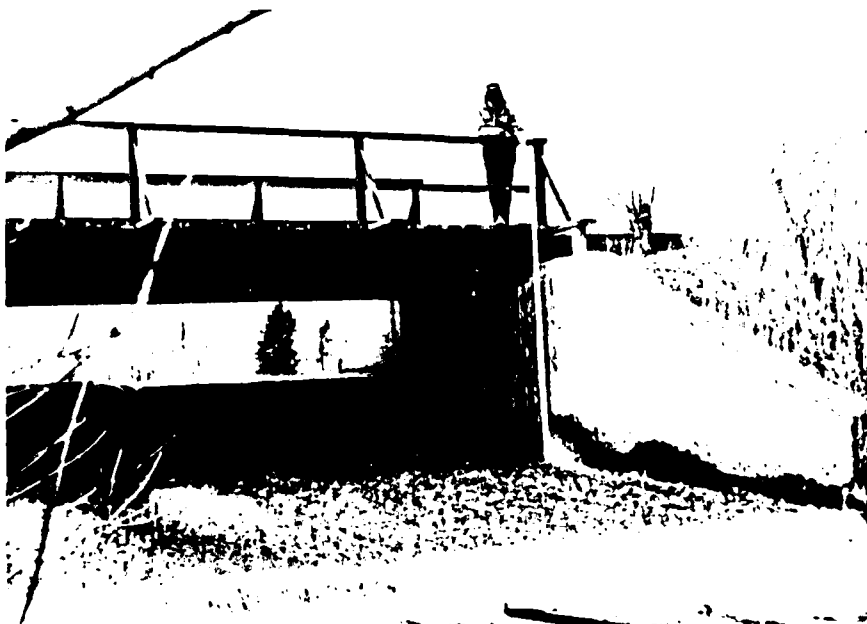
H. Spillway

Stoplogs are provided in the middle of the spillway weir. The upper stoplog protrudes above the top of the weir (Photograph H). The approach walls are badly spalled. The concrete at the upstream end crumbles to the touch. The downstream walls have pattern cracks, leaching and minor peeling and spalling. The spillway bridge, which is fenced shut at the right end, is in good condition.

The stoplogs in the spillway weir change the shape of the crest along the length of the notch. They also protrude slightly above the crest. Both these conditions reduce the spillway capacity slightly. However, their effects have not been included in the analysis described hereafter. The effects of possible pressure flow beneath the bridge have been included. The underside of the bridge also has the potential to collect debris; debris would reduce the spillway capacity. Its effects have not been included in determining the spillway capacity.

Stoplogs protruding above crest; badly spalled approach walls; minor deterioration of training wall concrete.
