VERONA LAKE DAM (NJ00386)

**PHASE I REPORT  
NATIONAL DAM SAFETY PROGRAM**

**Name of Dam:** Verona Lake Dam, NJ00386  
**State Located:** New Jersey  
**County Located:** Essex  
**Drainage Basin:** Passaic River  
**Stream:** Peckman River  
**Date of Inspection:** November 14, 1979

**VERONA LAKE DAM, I.D. NJ00386**

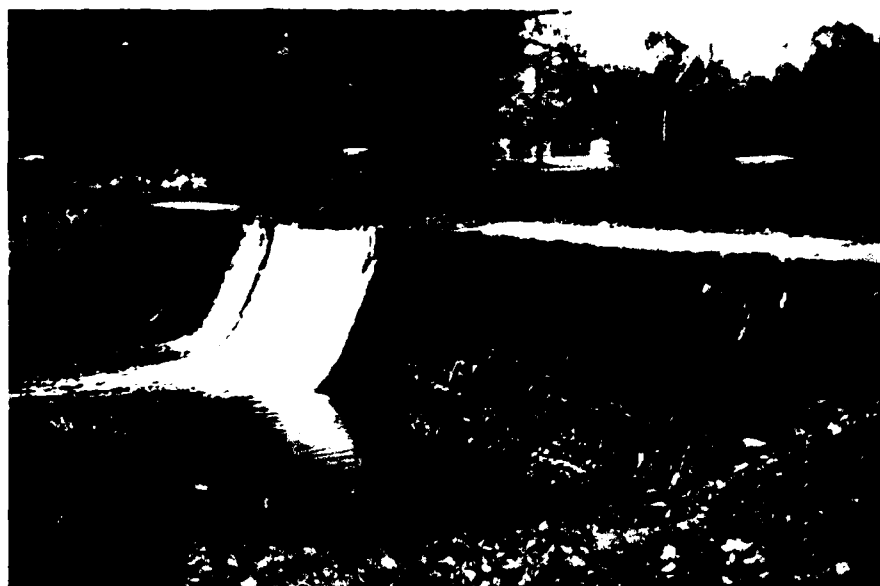
PHOTO 1  
SPILLWAY

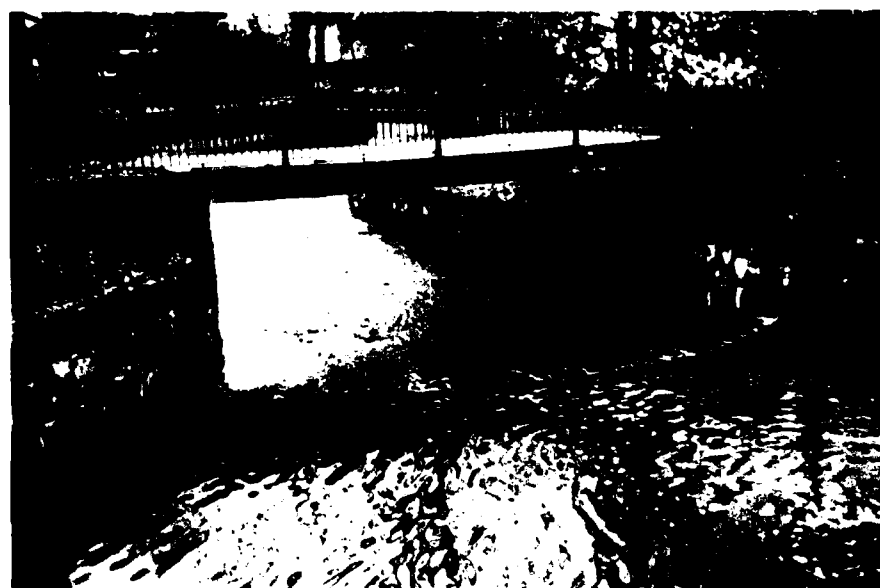
PHOTO 2  
CONCRETE BRIDGE AND STONE WEIR DOWNSTREAM FROM DAM
