PASSAIC RIVER BASIN  
BELCHER'S CREEK, PASSAIC COUNTY  
NEW JERSEY

**PINECLIFF LAKE DAM**  
**N J 00012**

**PHASE 1 INSPECTION REPORT**  
**NATIONAL DAM SAFETY PROGRAM**

**FEBRUARY 1980**  
**APPROVED FOR PUBLIC RELEASE;**

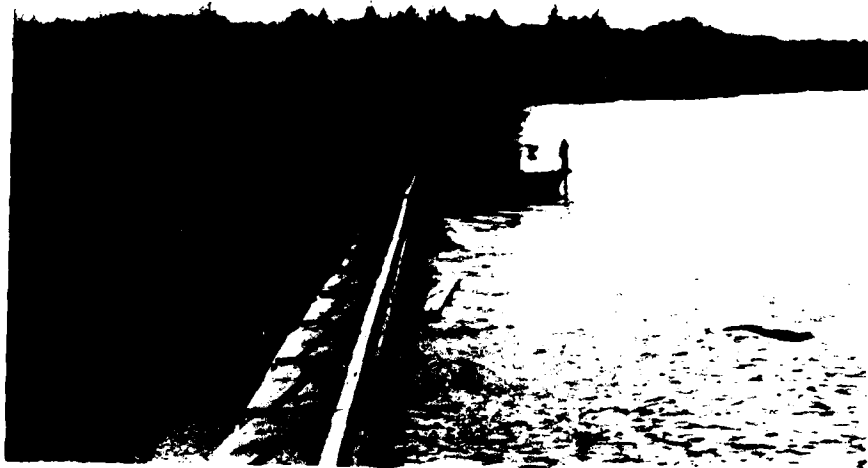
Photo 1 - View toward right abutment and embankment.  
Note outlet valve, rising stem and stand  
mounted on steel bracket, attached to abut-  
ment. Also note trees on embankment.  
(Photo taken December 5, 1979).

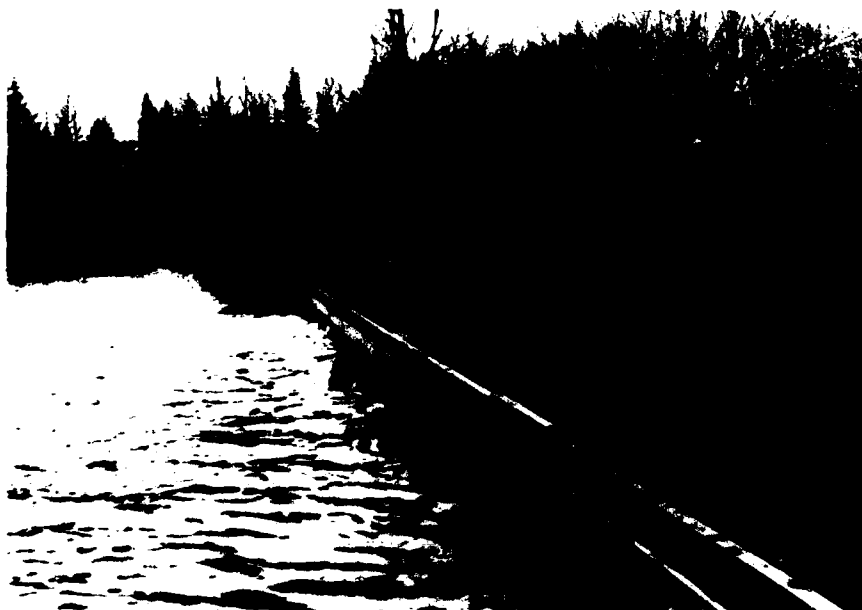
Photo 4 - View looking toward left abutment and embankment. (Photo taken December 5, 1979).
