RARITAN RIVER BASIN
SOUTH BRANCH OF RARITAN RIVER
HUNTERDON COUNTY
NEW JERSEY

CLINTON MILLS DIKE

NJ 00564

PHASE 1 INSPECTION REPORT

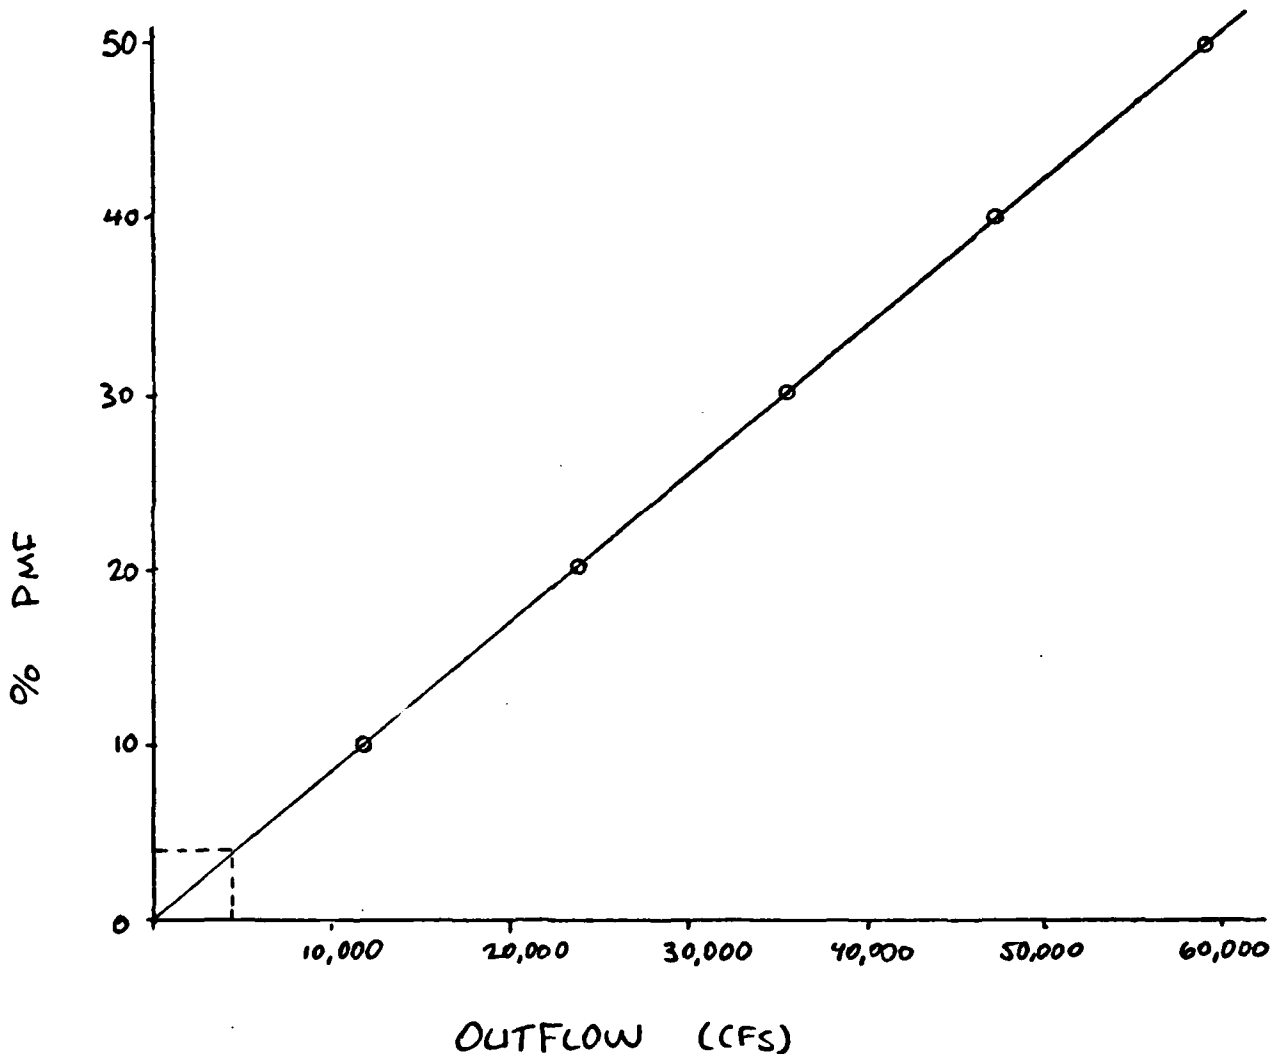
OVERTOPPING POTENTIAL

OVERTOPPING OF THE DIKE OCCURS AT ELEVATION
191.8 WITH $Q = 4397$ CFS \therefore DIKE CAN PASS
APPROXIMATELY 7.4 % SDF OR 3.7 % PMF
