OHIO RIVER BASIN
UNNAMED TRIBUTARY TO HARMON CREEK, WASHINGTON COUNTY
PENNSYLVANIA

PHASE I INSPECTION REPORT
NATIONAL DAM INSPECTION PROGRAM
PACW31-FO-C-0025

PA 480, Washington County, Pennsylvania
NDI No. PA 01125, PennDER No. 63-84, SCS No. PA 480
Unnamed Tributary to Harmon Creek
Inspected 27 March 1980

PHASE I INSPECTION REPORT
NATIONAL DAM INSPECTION PROGRAM
PA 480

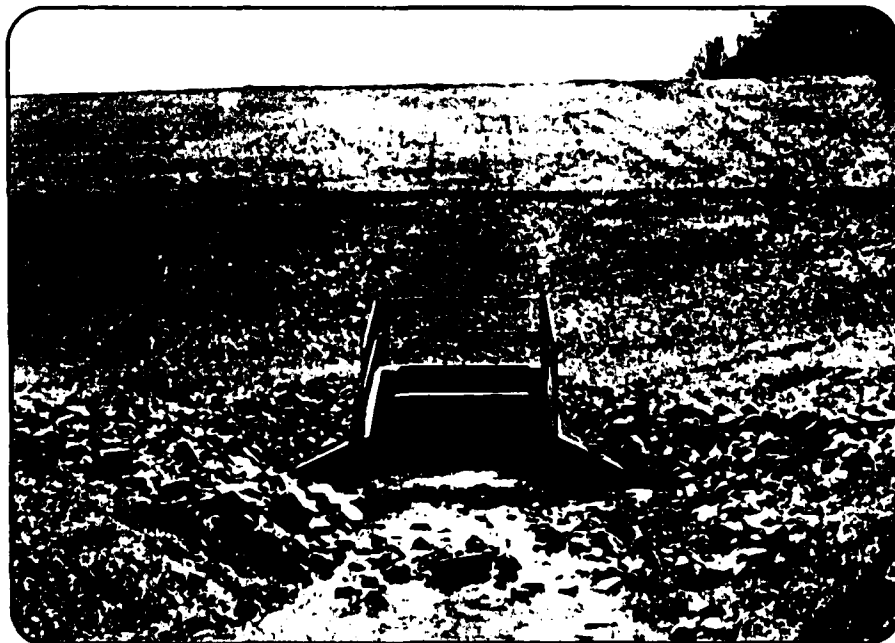
The concrete impact basin was in good condition.

PHOTO 2. View of the Impact Basin

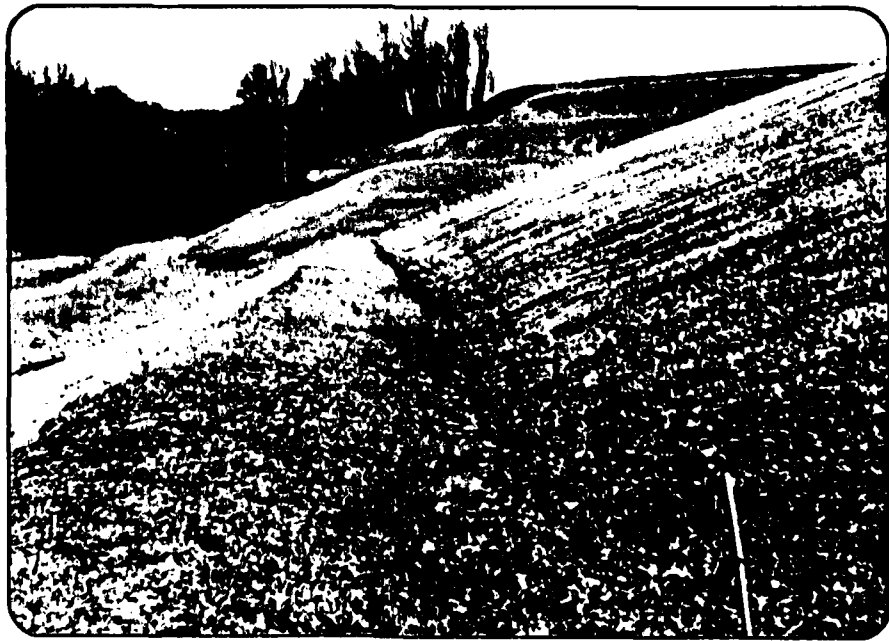
- 3) Some ponded water was observed on the bench on the downstream side of the embankment. Several areas on the embankment below this bench were relatively saturated. Because the

Several minor seeps were observed on the right abutment above the emergency spillway. These seeps, none of which were flowing more than 1 g.p.m., are the result of groundwater flow. There was some ponding of water on the bench on the downstream side of the embankment. There were also several areas on the embankment below this bench in which the soil was saturated.

PHOTO 4. View of Water Collecting at the Toe of the Bench on the Downstream Side of the Embankment

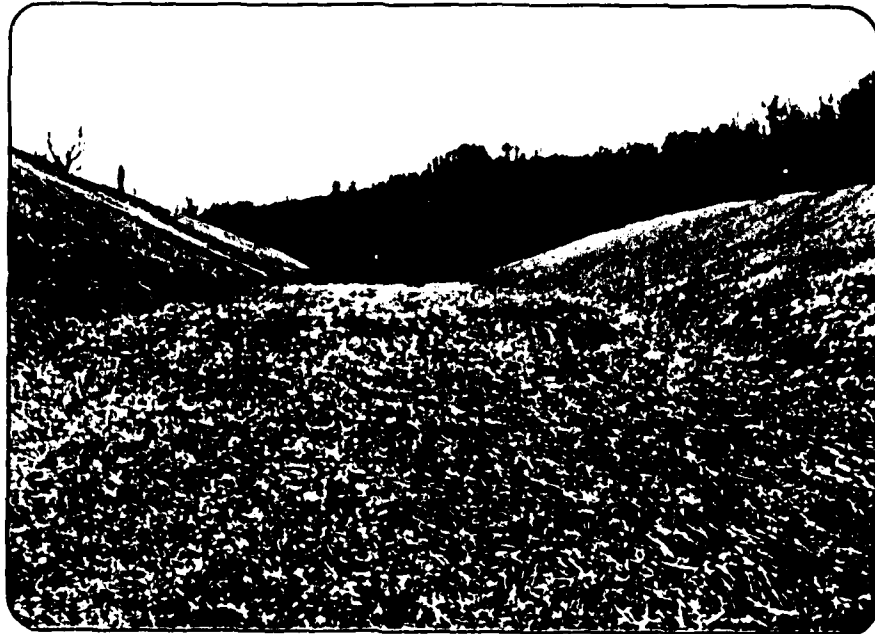
PHOTO 5. View of the Emergency Spillway Looking Upstream

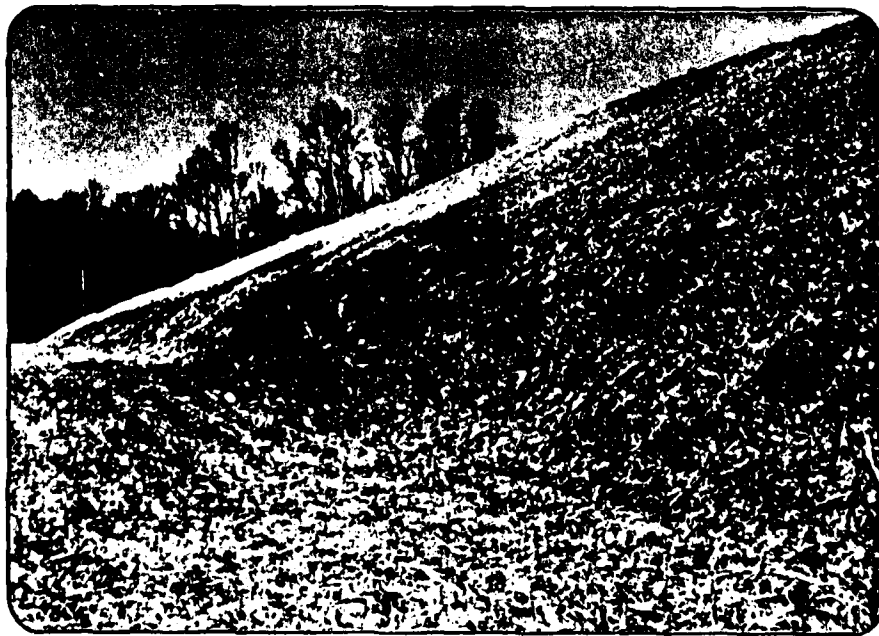
The right abutment consists of shale, siltstone, sandstone, and limestone. Some of the very soft, highly weathered shale and siltstone were considered to be a calcereous mudstone. These soft zones varied in thickness and slickensides were found in these deposits during the boring program. It was these soft zones which caused localized slumping and sliding in the emergency spillway after excavation because of fractures opening up due to rebound and change in the water table pattern. With time, additional slumping and sliding will occur in the emergency spillway area due to continued softening of the exposed areas of the mudstone. It is estimated that these localized slumps will not

interfere with the functioning of the emergency spillway but should be observed periodically to insure that the emergency spillway channel remains completely open.

PHOTO 6. View of the Slumping Area on the Right Side of the Emergency Spillway
