SIEGEL MARSH DAM

NDI No. PA 00015
PennDER No. 25-41

PHASE I INSPECTION REPORT

NATIONAL DAM INSPECTION PROGRAM

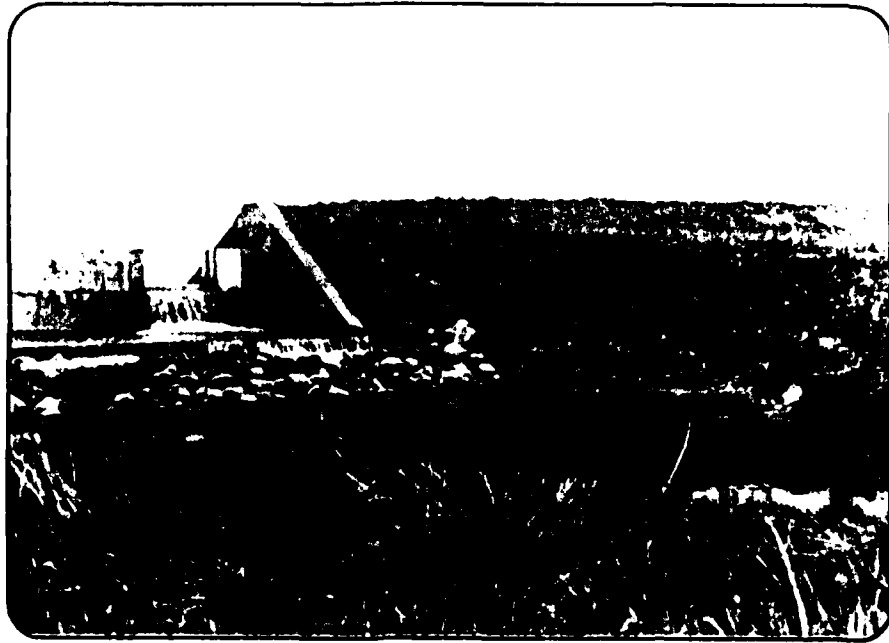
PHOTO 9. View Looking Upstream at the Erosion on the Left Side of the Discharge Channel of the Right Spillway

- 1) Place slope protection on the upstream face to prevent scour and erosion from wave action.
- 2) Place slope protection along the left side of the right spillway discharge channel.
- 3) Fill the low areas on the top of dam adjacent to the left spillway.
- 4) Clean and seal the joints in the left spillway.
- 5) Fill and reseed the tire ruts on the right embankment.
- 6) Clear the small brush from the toe and apron junction of the left embankment and left spillway.
