PHASE I INSPECTION REPORT

REPORT BY  
MICHAEL J. BAKER, JR., PEG

PA 483  
WASHINGTON COUNTY, COMMONWEALTH OF PENNSYLVANIA  
NDI No. PA 01124  
PennDER No. 63-75  
SCS No. PA 483

(6) PHASE I INSPECTION REPORT  
NATIONAL DAM SAFETY PROGRAM

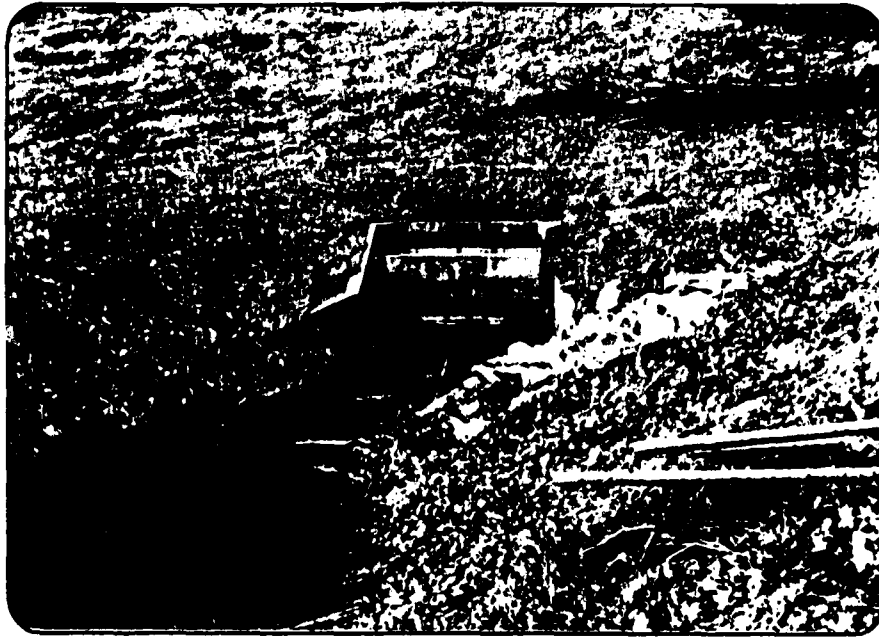
| VISUAL EXAMINATION OF | OBSERVATIONS | REMARKS OR RECOMMENDATIONS |
|---|---|---|
| OUTLET STRUCTURE | The outlet structure is a reinforced concrete impact basin with a baffle wall and end sill. The concrete appears to be in good condition with no cracking or spalling. | |

**PHOTO 5. View of the Impact Basin**
