LITTLE YOUGHIOGHENY RIVER SITE NO. 2

NDI I.D. NO. MD 33

PHASE I INSPECTION REPORT

NATIONAL DAM INSPECTION PROGRAM

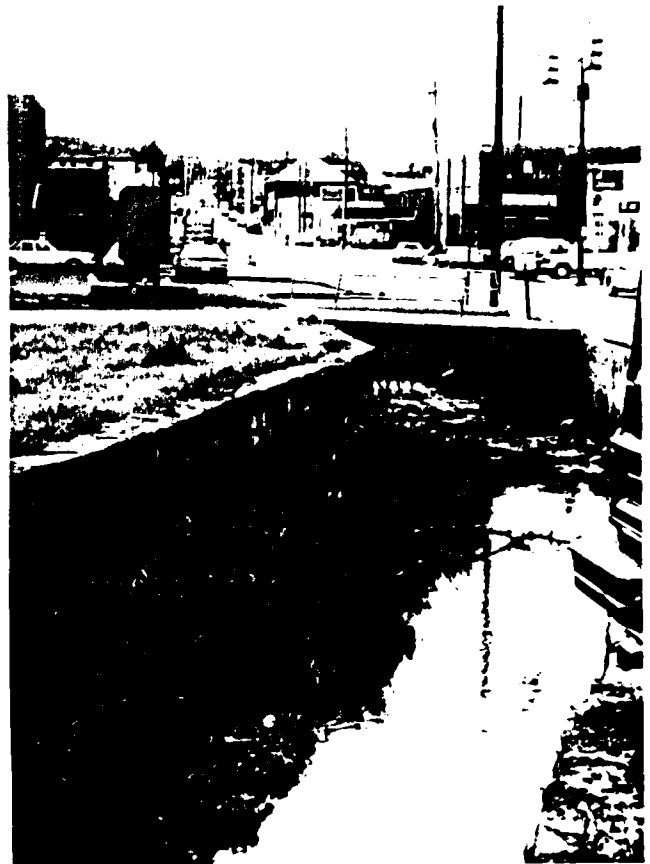
6

Wilson Run stream channel, downtown Oakland.
