LITTLE YOUGHIOGHENY RIVER SITE NO. 3

NDI ID NO. MD 45

⑥ PHASE I INSPECTION REPORT

Little Youghiogheny River Site Number 3
(NDI ID Number 45)
Youghiogheny River Basin

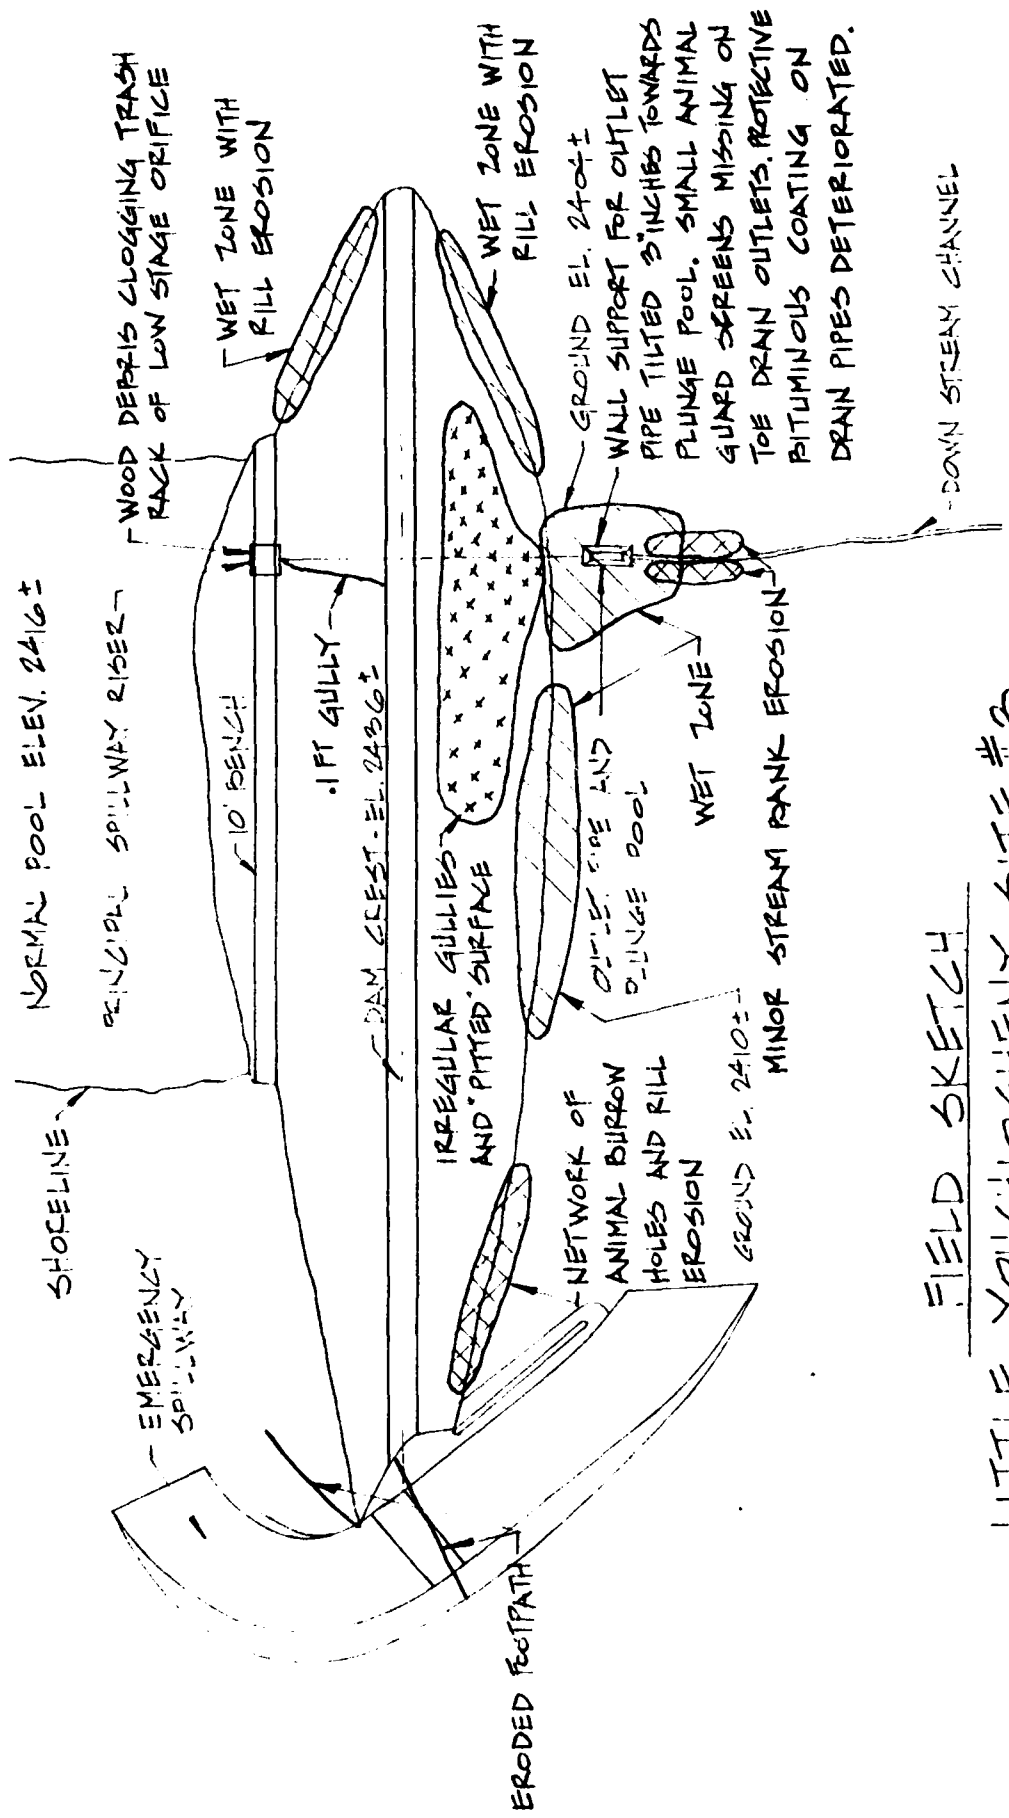
FIELD SKETCH
 LITTLE YOUGHIOGHENY SITE #3

- (3) Wet Zone. Wet zones were observed near the vicinity of the plunge pool and along the downstream embankment toe. (Refer to field sketch for approximate locations.) The wet zones are thoroughly saturated and very soft. These zones

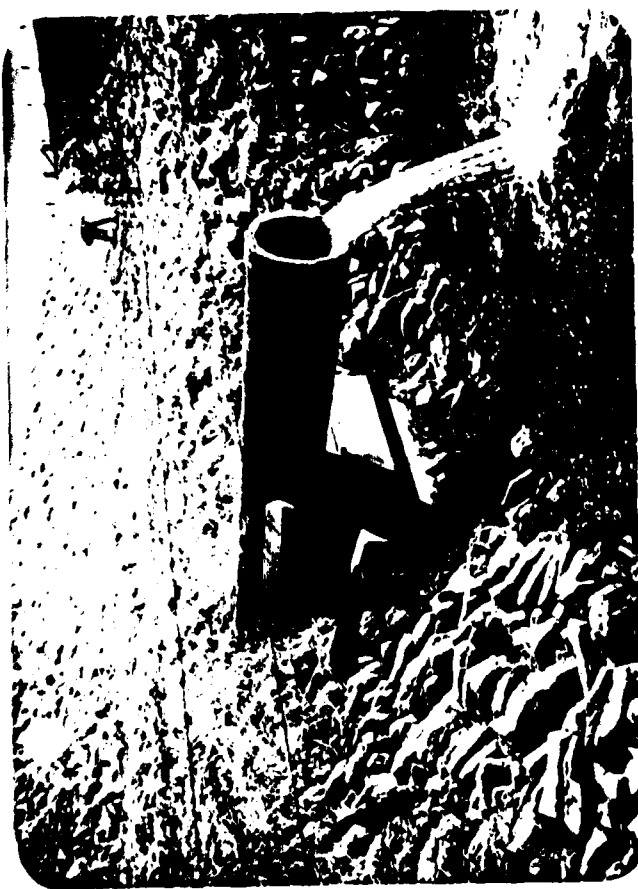
- 3) Outlet Works. A concrete wall, designed to support the outlet pipe at the location of the plunge pool, has moved outward toward the plunge pool approximately three (3) inches. This offset is evidenced by the misalignment of the concrete form break between the keyed pipe cradle and concrete wall bent. Exposed pipe and concrete cradle surfaces were observed in good condition with no spalling or cracking evident. (See Photographs 5 & 6.)

Small animal guard screens are missing from the seepage drain pipes. The protective bituminous coating on the corrugated drain pipes appears to be slowly deteriorating and has already exposed bare metal surfaces. Both drain pipes had a clear discharge at the rate of about 1 gpm.

- b. Appurtenant Structures. Continued movement of the outlet pipe support wall may open pipeline joints. In the event pipe joints open, some internal erosion of the sandy and silty clay embankment soils may occur. This erosion may become significant enough to affect the stability of the outlet pipeline. Insufficient data is available at the present time to ascertain the exact cause of the support wall movement or condition of pipe joints. An immediate inspection should be made of pipeline joints to determine if pipe joints have separated and exceed allowable tolerances. Periodic observation of the outlet pipe support wall is also advised to ascertain future movement. The general condition of the outlet pipe and wall support system is therefore considered fair.

- (3) Outlet Pipe and Support Wall. Continued movement of the outlet pipe support wall may open pipeline joints. In the event of pipe joints opening, some internal erosion of the sandy and silty clay embankment soils may occur. This suspected internal erosion may affect pipeline stability. Therefore, it is recommended an inspection be made of pipeline joints to determine if pipe joints have separated and exceed allowable tolerances. Periodic observation of the wall support system is also advised to ascertain future movement.

PHOTOGRAPH 5 View of outlet pipe, toe drain pipe and wall support system.

- c. Necessity for Further Investigation. As previously stated, it is recommended an immediate inspection be made of pipeline joints. This investigation should consist of measuring pipeline joint openings to determine if movement of the outlet pipe support wall system has separated pipeline joints beyond allowable tolerances. The scope of this recommended inspection is beyond the intended scope of a Phase 1 investigation.

- (b) Observation monitoring of the outlet pipe support wall system for evidence of continued movement.
 - (c) Observation monitoring of the erosion occurring on downstream channel stream banks.
