POTOMAC RIVER BASIN
GILBERT RUN, CHARLES COUNTY

JAMESON DAM

NDI ID NO. MD 38

PHASE I INSPECTION REPORT

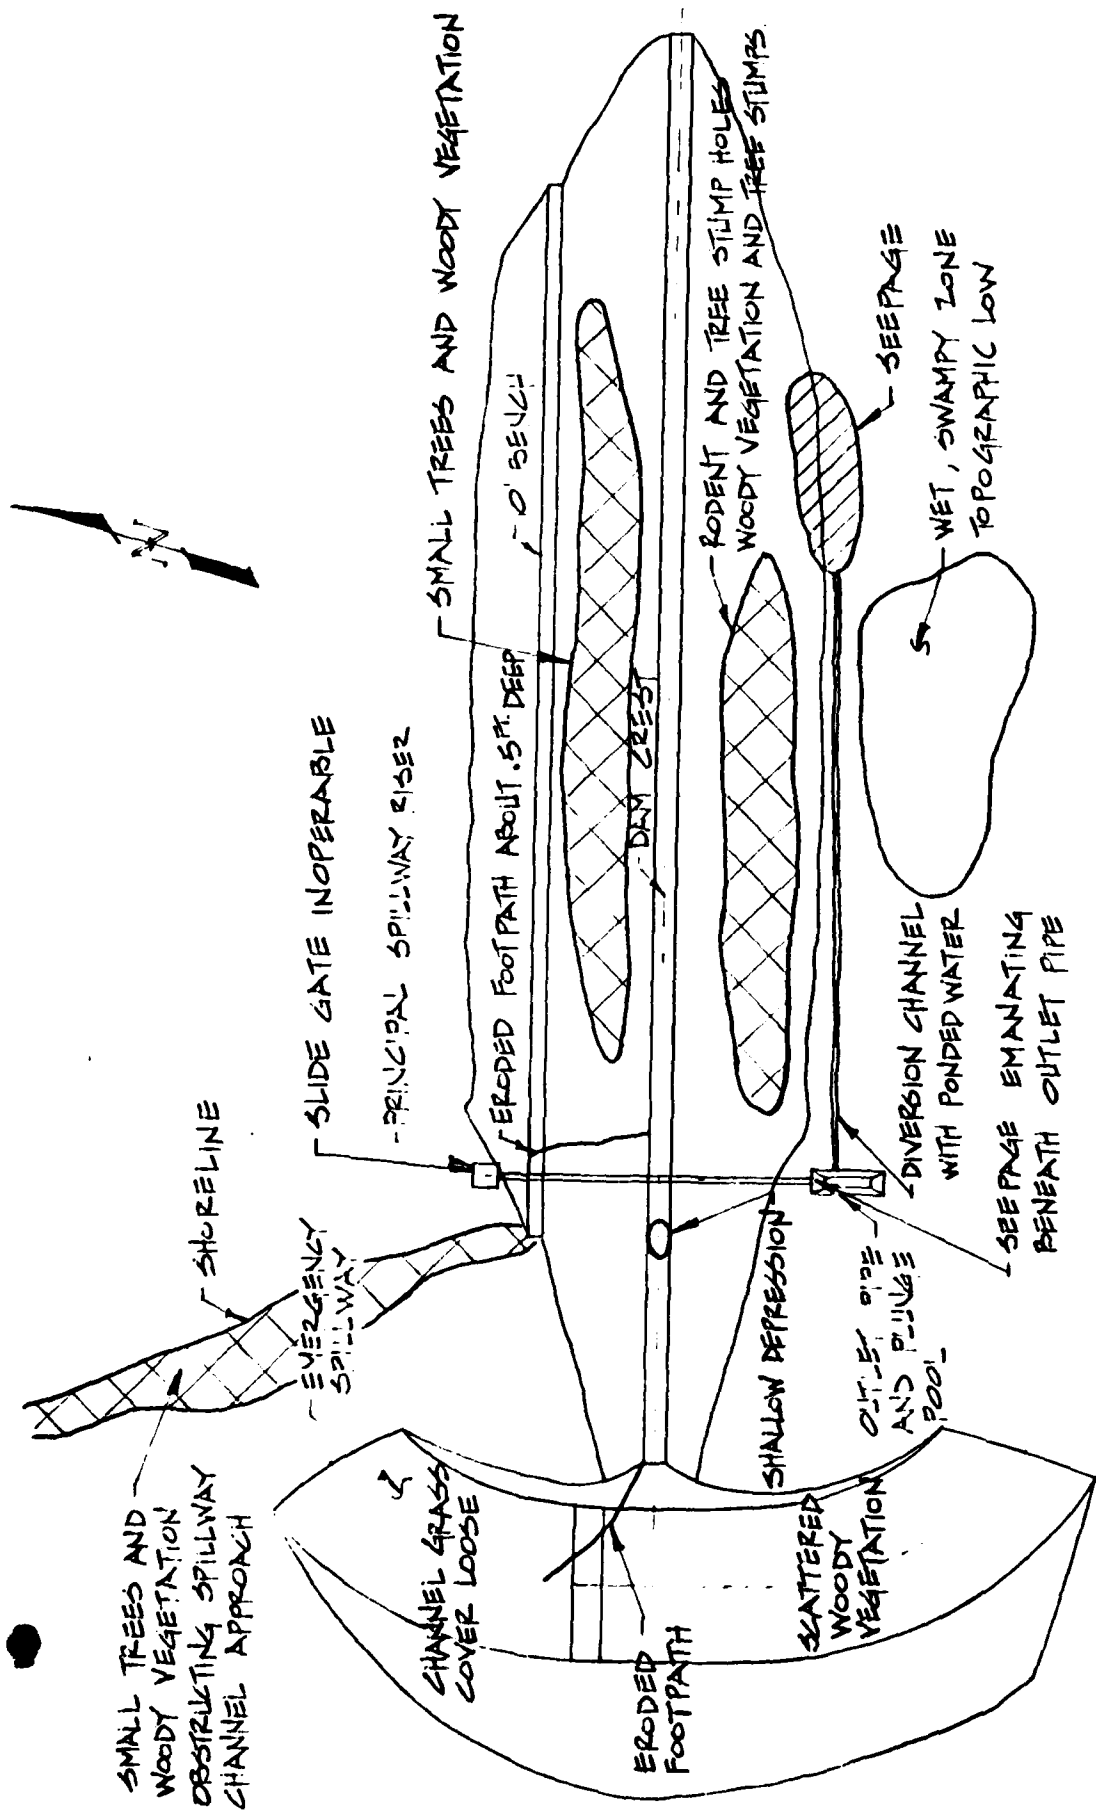
FIELD SKETCH JAMESON DAM

3. Seepage. As shown on the field sketch, a moderate volume of seepage was observed emanating from the toe of the downstream slope. This seepage was observed clear, but had apparently transported a fine sand material, as evidenced by small sand deposits. The location of the seepage sources approximately correspond to the "as-built" location of the blanket drain. Therefore, it is assumed the seepage originates from this outlet drain. It is further suspected the fine sand deposit is a transported product of the filter drain material.

4. Wet Zone. Wet zones were observed about the mid-length of the dam near the vicinity of the old streambed, and along side the seepage diversion channel. These wet zones are believed the result of seepage water ponding in the diversion channel. Dense vegetation growth and a poor drainage gradient appear to obstruct and restrict channel flow to almost a standstill.
