LITTLE YOUGHIOGHENY RIVER SITE NO. 1

PHASE I INSPECTION REPORT

NATIONAL DAM INSPECTION PROGRAM

ACKENHEIL & ASSOCIATES, BALTIMORE, MD, INC.
7902 BELAIR ROAD
BALTIMORE, MARYLAND 21236

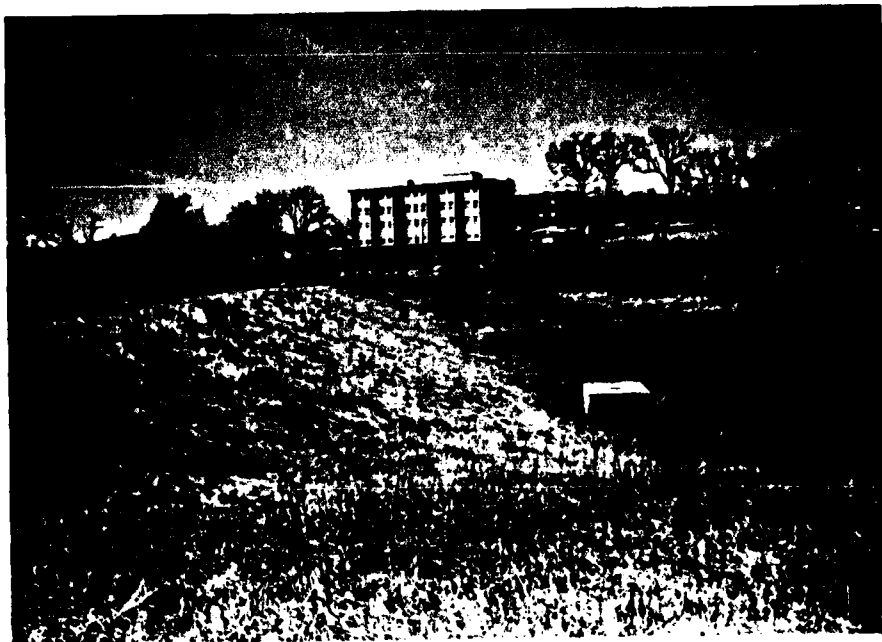
Upstream slope of dam looking west.
