**LAKE ASHBURTON**

**NDI ID NO. MD-108**

**PHASE I INSPECTION REPORT  
NATIONAL DAM INSPECTION PROGRAM**

**JUNE 1980**

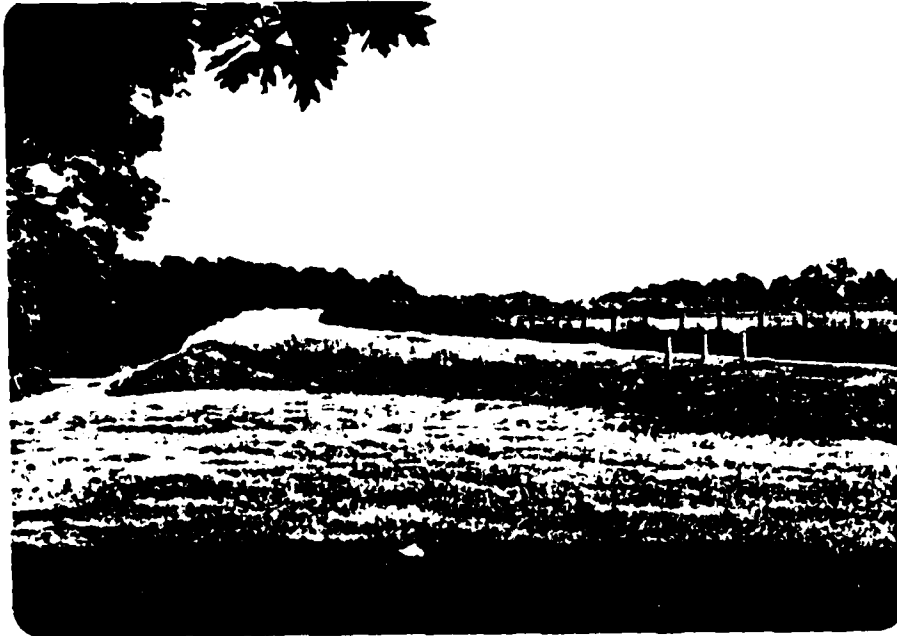
Downstream Slope

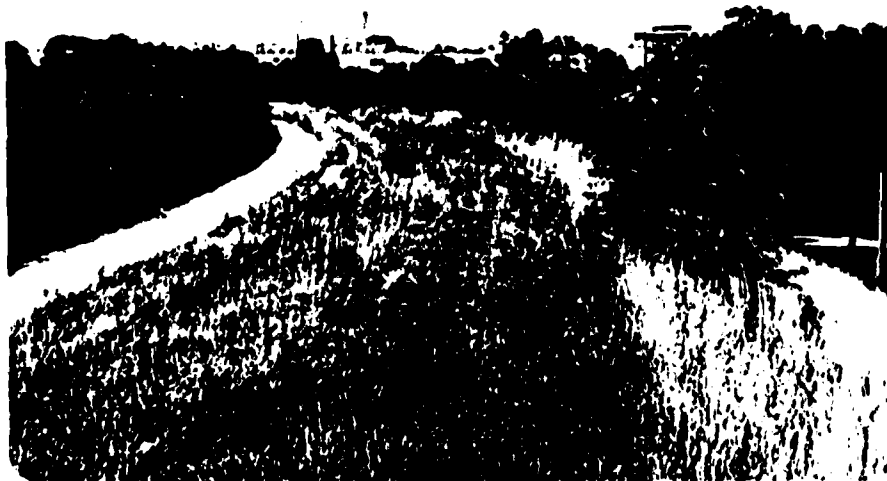
Embankment Crest

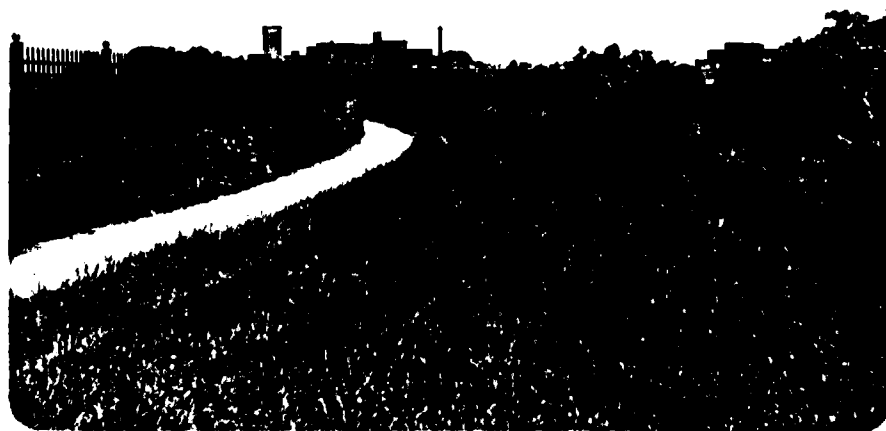
B. Crest of Eastern Embankment

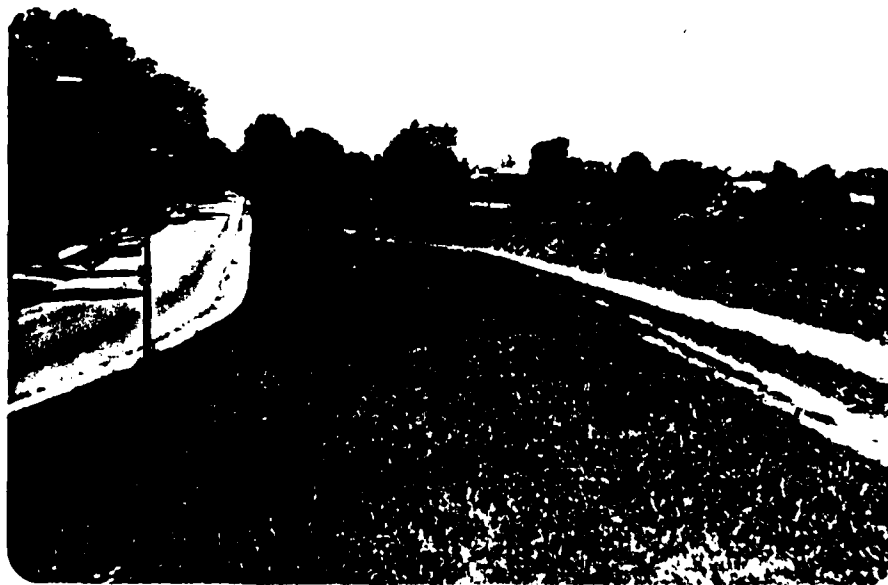
D. Downstream Slope of  
Southern Embankment

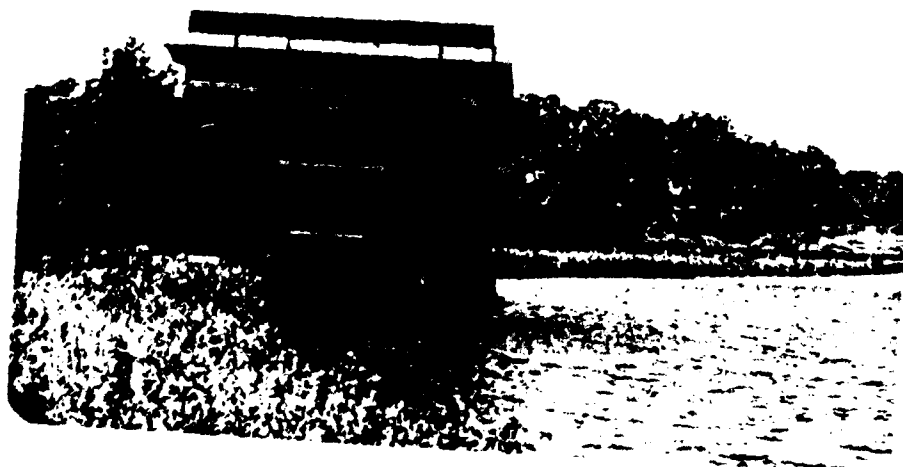
- c. Appurtenant Structures. The appurtenant structures were found to be in good condition. It is presumed that the gates in the Ashburton Gate House no longer serve any useful purpose and it is not known whether they are still operable.

H. Lake Ashburton Gate House
