ELECTRON MICROSCOPY USED FOR FRACTURE
MODE IDENTIFICATION

JUN 1980

CHARLES R. KLARICH, R. L. HUDDLESTON and M. J. DRABO
Materiel Testing Directorate
Aberdeen Proving Ground, Maryland 21005

BACKGROUND - BARREL SUPPORT JACKET FAILURES

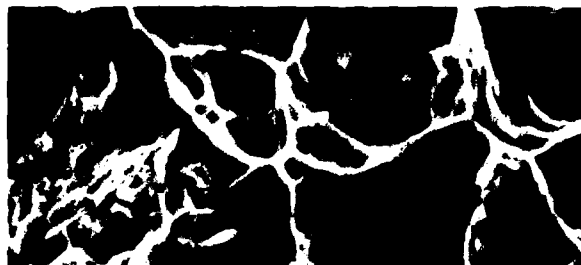
Ductile failure is characterized by the formation of voids on the fracture surface that plastically coalesce to form dimples. This micromechanism is termed microvoid coalescence. The fractograph of a tensile sample machined from a plain carbon AISI 1018 steel shows this type of failure. The size of the dimples is determined by number and location of the microvoids that are nucleated. The nucleation sites are inclusions, second phase particles, or grain boundaries.

Figure 1. A Fractograph of a 1018 Plain Carbon Steel Tensile Bar Which Shows Ductile-Dimpled Rupture. Magn: 2400X

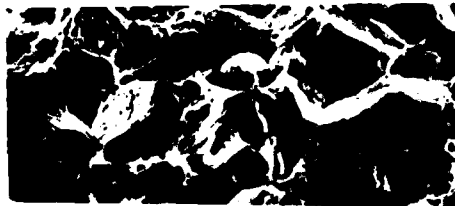
A brittle fracture with an intergranular mechanism was noted on a spider universal joint from the Infantry Fighting Vehicle (IFV). The U-joint was case carburized and was in service for a total of 474 miles when failure occurred (Fig 4).

Figure 4. Intergranular Fracture, U-Joint. Magn: 700X

Visual and low power optical examination did not reveal the intergranular fracture mechanism. The extent of the brittle cracking was a function of the case depth.

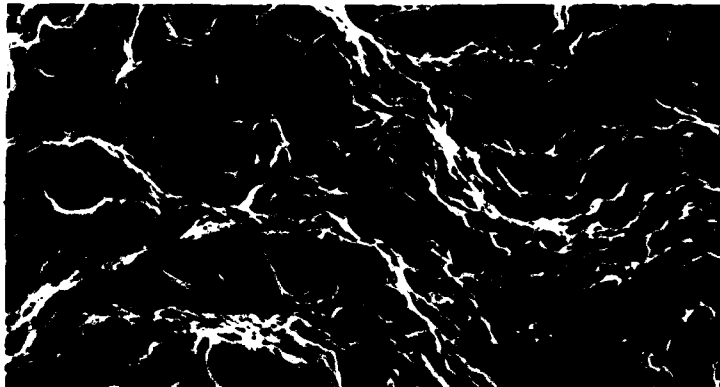
The fracture surfaces from BSJ Number 2 showed a ductile-dimpled fracture surface formed by microvoid coalescence. Manganese sulfide inclusions were visible in several of the dimples. This fracture topography is indicative of a tensile failure.

Figure 10. The Fracture Surface of BSJ Number 2 Showed a Ductile-Dimpled Fracture Surface Formed by Microvoid Coalescence. Magn: 1320X

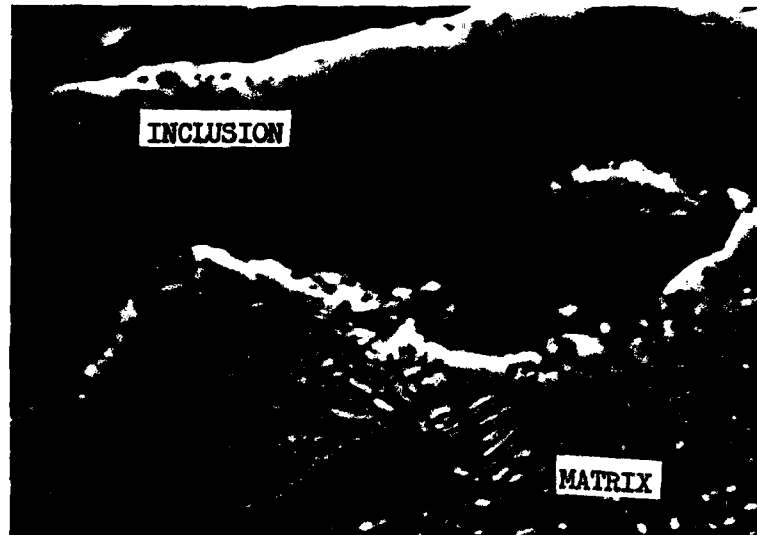
Figure 14. A SEM View of the Inclusion at the Fracture Surface on BSJ Number 1. Magn: 1800X

The platelets seen in the matrix are pearlite lamellae. These are alternate layers of ferrite and iron carbide. The globular particles in the matrix are manganese sulfide inclusions. Acquiring an X-ray energy dispersive spectrum from the fracture surface inclusion showed the elements Fe, Mn and Si were present. Elements on the periodic chart below atomic Number 13 (aluminum) are not detected. Elemental mapping was conducted for the elements Fe, Mn, and Si.

The iron concentration was distributed uniformly throughout the malleable iron and the inclusion. The iron concentration was the highest of the three elements mapped. Manganese was noted over the entire area that was mapped with the highest concentrations at the inclusions in the malleable iron. The silicon was concentrated near the fracture surface in the region examined.
