TECHNICAL REPORT HL-80-12

## UTILIZATION OF FILTER FABRIC FOR STREAMBANK PROTECTION APPLICATIONS

Malcolm P. Keown, Elba A. Dardeau, Jr.

Hydraulics Laboratory  
U. S. Army Engineer Waterways Experiment Station  
P. O. Box 631, Vicksburg, Miss. 39180

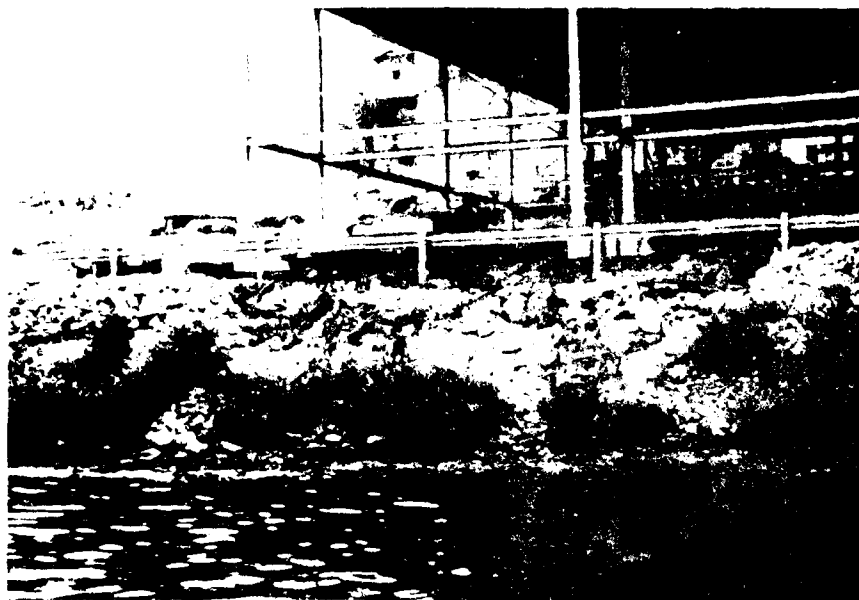
57. Partial failure of the revetment occurred in March 1972 (Figure 30). As a result of this failure, an inspection was conducted by ORP personnel on 29 March 1972 after the water had receded to 4 ft below the top of the original concrete slurry revetment. The investigation revealed that in many locations the 1971 protection had been placed on top of the original concrete slurry revetment with no toe support to prevent the stone from sliding downslope (Figure 31). The original contract drawings (Figure 29) clearly indicate that the new riprap should have been keyed through the surface of the existing protection as toe support. In a number of sections the riprap had slid into the river, thus exposing and often tearing the filter fabric.

Figure 30. Damage to bank protection at Wheeling Wharf Parking Garage after the 1972 failure. Riprap has slid down the slope into the river and the filter fabric has ripped.

58. Repair of the damaged revetment was requested on 19 June 1973 by the Engineering Division of ORP and was completed by personnel of the Operations and Maintenance Branch on 13 September 1973. Figure 32 shows a profile view of a typical section of the repairs to the slope protection. The total cost of the 1973 repairs was \$33,700 which included removal of the 1971 revetment and part of the lower bituminous pavement, purchase of filter fabric (Poly-Filter X, manufactured by Carthage Mills of Cincinnati, Ohio) and limestone riprap, entrenchment of toe stone through the original concrete slurry revetment, placement of the riprap, repaving some of the eroded bituminous pavement, and replacement of some of the bituminous pavement on the lowermost parking level with a slurry-grouted riprap. Where possible the existing filter fabric (Filter-X) was left in place; but where the fabric was damaged or missing, new fabric (Poly-Filter X) was used. The U. S. Army Engineer Division, Ohio River (ORD) selected this revetment as an existing site for monitoring as a

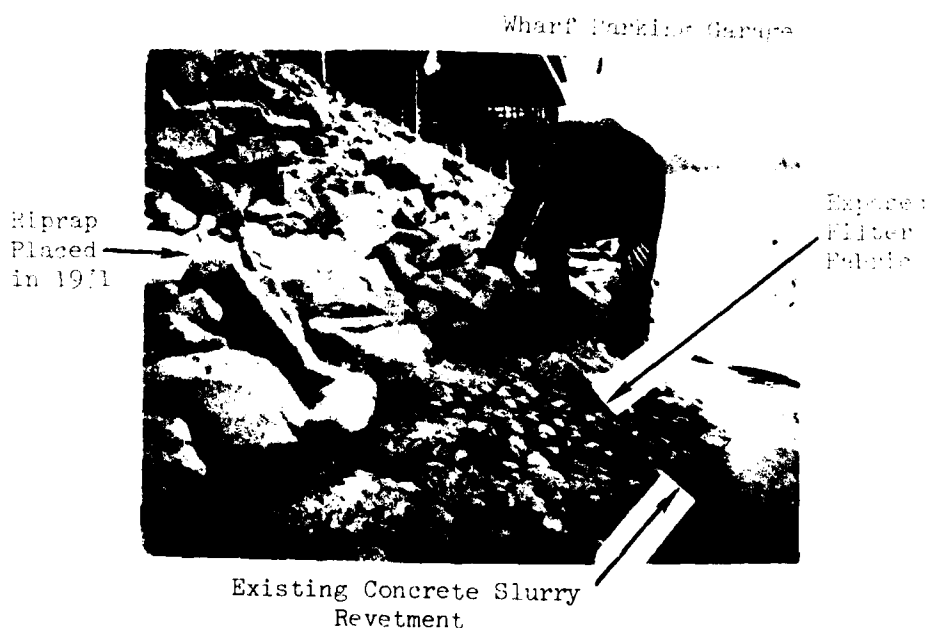
Figure 31. Condition of revetment of Wheeling Wharf Parking Garage on 31 March 1972 showing how riprap and filter fabric were placed directly over existing concrete slurry revetment without entrenching toe.

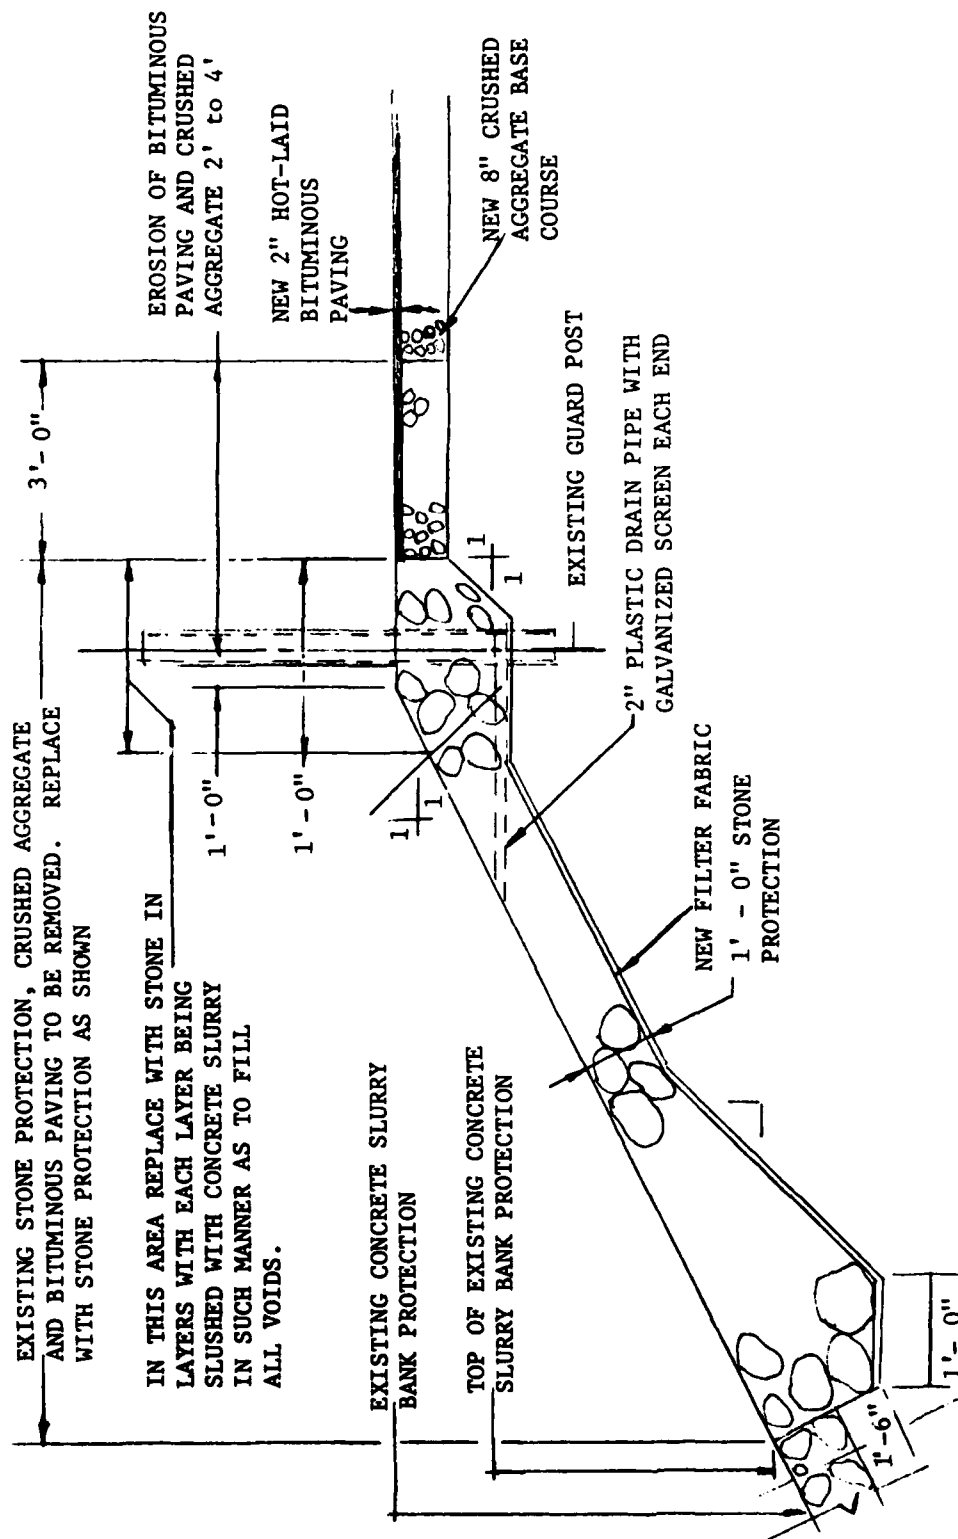
Figure 32. Profile view of 1973 repair to revetment, Wheeling Wharf Parking Garage (adapted from Ohio River Hannibal Locks and Dam, Ohio and West Virginia, Wharf Parking Garage, Slope Repair Drawing No. 0-LHA-100167.1, ORP, not dated)

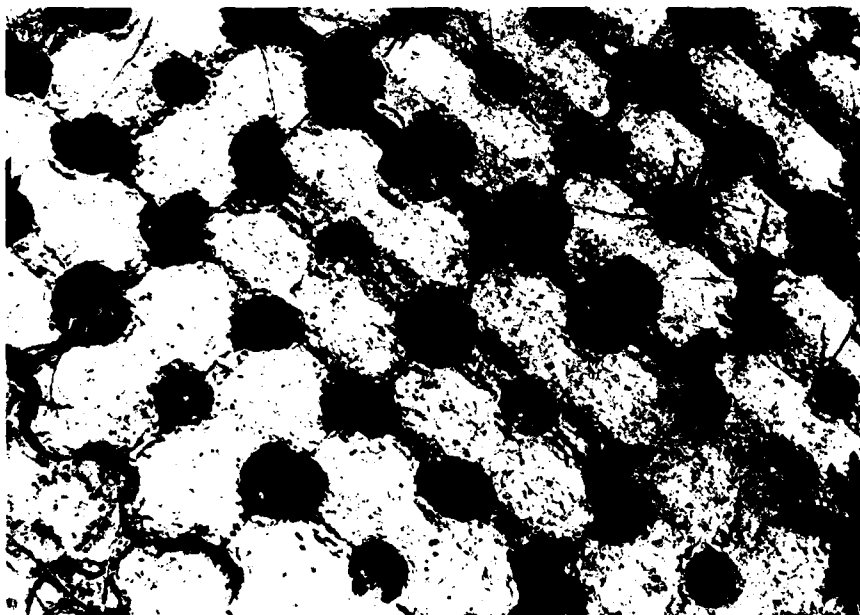
Figure 59. Filter fabric visible through precast cellular blocks Morameal Revetment, La. (9 May 1978)
