| REPORT DOCUMENTATION PAGE | | READ INSTRUCTIONS<br>BEFORE COMPLETING FORM |
|---|---|---|
| 4. TITLE (and Subtitle)<br>Phase I Inspection Report<br>Ischua Creek Watershed Project Site 6A<br>Allegheny River Basin, Cattaraugus County, NY<br>Inventory No. 571 | | 5. TYPE OF REPORT & PERIOD COVERED<br>Phase I Inspection Report<br>National Dam Safety Program |
| 14. MONITORING AGENCY NAME & ADDRESS (if different from Controlling Office)<br>Department of the Army<br>26 Federal Plaza New York District, CofE<br>New York, NY 10287 | | 12. REPORT DATE<br>10 September 1980 |

PHASE I INSPECTION REPORT  
NATIONAL DAM SAFETY PROGRAM  
ISCHUA CREEK WATERSHED PROJECT  
SITE 6A  
I. D. No. NY. 571  
ALLECHENY RIVER BASIN  
CATTARAUGUS COUNTY, NEW YORK

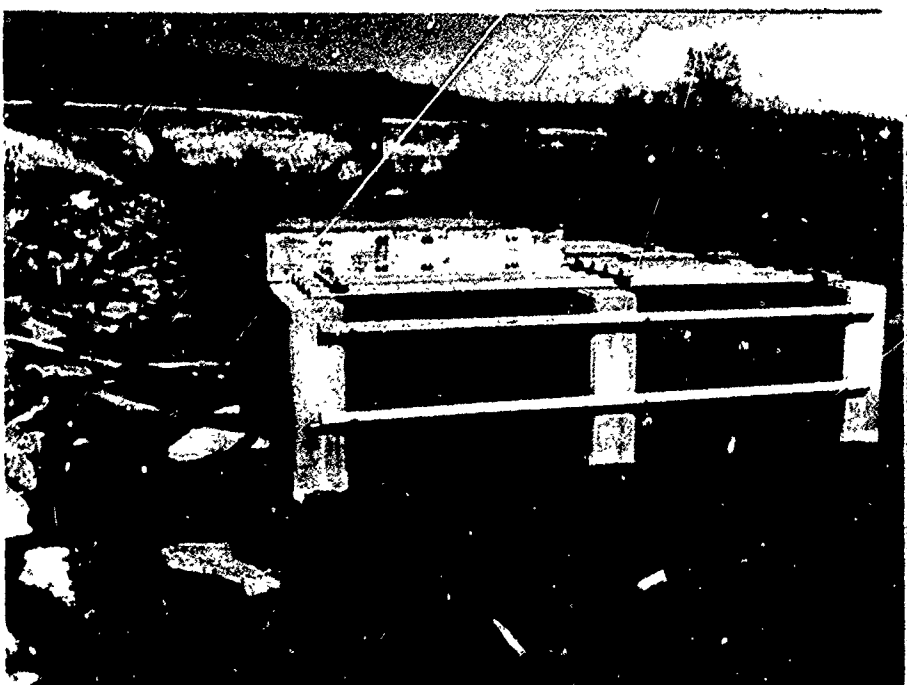
The reservoir is drained by a 30 inch I.D. reinforced concrete pipe and a manually operated slide gate with the gate stem situated at the top of the east drop inlet structure. The slide gate is in an operable condition, however, when fully closed, leakage estimated at between 10 and 20 gallons per minute passes around the gate.

Close-up of intake structure  
and reservoir drain gate  
operating stem.

Note: Reservoir Gate  
doesn't fit tight  
≈ 10-20 gpm  
leakage
