HAWK MOUNTAIN DAM

NDI ID No. PA-01129  
DER ID No. 54-180

PHASE I INSPECTION REPORT

11 JUL 80

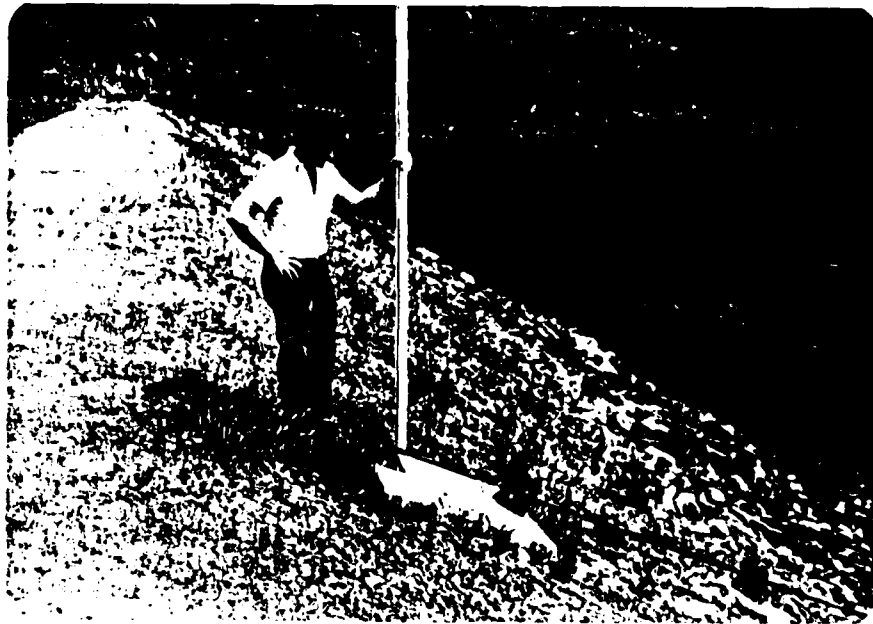
c. Appurtenant Structures. The outlet works is in good condition (Photographs C and D). The Owner opened the outlet works gate about 5 percent without any problems. The main spillway is in good condition

C. Outlet Works Operating Mechanism

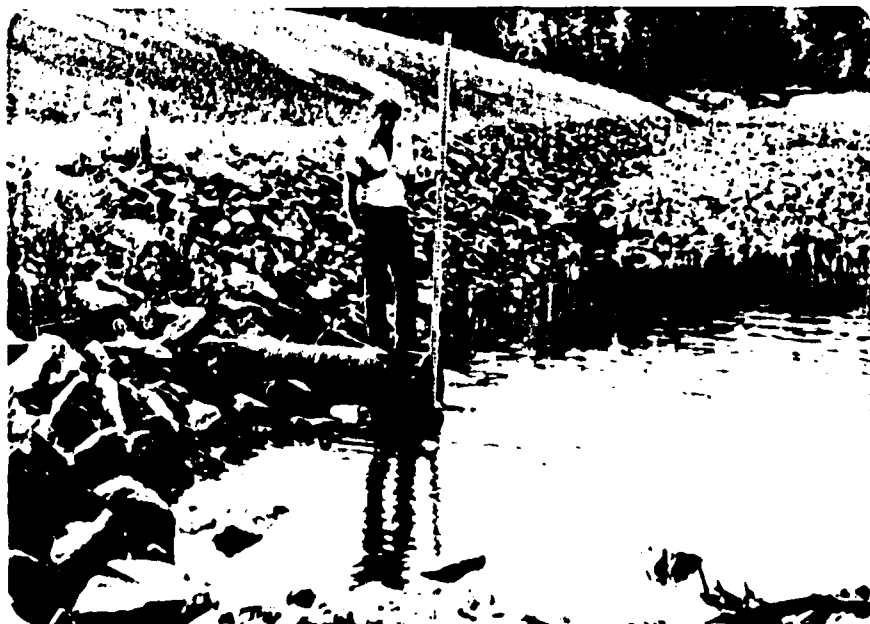
D. Outlet Works Outfall

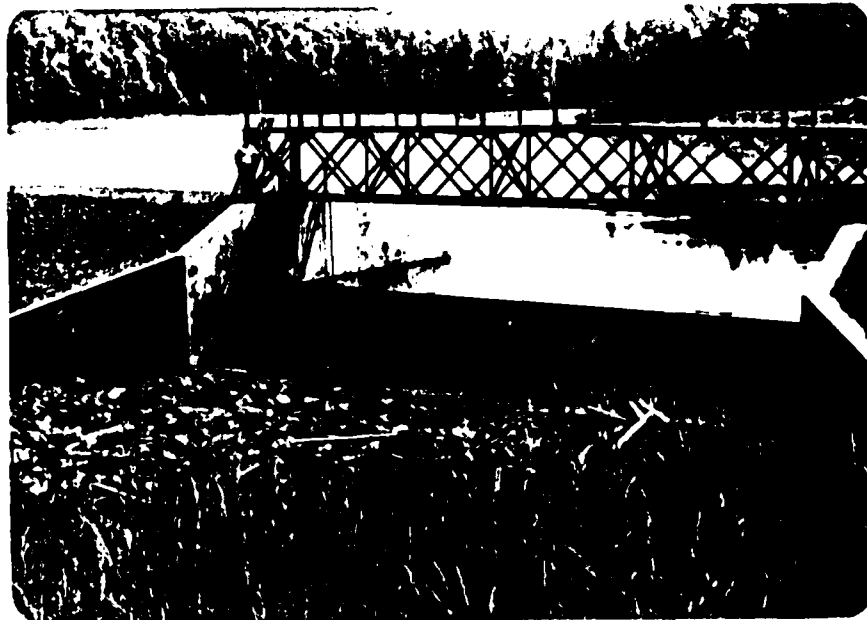
(Photographs A and E). The only deficiency observed at the area was significant seepage of about 2 gpm from one weephole at the left downstream wingwall (Photograph F). The spillway bridge is also in good condition. The spillway exit channel is protected by large riprap, which is in good condition.

E. Spillway
