NATIONAL DAM INSPECTION PROGRAM. HILLTOWN DAM (NDS ID NUMBER PA--ETC(U)

HILLTOWN DAM, BUCKS COUNTY  
PENNSYLVANIA

PHASE I INSPECTION REPORT,  
NATIONAL DAM INSPECTION PROGRAM

AUGUST 1980

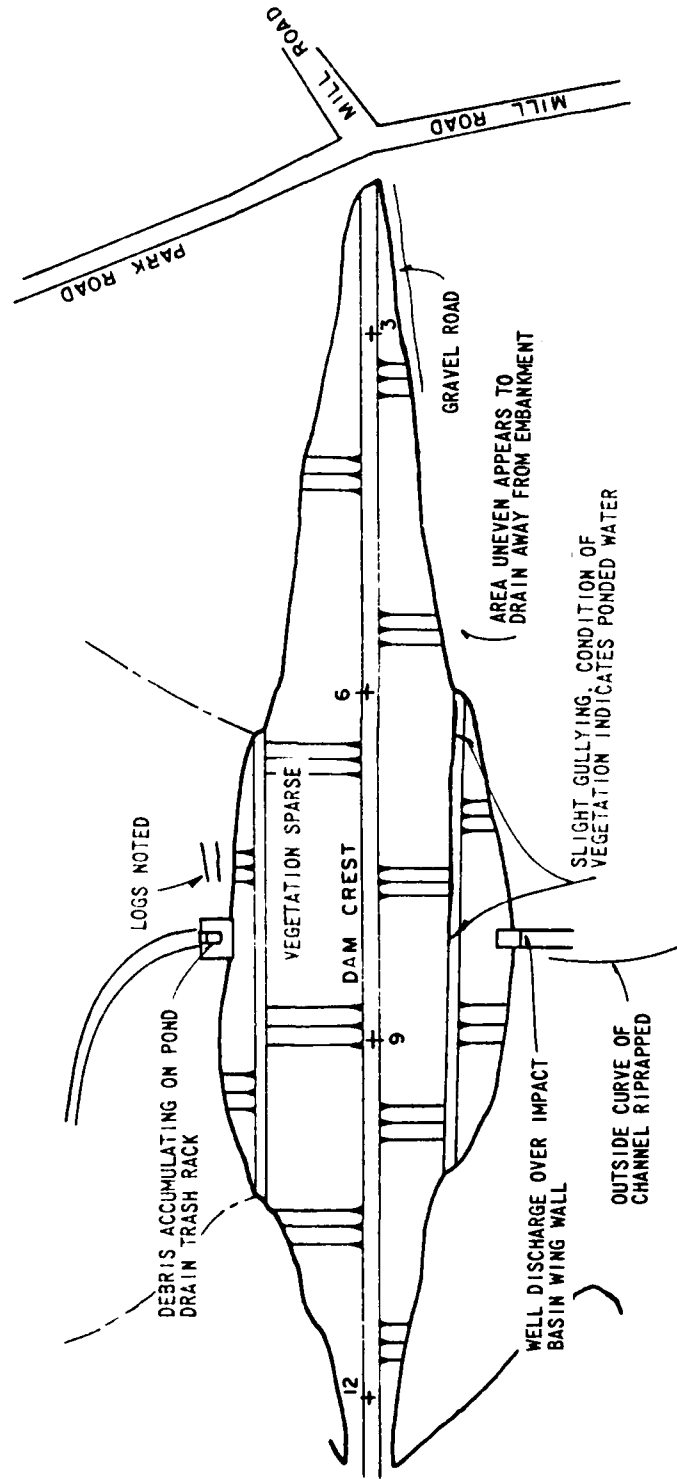
FIELD OBSERVATION PLAN  
HILLTOWN DAM  
(SCS PA 625)

*Crest protected by gravel. The berm on the downstream face is designed to intercept surface runoff and discharge the runoff to a rock gutter at the toe between the berm elevation and discharge channel. Sparse vegetation was at the intersection of the downstream face and berm, also having the appearance of vegetation subject to standing water. Some gullying was observed between dam station 8+00 and rock gutter.*
