**ETHEL SPRINGS DAM**

NDI No. PA 01121

**PHASE I INSPECTION REPORT  
NATIONAL DAM INSPECTION PROGRAM**

ETHEL SPRINGS DAM  
WESTMORELAND COUNTY, COMMONWEALTH OF PENNSYLVANIA  
NDI No. PA 01121  
PennDER No. 65-13

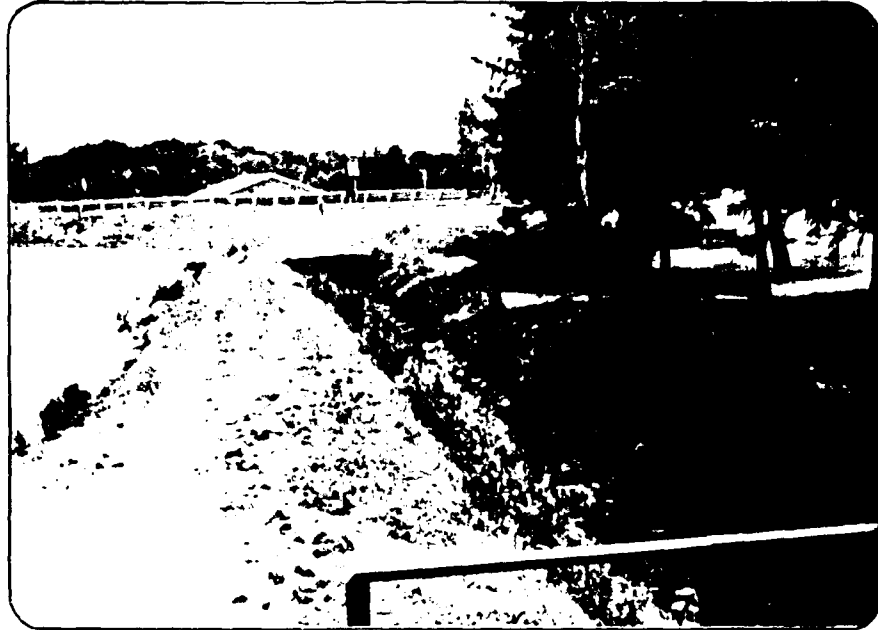
The presence of seepage and an uncompacted breach repair on the dike raises questions concerning the method of construction and long term stability of this dike. It is recommended that a detailed investigation of the dike be performed.

PHOTO 1. View Looking Downstream towards Dam along Crest of Dike

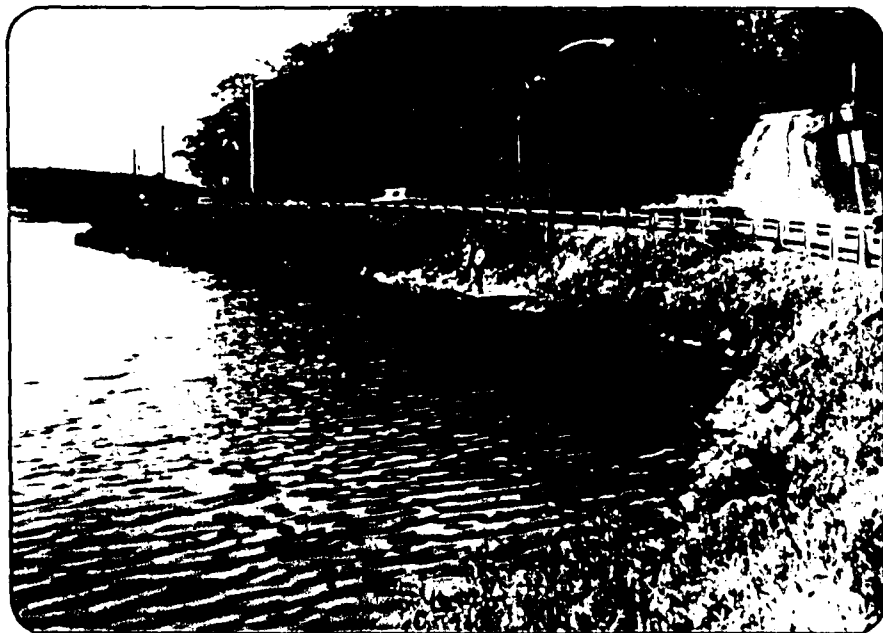
- c. Appurtenant Structures - A 6 inch high course of bricks has been installed on the crest of the spillway orifice. This has reduced the size from 1.5 feet high to 1.0 feet high. The intake pipes have only downstream closure provided. No other problems were observed with the appurtenant structures during the visual inspection.

**PHOTO 4. View of Reservoir Outlet at Left Abutment**

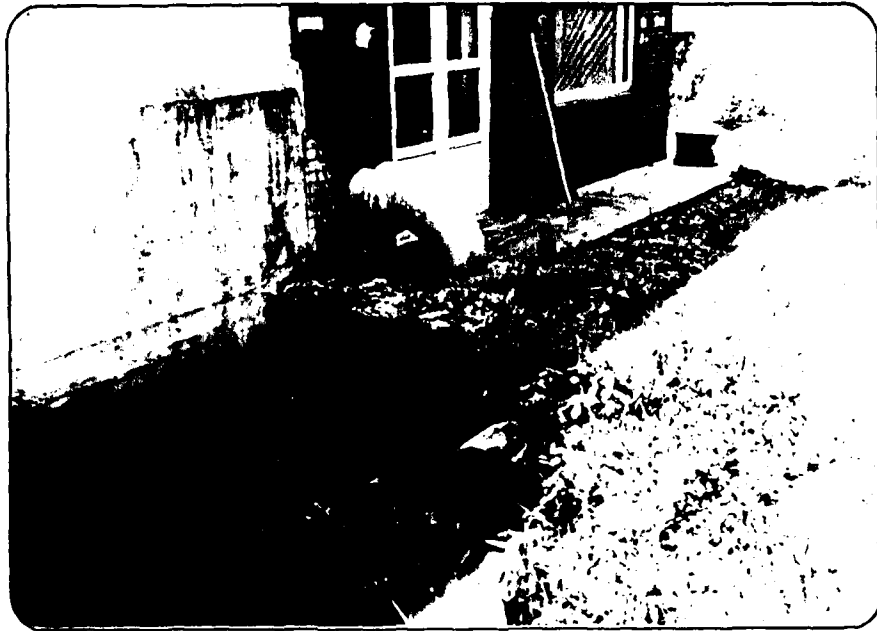
**PHOTO 5. View of Reservoir and Canal Outlets**

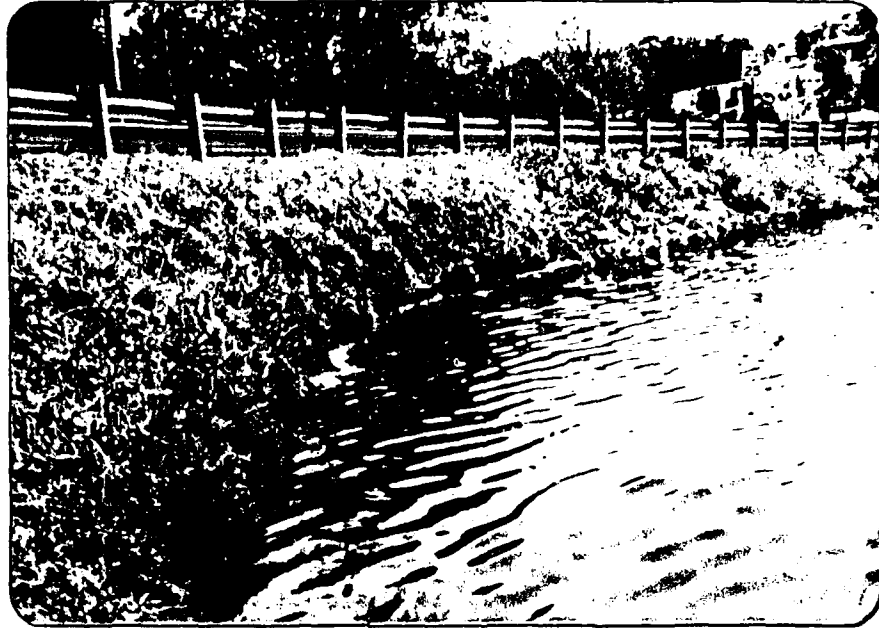
- a. Visual Observations - The erosion and scour on the upstream face of the embankment has made the upper portion (the portion above normal pool level) locally very steep. The presence of a bowed section of guardrail may be an indication of localized movement of the slope. It is recommended that the upstream face be properly repaired and adequate slope protection be installed. A detailed investigation of the embankment slope stability is required to be performed on the embankment slopes before this work is performed.

**PHOTO 7. View of Erosion along Upstream Face of Embankment**

- 1) Immediate initiation of an engineering study to further evaluate the spillway capacity and develop recommendations for remedial measures to reduce the overtopping potential of the dam. As a part of the analysis, detailed "as built" information concerning the conduits should be obtained.
- 2) Initiate an engineering study to provide a quantitative assessment of the dam and dike stability and develop recommendations for remedial action as necessary.
- 3) As a part of the aforementioned studies, the "as built" condition of the dam should be determined and recorded on engineering drawings for future reference.
- 4) Repair the eroded and scoured areas on the upstream face of the embankment and install proper slope protection.
